KL0S Shack Note #23

Amplifier Tube Socket Repair

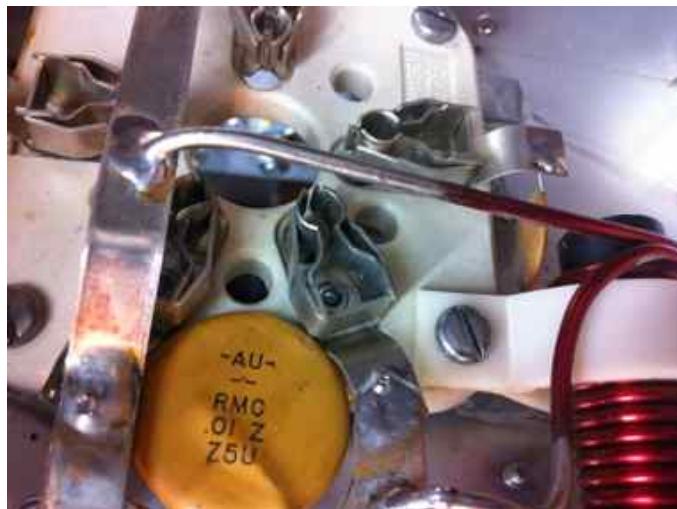
Fast forward – the other day the same half-power fault appeared and sure 'nuff the tube in the same position as before that would not light. Nuts! I disassembled the amp (you get to be an expert at that after 30+ years) and found the same filament pin solder reflow issue had manifested itself on the new tube and apparently on the same filament pin as before. Obviously that can't be a coincidence, there had to be more to the story.

The loose tube socket pin – compare the clip closure to the others

It would not be brain surgery to replace the tube socket (just a PITA) but that appeared to be the only real solution. Although I have a couple of spare 3-500Z sockets I had no desire to take that on so off to the Internet I went to look for other hopefully easier fixes. I found a recent thread in

the eHam forums where this exact problem was being discussed. One contributor wrote that the spring clips that compress the small split style tube holding connectors into which the tube pins are inserted can lose their "springiness" over time and that it was a simple affair to either replace the clip or attempt to squeeze it back into proper shape; that's not a great option since it had already deformed previously and would be prone to doing so again. Fortunately I have a couple of spare 3-500Z sockets and I found that it was in fact very easy to remove one of the good spring clips.

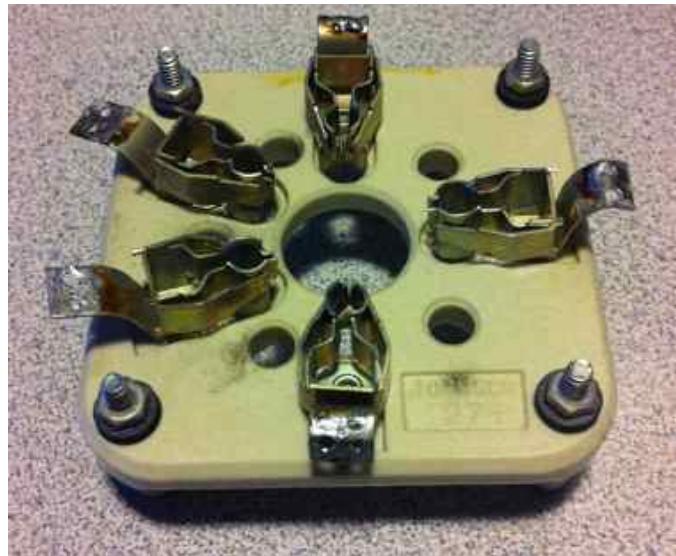
Spare tube socket parts donor

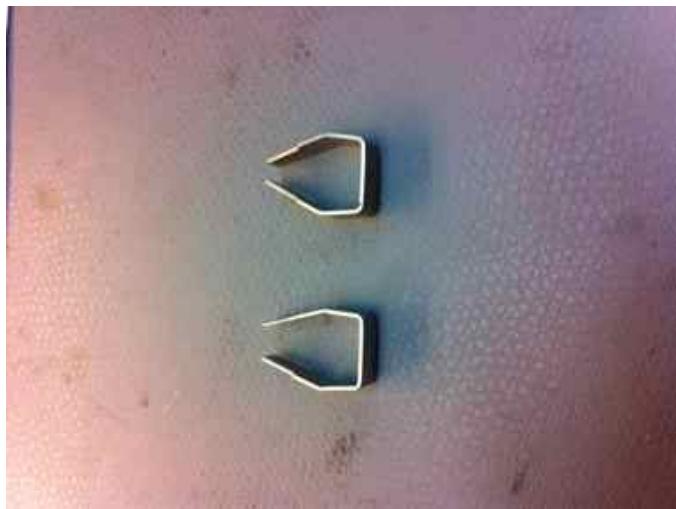
So back into the L-4B I went and it took me less than a minute to replace the spring clip and as you can see the difference between the old and new clip was substantial:

The replacement clip (top) compared to the loose clip

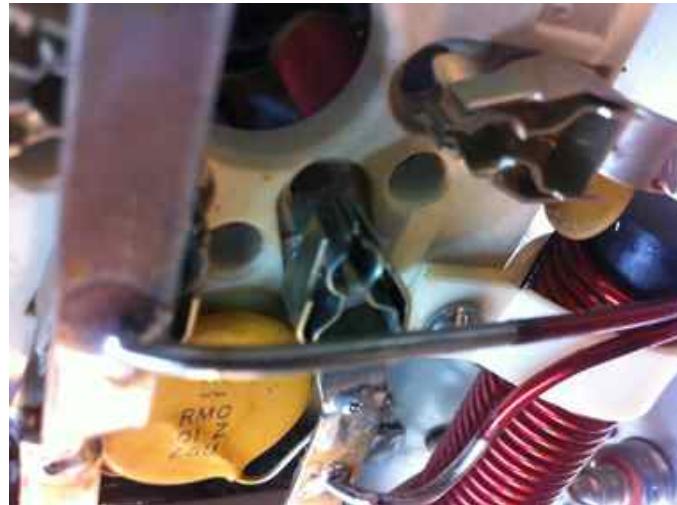
New spring clip in place

You can see from the above picture that the new clip now compresses the pin holder tighter than before. And with the tube reinserted into the socket the difference was also apparent.

I then "reflowed" the solder in the offending filament pin by turning the tube upside down, carefully applying heat to the pin and adding a small amount of silver solder to the mix. After letting the pin cool I checked the continuity between the two filament pins and it was still ok. I'll make the same repair to the original tube since it's part of what's now the backup pair.

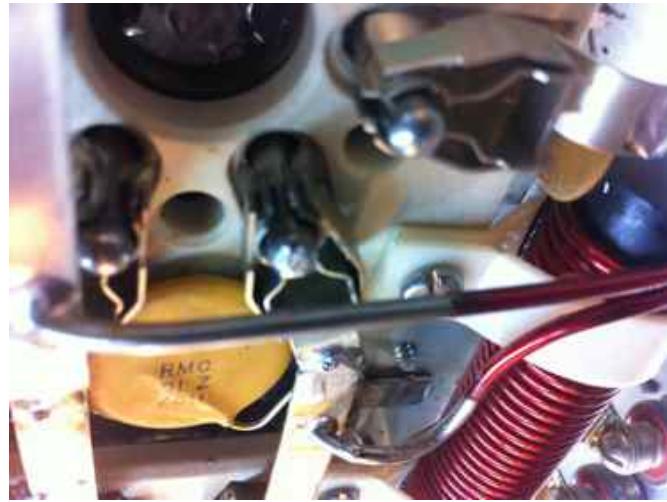
Tube replaced – filament pin nice and tight
