Circuit Improvements and Maintenance Procedures for the TS-830S

by Richard L. Measures, AG6K

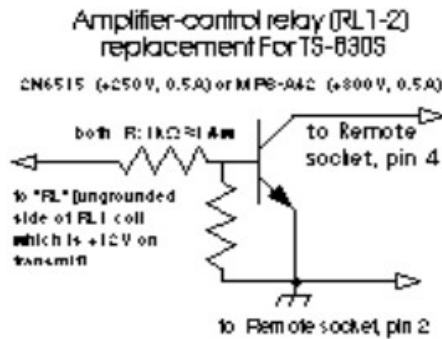
15. Problem: Excessive delay in relay control signal to external amplifier--which causes hot switching in the amplifier's RF relays. Cause: The RF relay in the TS-830S also switches the external amplifier relay control line. Thus, the amplifier relays can not begin to close until the RF-relay in the TS-830S has closed. **Fix:** Install a NPN >200v switch transistor [MPS-A42 or=] in the TS-830S to take over the job of relay control line switching. The input [base] of the switch transistor is driven by the +12V on transmit signal ["RL"] that drives the coil of the TS-830S' RF-relay, RL1. The base-current is limited to approx. 11mA with a 1k Ohm series resistor. Connect another 1k Ohm resistor between the emitter and the base to drain off the stored charge in the base. The emitter connects to chassis-ground. The collector connects to the wire from pin 4 on the Remote socket. Pin 2 of the remote socket should be connected to chassis-ground or to the emitter of the transistor. The NPN transistor can only switch a positive relay-control line voltage, so this circuit will not work on negative relay-control voltage amplifiers like the SB-200 and the 30L-1. The fix is to convert these amplifiers to [standard] positive V relay control line polarity. A solid-state electronic

cathode bias switch [ECBS] is useful in this application. Such a circuit is shown in *QST* magazine, January 1994, "The Nearly Perfect Amplifier."

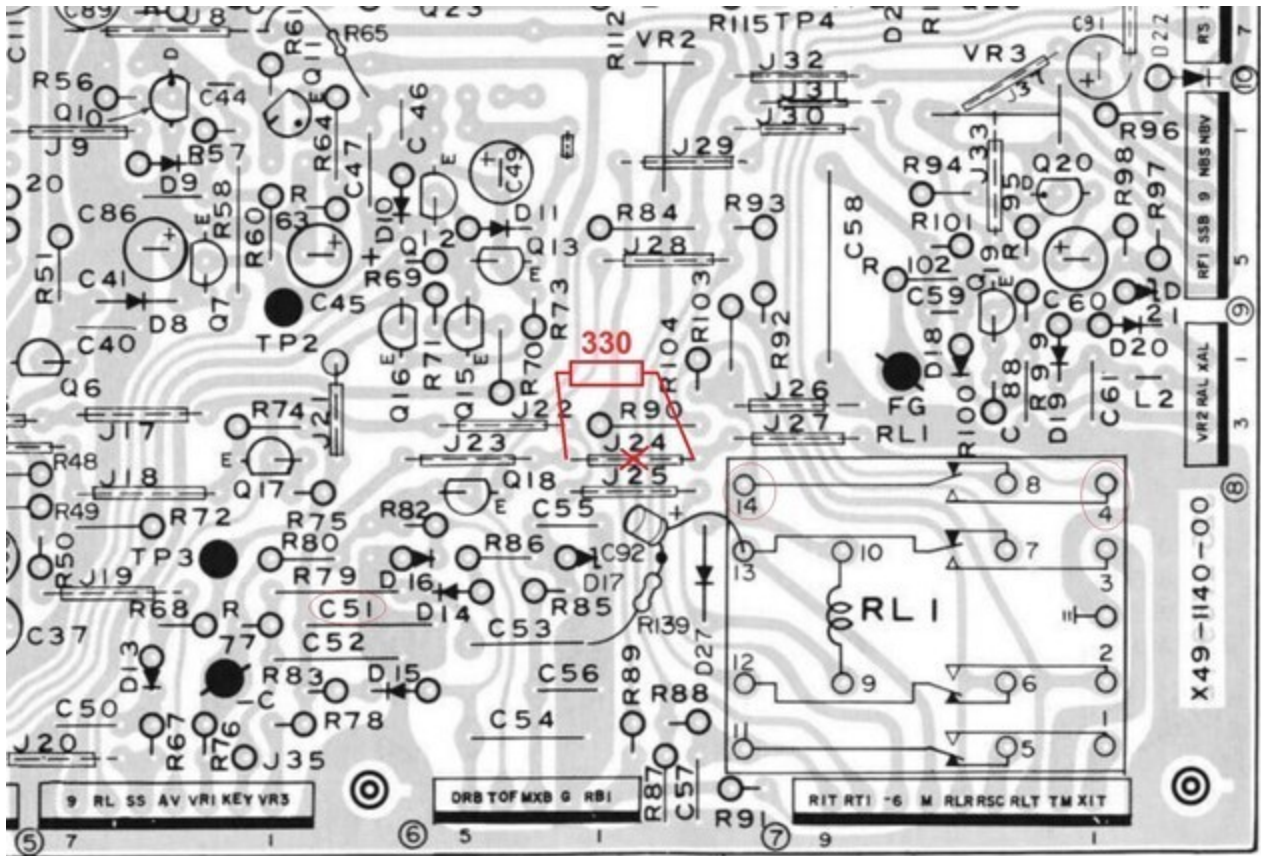
16. Problem: On the AF-AVR Unit, the 4-pole relay contacts which switch the bias to the finals may fail after extensive use. This relay is neither cheap nor easy to replace. The failure is caused by the repeated shorting to ground of a charged capacitor in the bias circuit by one set of the relay contacts during T/R transition. **Fix:** On the circuit diagram, find the leftmost set of contacts. The arm [movable contact] of this set of contacts is grounded. Fix: cut the trace from the arm to ground in 2 places about 5mm apart. Remove the foil between the cuts. Solder a approx. 100 Ohm, 0.25W resistor across the gap. The resistor will limit the peak discharge current during T/R-R/T switching to a value that will not burn the relay contacts.

If we look at the PCB in the service manual, we will understand - there is no possibility to isolate the relay contact from the ground by cutting the PCB trace. On the PCB, this relay contact [No:14] is connected to the relay winding and two resistors, and only then is it connected to ground via jumper J26. Therefore, it would be necessary to cut the PCB trace in two places, then connect the relay winding to the ground and only then connect the relay contact to the ground through a 100 Ohm resistor.

Capacitor C51 is shorted to ground by relay contact No:4, so a current-limiting resistor must be connected to it. Capacitor C51 charges up to 87 V DC. If we solder 330 Ohm resistors, the current pulse through the relay contact will be limited to 260 mA. This does not have a noticeable effect on the operation of the bias circuit, it is not even necessary to adjust the bias.

Problem Fix: Replace the jumper J24 on the AF board with a 330 Ohm 0,25 W resistor. A 330 ohm resistor will limit the current pulse through the relay contact to 260 mA. Jonas, LY1O
