DG1 DISPLAY

TS820S DISPLAY PROBLEMS

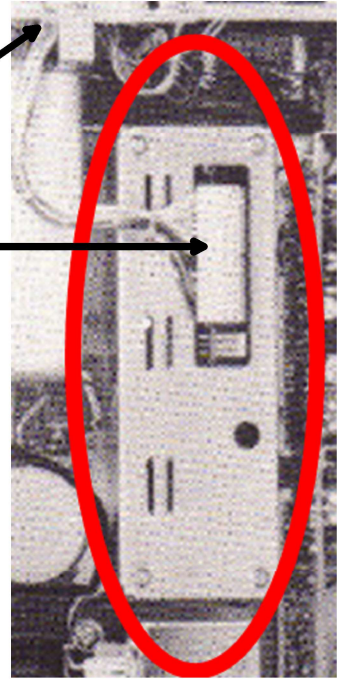
Some DG1 displays do not have molex connector but are soldered.

Apply a small amount of DeOxit cleaner to both plug and pins.

Put connectors back on and test.
