SERVICE BULLETIN

from: TRIO-KENWOOD COMMUNICATIONS, INC.

SUBJECT: SERVICE NOTE ON DG-1

SUBJECT: DG-1 STANDARD SERVICE PROCEDURE

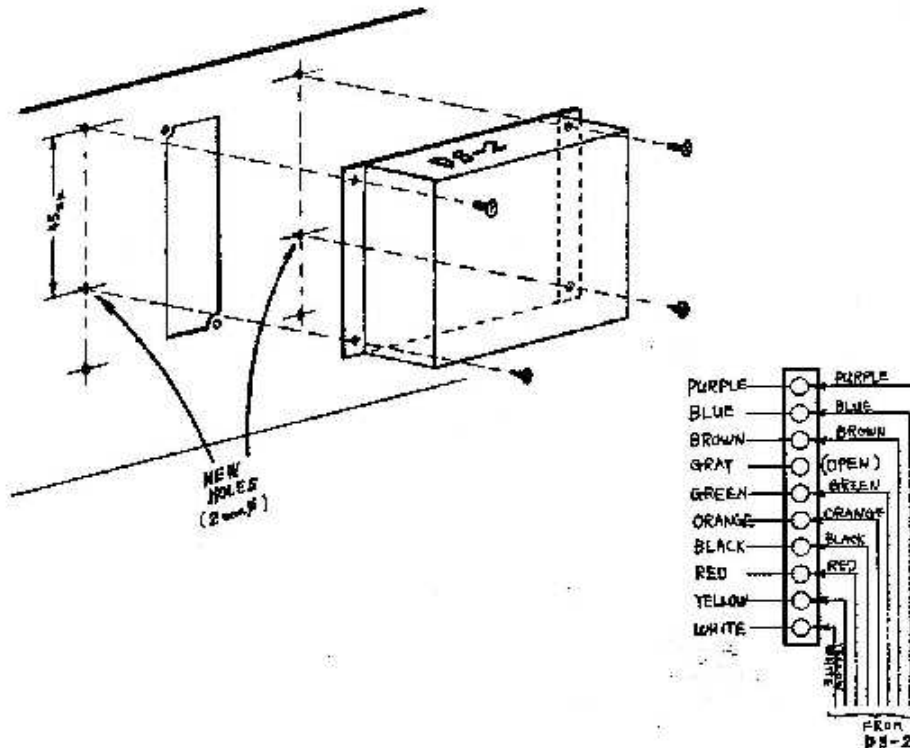
The DS-1A DC-DC converter for the TS-820 series and TS-520/S has been replaced by a new model, the DS-2. Wiring color code is the same. Physical size is smaller. Two additional mounting holes must be drilled in the transceiver rear panel.

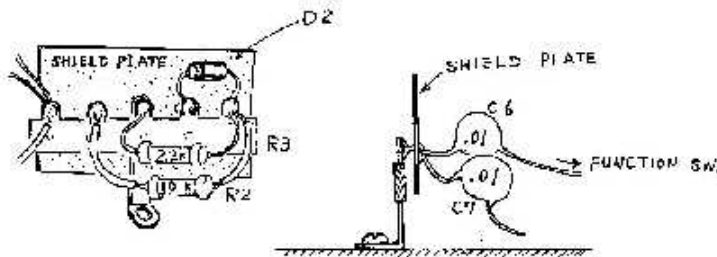
For Sweep interference from the SM-220 back into either a TS-520, or TS-180S, install an additional shield in the RF compartment in the SM-220.

1. Disconnect the power cord from the back of the scope.
2. Remove the scope top cover.
3. Loosen the Function and RF ATT shaft couplers using a 1.5mm allen key. Withdraw the shafts away from the RF compartment.
4. Remove RF compartment screws from the rear panel.
5. Remove 4 screws to open the RF comp.
6. Remove one screw to remove internal shield.
7. C6, a .01uF, runs from the Function Switch to a ground point under the RF ATT switch. Cut the ground lead and shorten so the cap is grounded to the ground point under the function switch.
8. R2, a 10k ohm, is attached to the terminal strip directly under the function switch. Reposition this resistor from the top of the terminal strip to the bottom of the strip.
9. Install the additional shield to the ground point under the function switch.
10. Reverse disassembly procedure to reassemble.

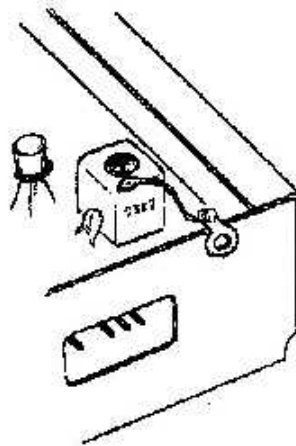
We have found a few cases of feedback when the pan display option was installed in the SM-220 Station Monitor. This is due to the isolated ground of the BS-5 or BS-8 pan display option. It may be remedied by grounding the case of the input transformer in the BS-5 or BS-8 to the case. (See drawing below.) This change will be incorporated in all future deliveries of the BS-5 and BS-8.

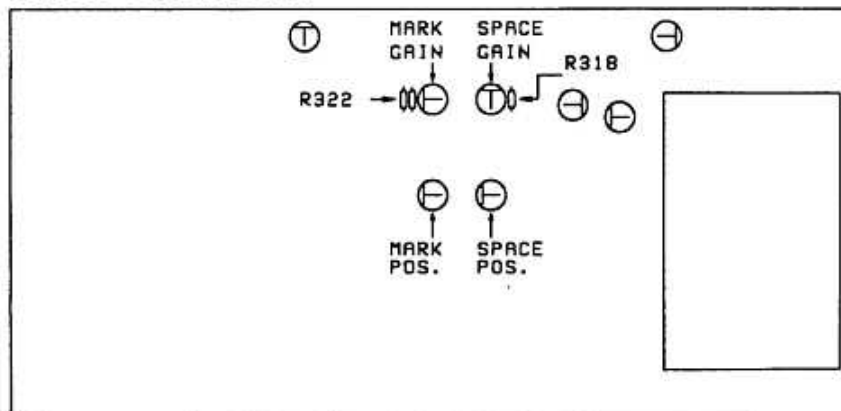
Some users of the SM-230 have reported that the MARK and SPACE gain adjustments do not sufficiently reduce the signals to display them on the CRT. The following modification will correct this condition.

1. Disconnect the power cord and control cables.
2. Remove the top cover (6 screws).
3. Locate the Horizontal unit. This board is vertically mounted on the right side of the SM-230.
4. Locate resistors R318 and R322 on the Horizontal unit.
5. Replace R318 and R322 with 680 ohm resistors.
6. Assemble the SM-230.
7. Adjust the MARK and SPACE gain adjustments as necessary to obtain the correct cross pattern.

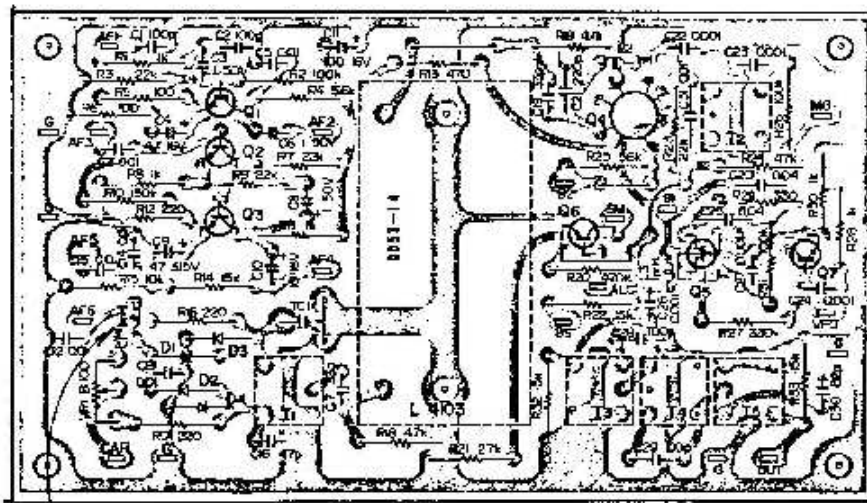
FOIL SIDE OF BOARD

There have been some cases of 120Hz hum in the T-599D. This may be reduced by removing L-1 (1mH) on the generator unit (X52-0009-00) and replacing it with a 47 ohm resistor. Shown below is the generator unit board with this change.

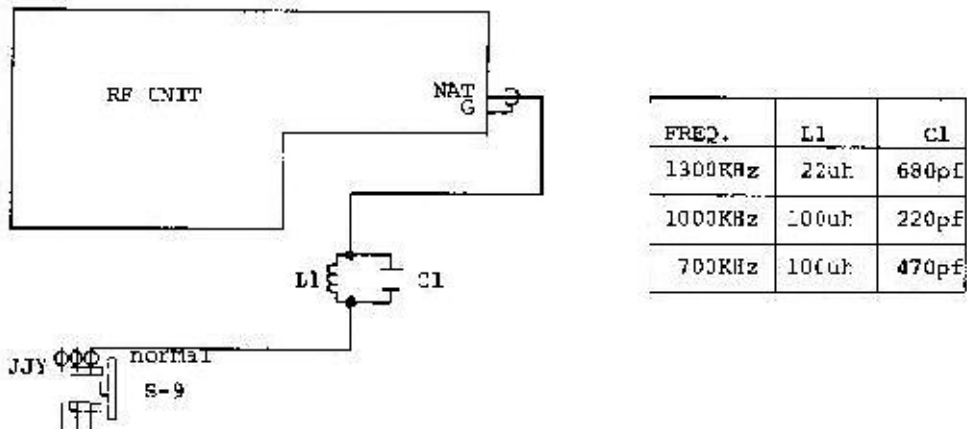
We have found a few instances of customers who live near an AM broadcast station hearing that station on the 2.5MHz band of their TS-520. Shown below is a filter that may be installed if this occurs.

A suggested location for the filter is on a small terminal strip that is then mounted on a mounting screw of the RF unit. This screw is located at the front corner next to the VFO. The cable between S-9 (WV switch) and terminal NAT of the RF unit is removed from terminal NAT and connected to one side of the filter. A short piece of RG-174/U is then connected from the other side of the filter to the terminal NAT. This should prevent the AM broadcast interference.

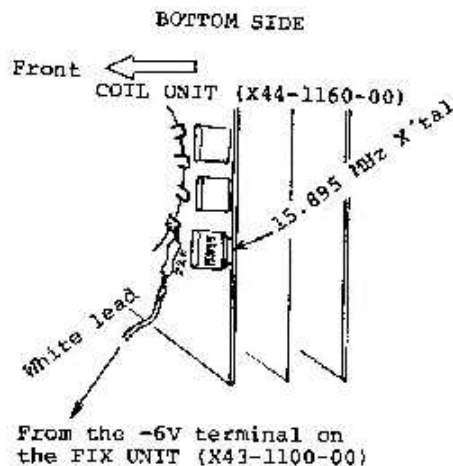
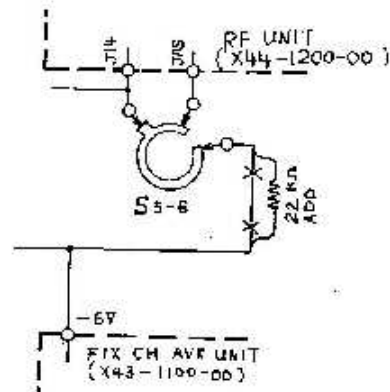
Cause of failure may be traced to an intermittent shorting between the 14V DC & -6 DC supplies as the Band Switch is rotated between 40 & 80 M. This will weaken or destroy D8, 6V Zener on the FIX CH AVR unit. To prevent repeat failure, break the WHITE lead & install a 22k ohm $\frac{1}{4}$ W resistor at the Bandswitch S5-6, between the -6V supply line and switch terminal. And of course replace D8 on the FIX CH AVR unit, X43-1100-00.

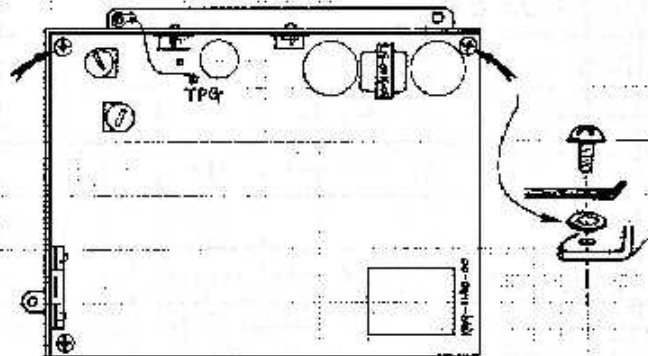
Some users may report an intermittent shift in display and operating frequency. This may typically be a 1 to 4 KHz random shift. Cause will be a loose grounding screw on the AF-AVR unit heat sink.

1. Remove the top cover (8 screws) and unplug the speaker.
2. Remove the bottom cover (8 screws).
3. Remove 5 screws holding the AF-AVR unit and swing the board over. Leads do not have to be unplugged.
4. Add two tooth-lock washers as shown.
5. Replace the circuit board and heat sink to the chassis, adding the solder lug as shown.
6. Solder a jumper between the TPG wrap post and the added solder lug.
7. Replace the top and bottom covers.
