Kenwood TS-830

Survival Guide

Kenwood TS-830 Survival Guide, ed. [Olaf Rettkowski](#), DL9AI, ver.1.2, 03 Dec 2002,
rev. 27 Oct 2023

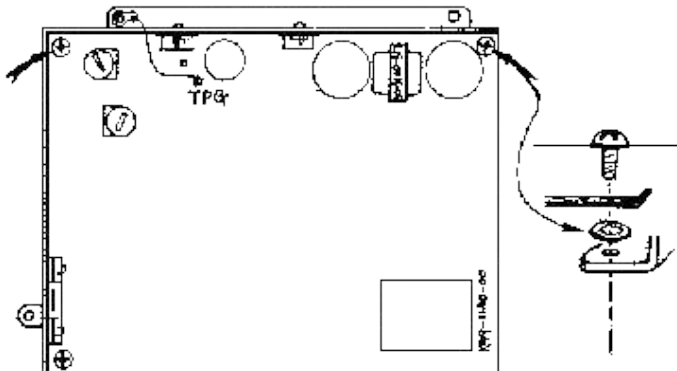
Some users may report an intermittent shift in the display and operating frequency. This may typically be a 1 to 4 KHz random shift. Cause will be a loose grounding screw on the AF/AVR unit heat sink.

1. Remove the top cover (8 screws) and unplug the speaker.
2. Remove the bottom cover (8 screws).
3. Remove 5 screws holding the AF/AVR unit and swing the board over. Leads do not have to be unplugged.
4. Add two tooth-lock washer as shown.
5. Replace the circuit board and heat sink to the chassis, adding the solder lug as shown.
6. Solder a jumper between the TPG wrap post and the added solder lug.
7. Replace the top and bottom covers.

Installation time for this procedure is 1/2 hour or less.

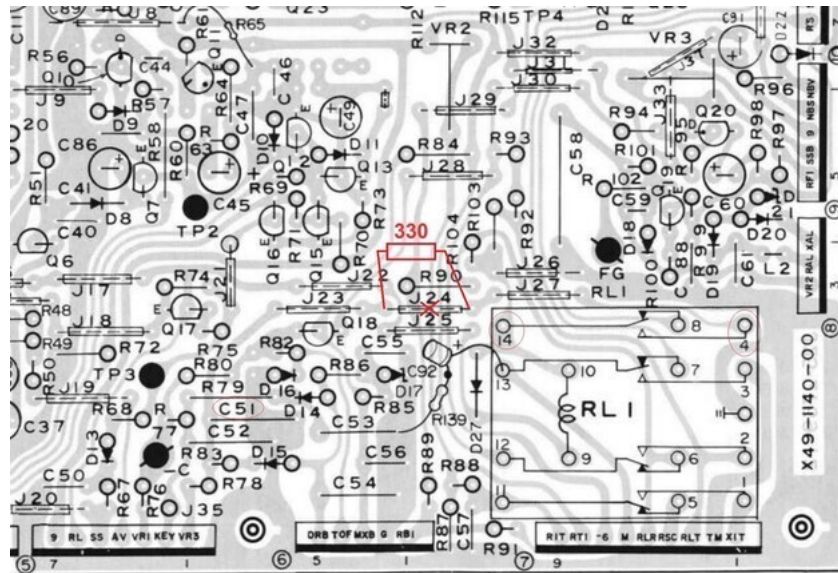
6.12 On the AF-AVR Unit, the 4-pole relay contacts which switch the bias to the finals may fail after extensive use.

This relay is neither cheap nor easy to replace. The failure is caused by th.00000 repeated shorting to ground of a charged capacitor in the bias circuit by one set of the relay contacts during T/R transition.

Fix: cut the trace from the arm to ground in 2 places about 5mm apart. Remove the foil between the cuts. Solder a approx. 100 Ohm, 0.25 W resistor across the gap. The resistor will limit the peak discharge current during T/R-R/T switching to a value that will not burn the relay contacts.

I did this on my TS-830S, everything works Ok and relay RL1 is safer.

[see graphics below]

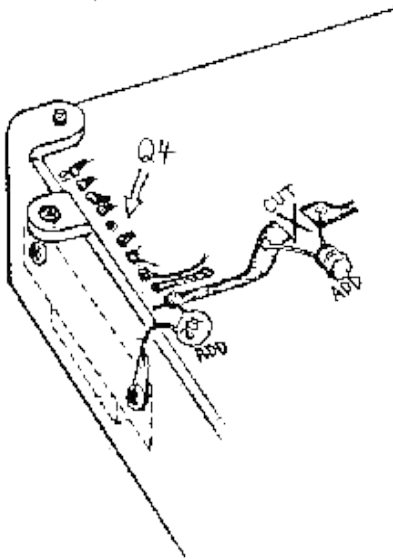
Transmitter "talkback", either with or without a linear amplifier, may be eliminated by adding a filter at the receiver audio power amplifier.

On the AF unit X49-1140-00 at Q4, cut the 12 V DC B+ line between R47 and C28, and add a 1 μ H choke (L40-1092-02) in-line. Add a 0.01 μ F cap (C52-1710-36) from the IC pin 1 to ground, as shown using a 3 mm lug (E23-0015-04) under the IC mounting screw on the heat Sink.

Installation time for this procedure is ½ hour or less.
