## Background on the L41

## Repair of L41

## Rewinding TS-830s L41 RF coil

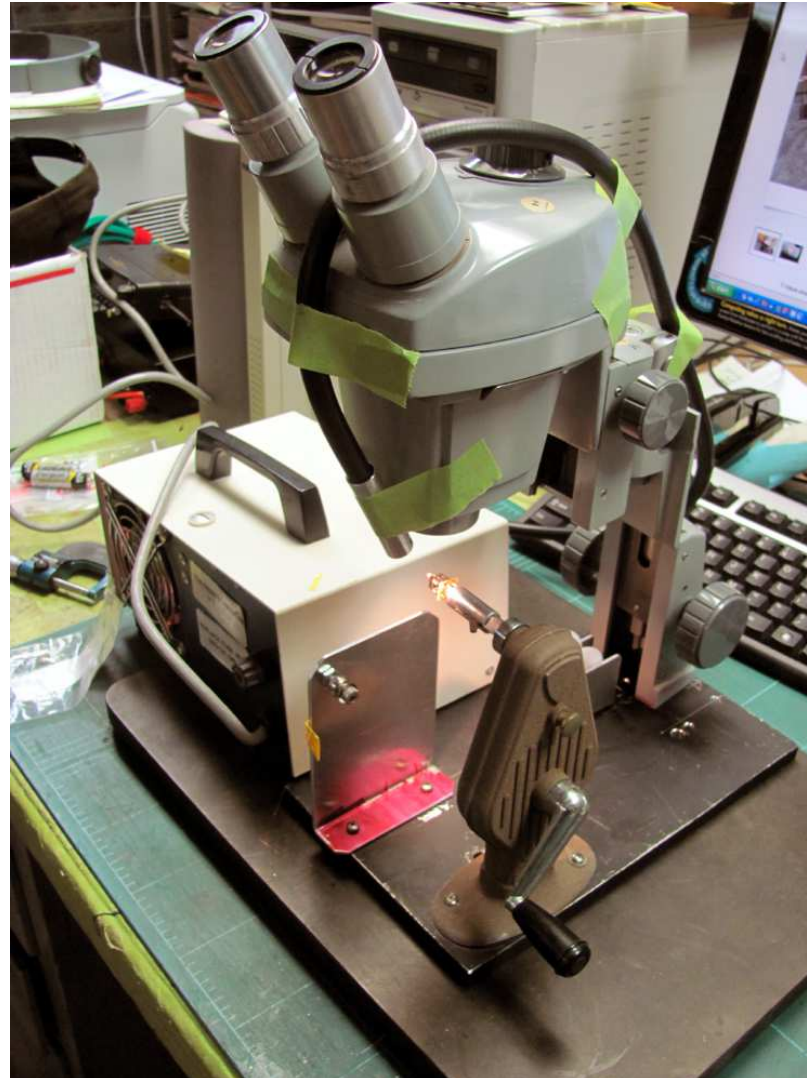
B&L Microscope.

Fiber optical light source  
(cold light).

8mm Film editor  
winder & mandrel  
to support L41.

Wire tensioner.

- No NOS L41s available, so it needs to be rewound.
- #41 magnet wire; 6T on primary, 26T on secondary.
- Need high magnification, a mandrel to hold the L41 bobbin, and a winding spindle. Cannot just scramble-winding it by hand; Make an even, multi-layer solenoid winding.

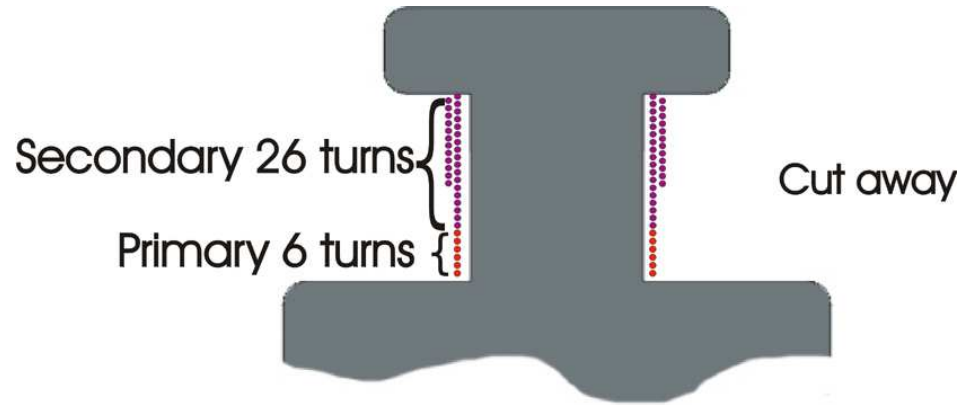
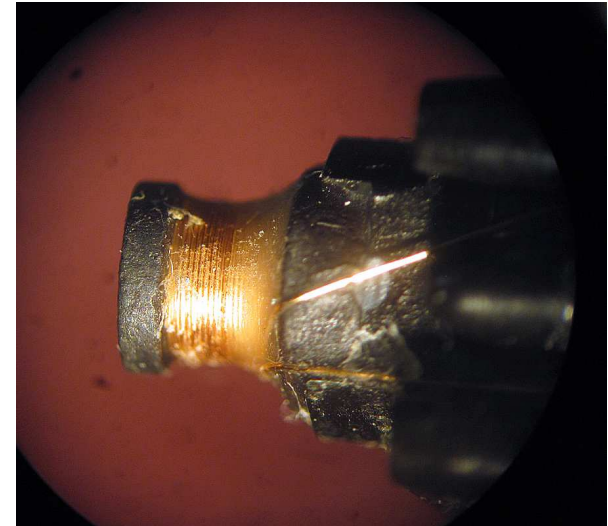
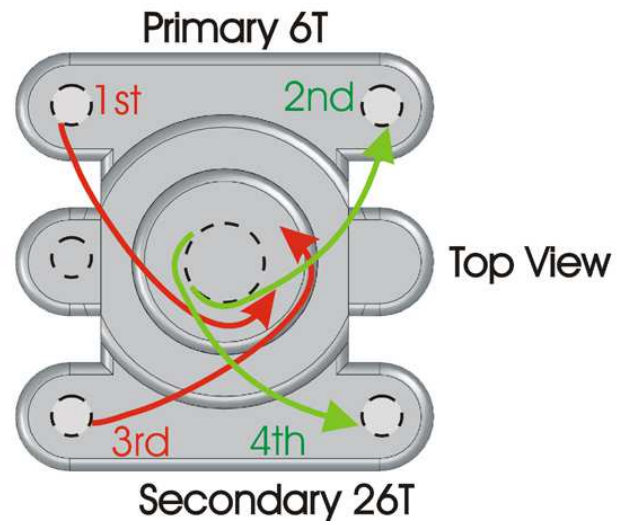
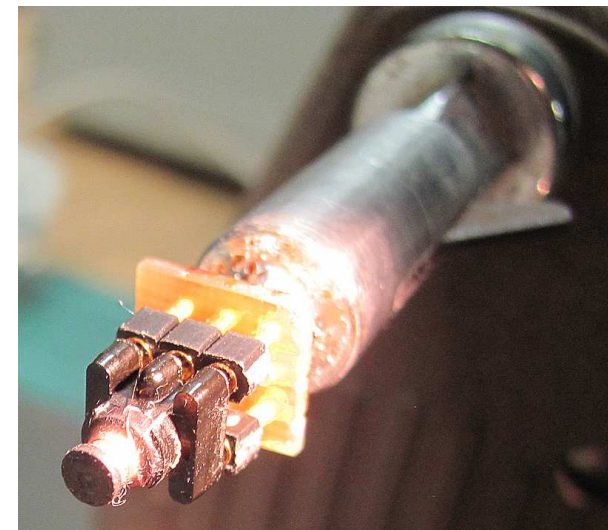
One can actually count the windings
