SERVICE BULLETIN

from: TRIO-KENWOOD COMMUNICATIONS, INC.

SUBJECT: TS-180S DFC HUM WITH PS-30

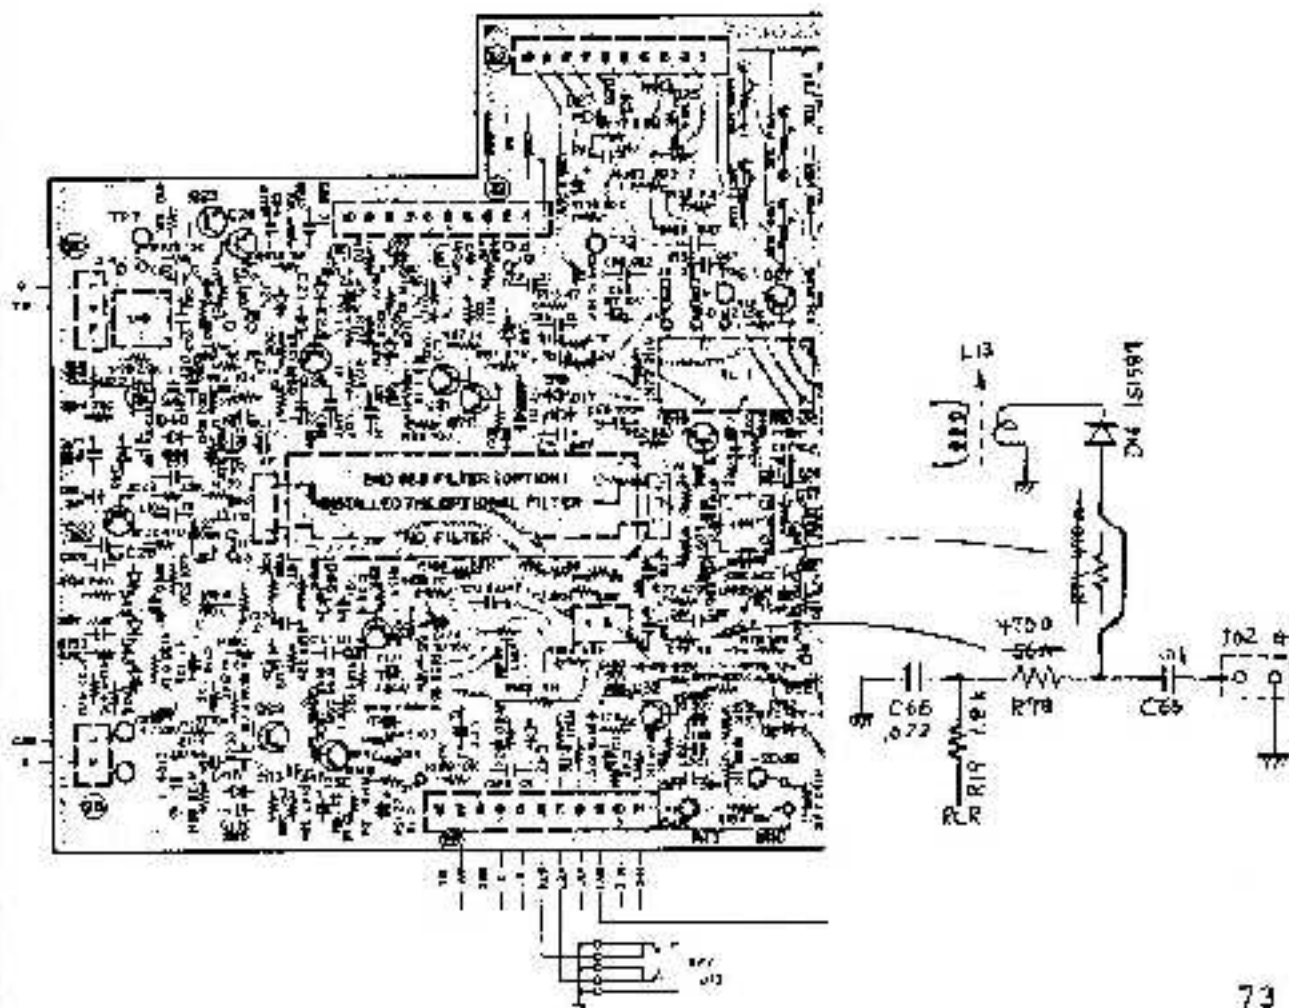
TS-180S owners who desire to operate an SM-220 for IF output display will require a wiring change to the IF unit X48-1240-00. No additional parts and no adjustments are required.

Remove R77, 470 ohm, and replace with wire jumper. Remove R78, 56 ohm, and replace with old R77. The 56 ohm resistor is not used.

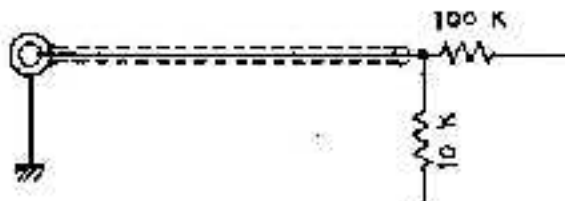
Fixed Divider

For those operators who desire a Patch input similar to the TS-520S or TS-820S, an input connection and terminal must be added at the Mic input preamp circuit.

Use a 100Kohm in series, with a 10Kohm to ground on the input side of the 100Kohm resistor. Use shielded line, and connect as follows:

On the IF Gen unit X49-1110-01 install the fixed divider at the junction of R43 10K, C42 100pF, & C43 1uF (input of Q18). Add an RCA jack, or use remote pins 7 and ground for input.

On the IF Gen unit X48-1240-00 install the fixed divider at the junction of R167 10K, C128 .001uF, & C129 1uF (input of Q32). Add an RCA jack, or use remote pins 7 and ground for input.

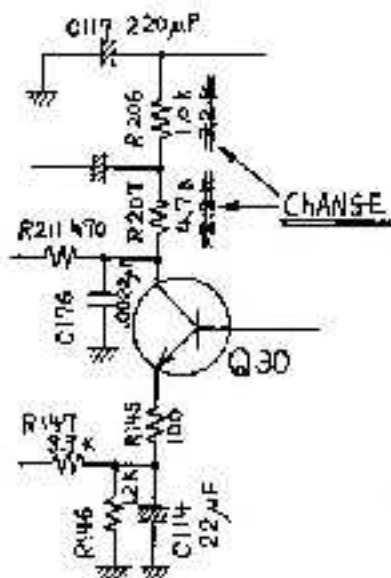
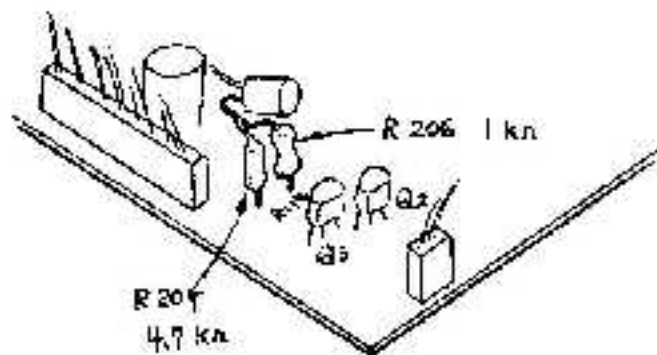
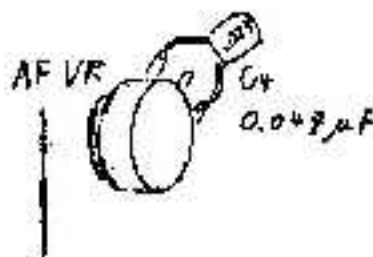
RX audio output from the TS-180S may be increased a total of 4.7 dB. This is an optional change which you can make at the owners request.

On the IF unit X48-1240-00 change components:

R206 2.2K change to 1 K ohm

R207 2.2K change to 4.7 K ohm

On the AF Gain Control, between pin 1 and 3;

C4 .047uF change to .027uF mylar

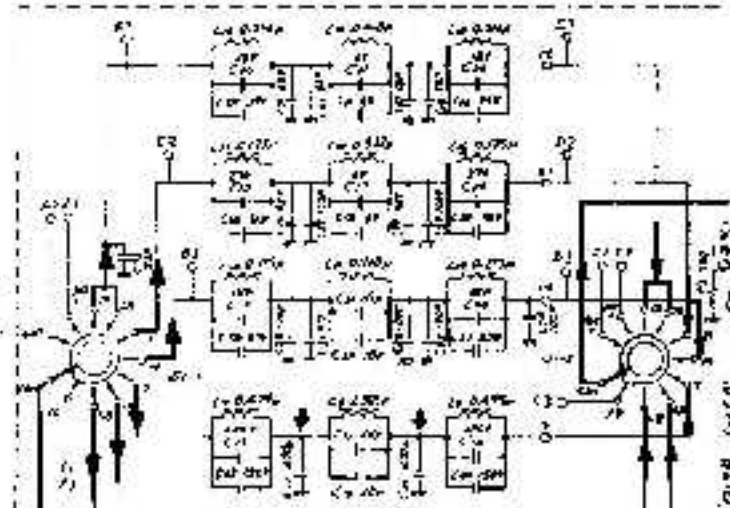
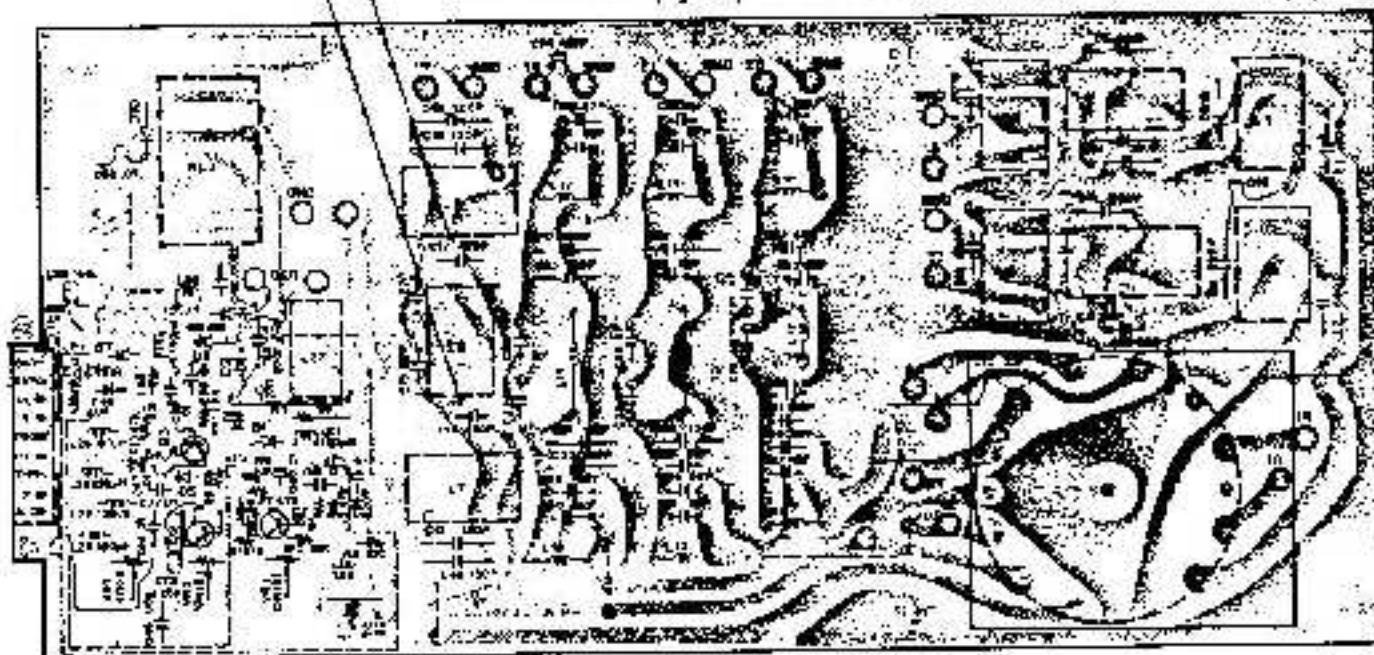
▼ LPF UNIT (X51-1180-00)

Some operators may experience intermittent reduction or loss of ALC, especially after several minutes transmit time.

On the LPF unit X51-1180-00, change C14, C17 from 470 pF to 390 pF. Check ALC level and adjust if necessary, per section 406 ALC meter adjustmet, TS-180S service Manual.

New part: CM93D2H390J 390pF +/- 5% 500v mica or ceramic

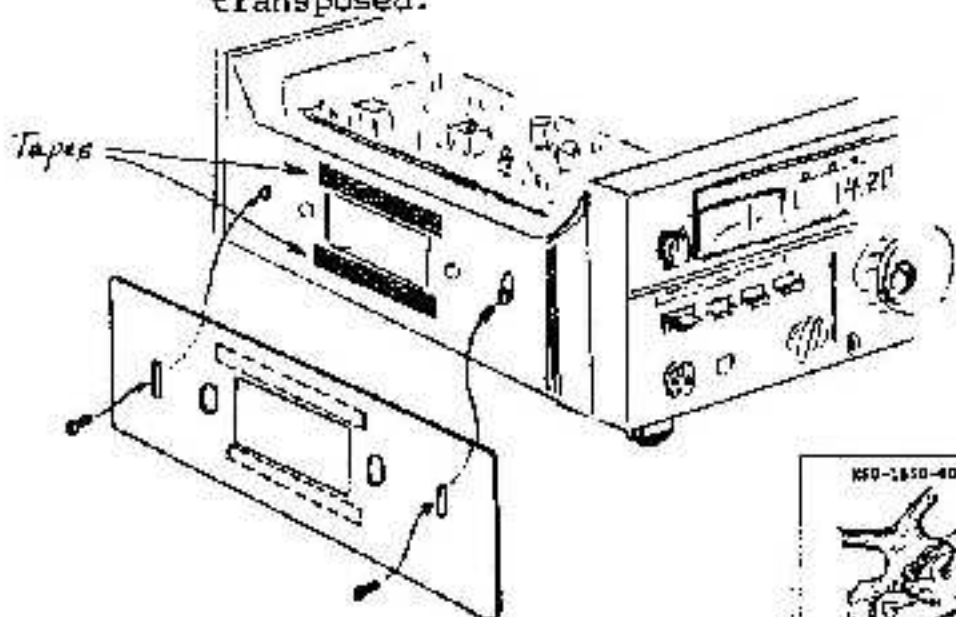
For complaints of either induced power supply hum, or intermittent frequency stability while using the DFC, perform the following changes to the VCO unit X50-1550-00:

Note: On page 37 of the Service Manual, the VCO Board view shows reversed callouts for Q11 & Q15. D & S, and G1 & G2 are transposed.

- *1. Install a 330K ohm resistor between Q11 G1 & the 8V line. Connect from L7 at C12 to Q11 G1, at R35.
- *2. Replace L12 68uH with new part L40-6831-21.
- *3. Replace L13 150uH with new part L40-1541-27.
- *4. Install magnetic shield as illustrated. Use the two existing screws, plus double faced tape to prevent vibration.

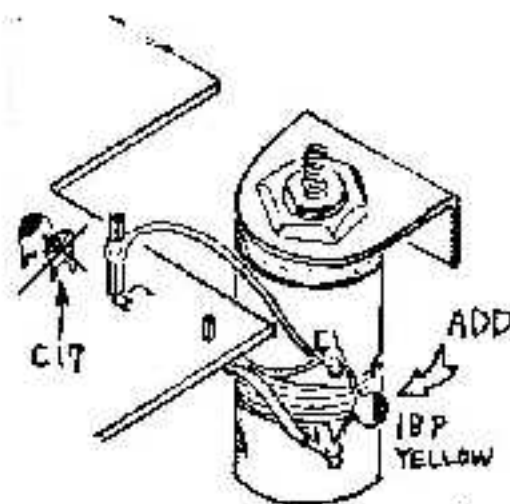
VFO drift characteristics may be improved by changing a capacitor value and location in the VFO.

1. Begin by calibrating the analog dial to the Digital Display at 14.000.0 MHz. DO NOT disturb this calibration while working on the VFO.
2. Turn off the main power and remove the VFO unit by two 3mm hex head bolts.

3. Withdraw out the front panel and unplug the leads.
4. Remove the VFO cover by five Phillips head screws.
5. Remove C17 from the PCB. This may be cut flush to the board.

6. Install the 18 pF yellow cap across the tank coil terminals. Position the cap near the coil.
7. To reassemble, performs steps 3, 2. Snug all VFO case screws. A later complaint of frequency jump would indicate a loose VFO shell.

8. Turn on the radio and check analog dial calibration against the Digital Display. Adjust VC1 (center of the Seal Tape) only if the zero- point has moved.

9. VFO linearity final check: The Digital readout and analog dial should agree to within +/- 2 kHz at every 100 kHz dial point.

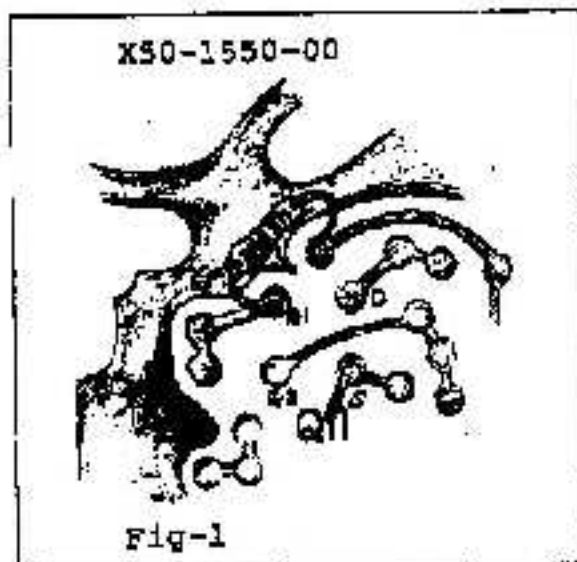
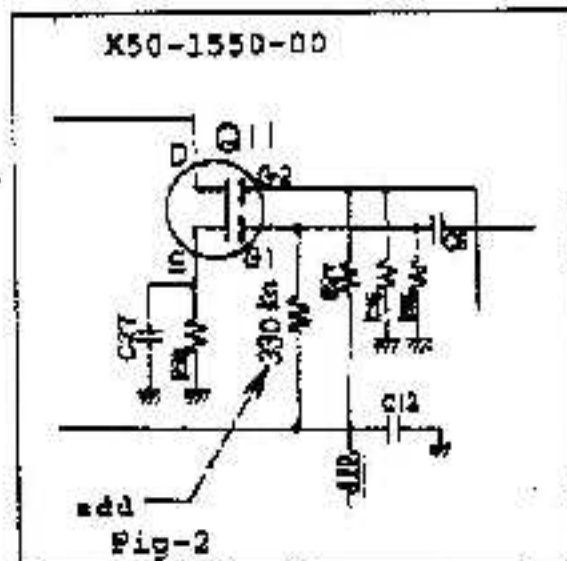
TS-180S operators may report intermittent DFC instability, especially at 10Khz even points. This may be characterized in some cases as PM'ing.

On page 37 of the Service Manual, the Board view of the VCO unit contains reversed callouts for Q11 & Q15 FET's. D & S, and G1 & G2 are transposed.

On the VCO unit X50-1550-00, install a 330K ohm resistor between Q11 G1, and the 8V line. Connect from L7 at C12 to Q11 G1, at R35.
