SERVICE BULLETIN

from: TRIO-KENWOOD COMMUNICATIONS, INC.

SUBJECT: SERVICE NOTES ON TS-820

DATE 10-25-77

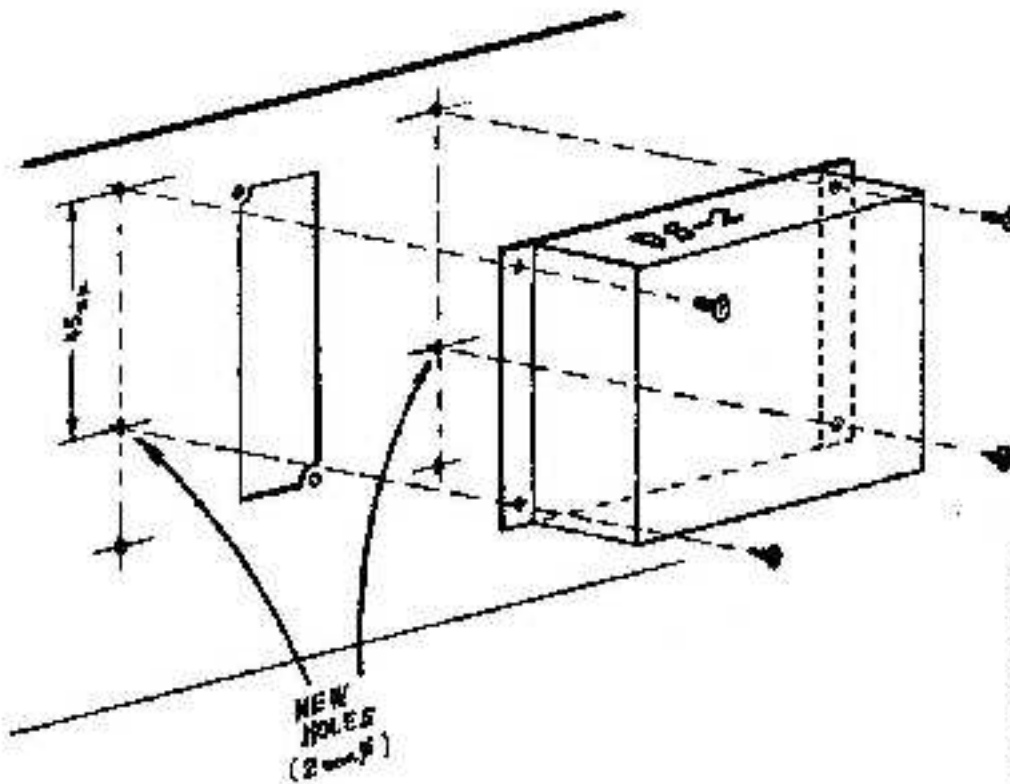
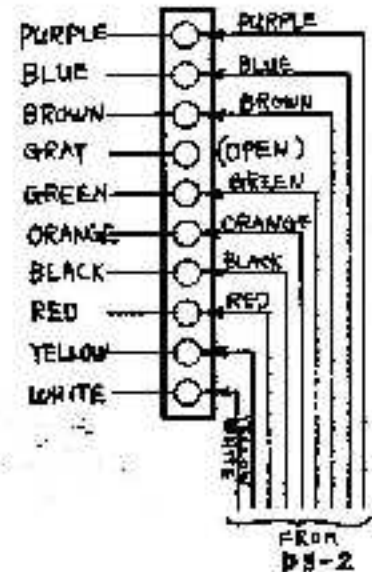
The DS-1A DC-DC converter for the TS-820 series and TS-520/S has been replaced by a new model, the DS-2. Wiring color code is the same. Physical size is smaller. Two additional mounting holes must be drilled in the transceiver rear panel.
