KENWOOD 2016 Dayton Hamvention Kenwood Forum

Agenda:

- VFO Delayed Power On Modification
- TS-900 & TS-511 restoration
- Band Switch Repair
- TS-530 & TS-830 Sloppy Band Switch
- TS-530s/TS-830s Molex Connectors
- TS-830 CW Filter Option
- Final Unit Cathode/Screen grid protection
- TS-830 Low Audio
- RF Board Cracked RF Board Sprockets
- VFO Stability
- TS-820S Digital Display
- Hybrid restoration Techniques
- Help with Parts, Documentation & Service
- Questions and Answers

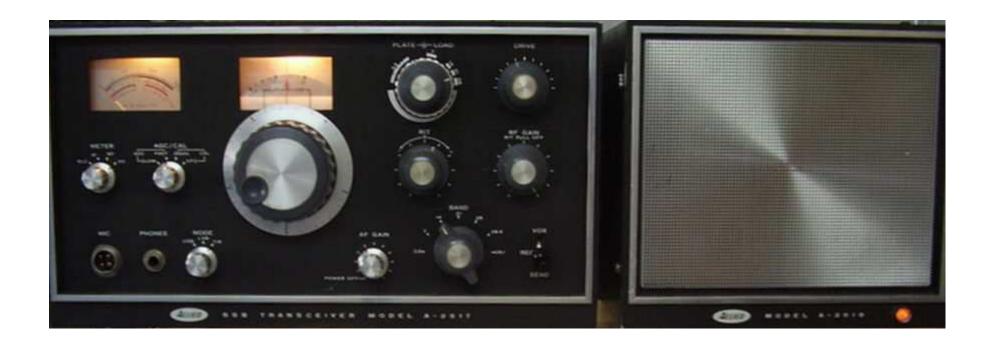
The Allied Radio Model A-2517 was the first ham band transceiver that Kenwood produced and was introduced in September 1970?

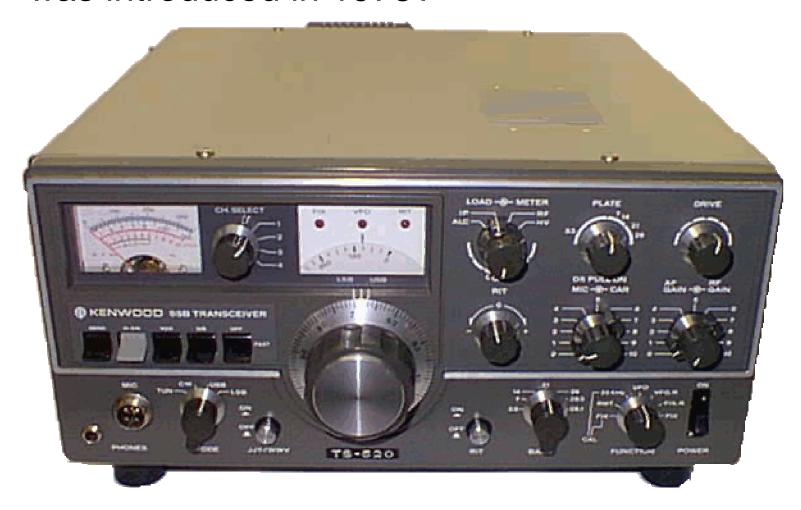
The TS_520 transceiver was the best seller and was introduced in 1973?

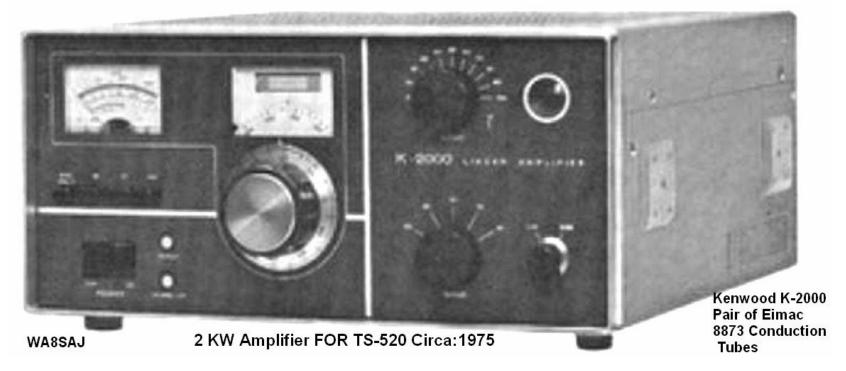
The K-2000 linear amplifier was built to match the TS-520 and T-599A radio's and was introduced in 1975 QST, Henry Radio advertisement.

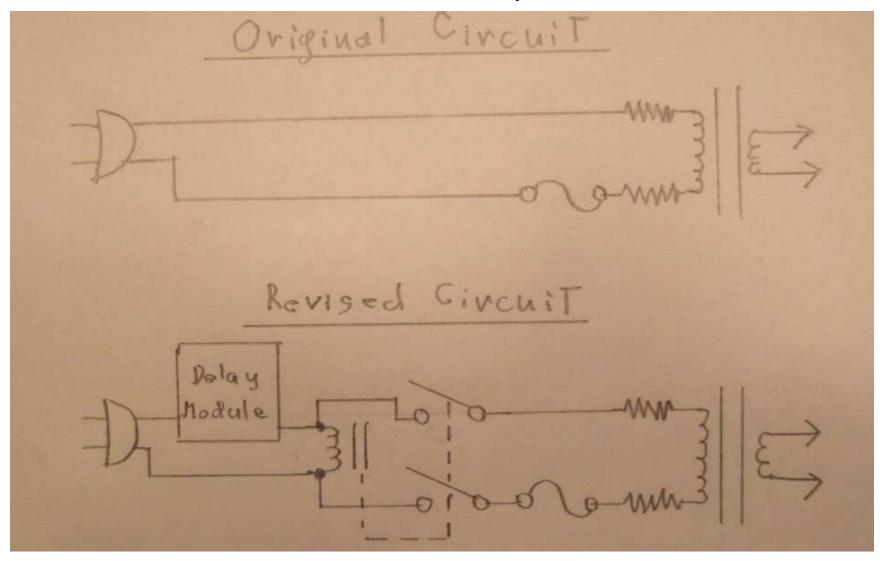
VFO-230 Delay Power On Modification

By: K9SQG

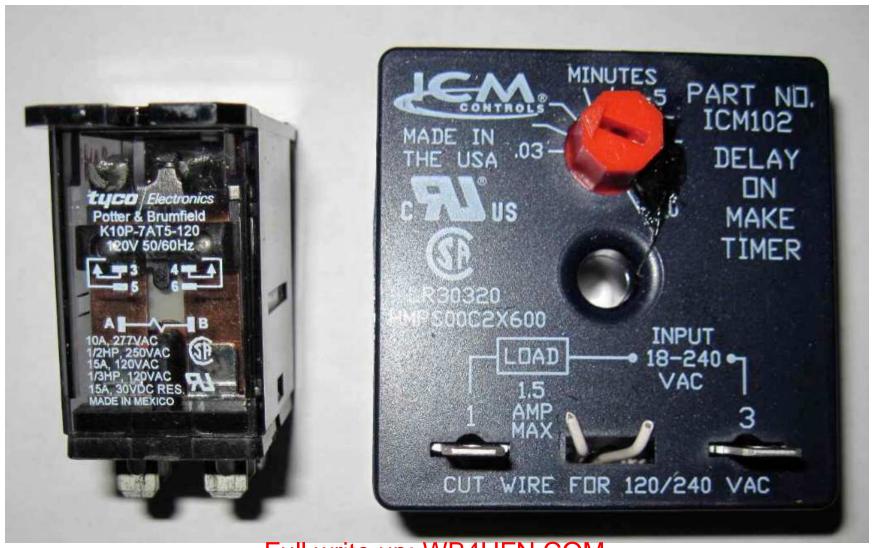
Delay Power On Timer ICM Controls and is an ICM102 p/n HMPSOOC2X6OO.

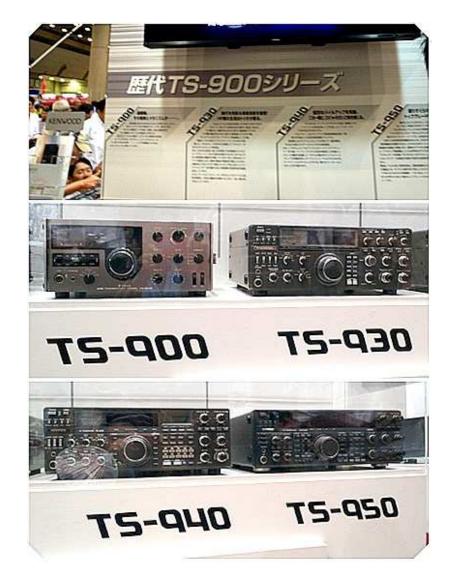
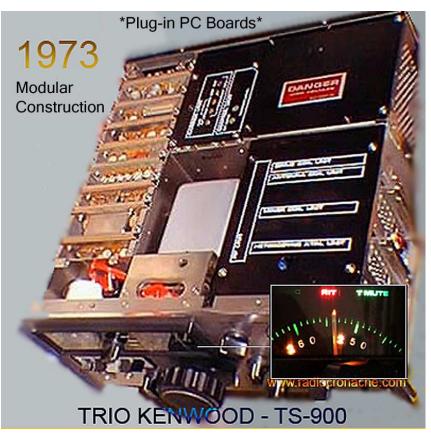
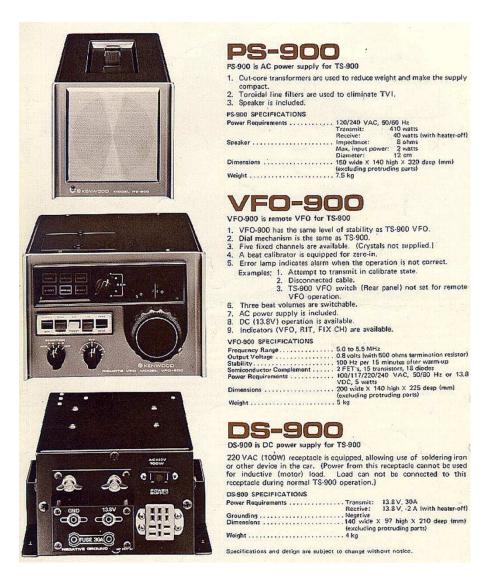
KENWOOD "1st Gen" of the 900 Series; Followed by 930/940/950/990

Three Tubes: 6LQ6 (2); 6GK6 (1)

IF freq: 3.395 MHz

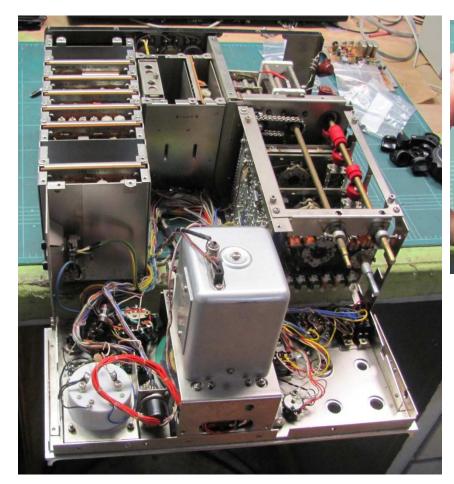
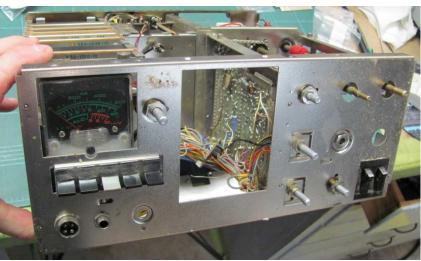
TS-900 Radio

Front cover removed

The whole front panel assembly is hinged for maintenance

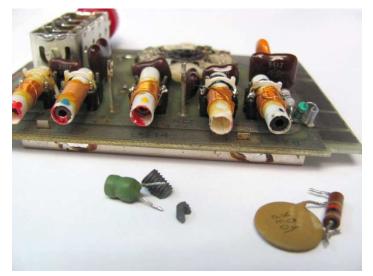
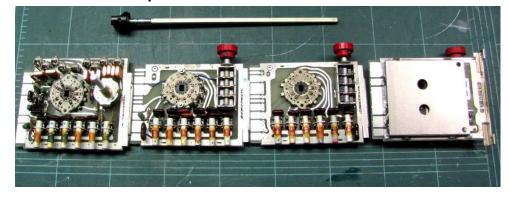
The four boards ready to re-install

The driver board had many problems: Broken slug, another missing; Opened RF choke

1st RF card Oscillator Coils

2nd RF card Mixer Coils

3rd RF card Antenna Coils

4th RF card Drive Coils & Backplane

These cards removed, de-fluxed with solvent, and inspected. Then re-lubed with "DeoxIt"

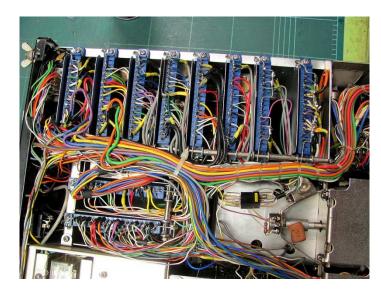
Chassis was cleaned & inspected

Bottom view of the wire harness

To avoid confusion during re-alignment, RF coil packs are labeled.

Audio balance pot is critical; If set wrong, audio is distorted

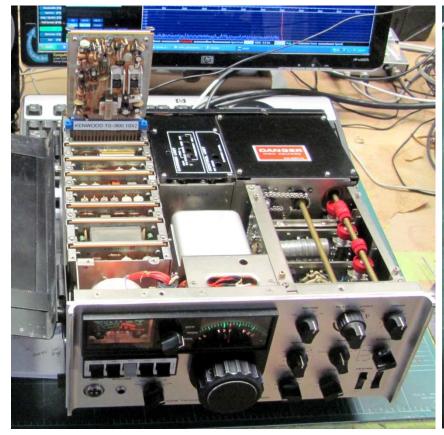
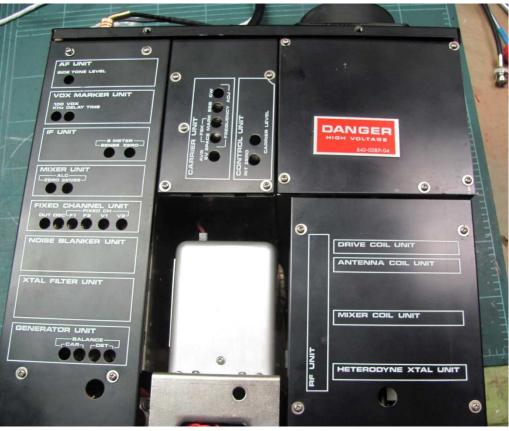
TS-900

- •Extender board needed to adjust audio board; It's worth buying (\$25) on Ebay.
- •Service Manual from Vintage Manuals W7FG.com (\$34)

Alignment finished; Last step to replace the nice decorative covers.

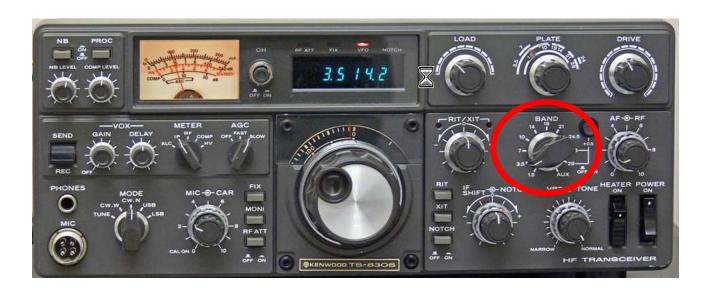
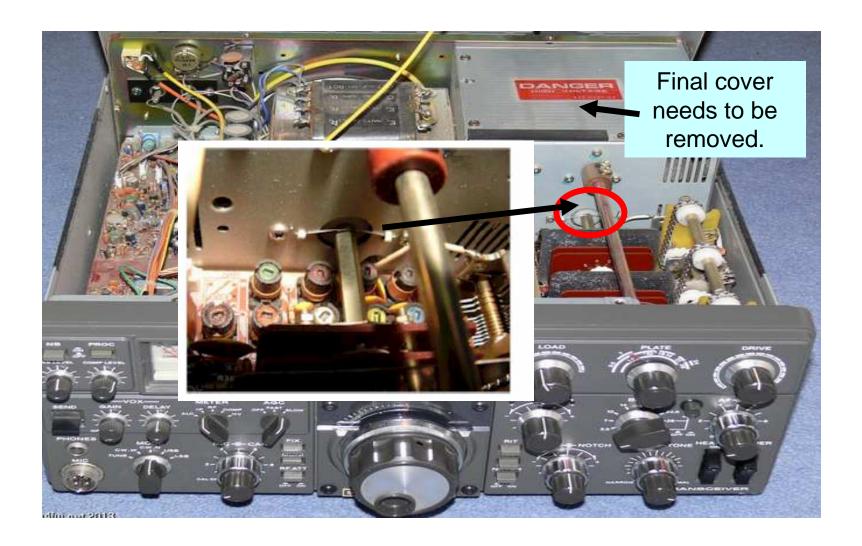
- Band switch is sloppy (has a lot of play).
- The original band switch couple is probably cracked and needs to be replaced ASAP before equipment damage occurs.

- Procedure of inspecting and replacing this coupler are located at:
- http://wb4hfn.com/KENWOOD/Articles/
- Replacement coupler sold at these 2 locations:
- www.k4eaa.com
- http://www.hybridrestore.com/

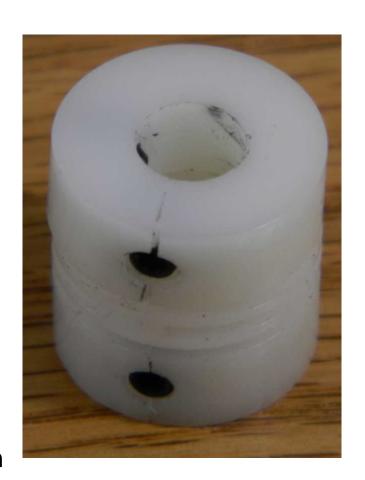
Removing the Old Coupler (By: W0NTA)

- I begin by putting the band switch to the 160 meter position (1.5 on the switch scale).
- Loosen both of the set screws in the coupler.
- Turn the band switch to the 30 meter position (10 on the switch scale).
- Loosen the other two set screws.
- You can now pull the band switch knob and shaft out through the front panel.
- Do not move any of the switch wafers while this shaft is removed.
- I have found that one can simply remove the old coupler through the hole in the final cage and up over the driver coil set.
- Sometimes it takes some effort to get it in just the right position to get it out. I suppose one could cut the coupler off and remove the pieces, but have never had to do that.

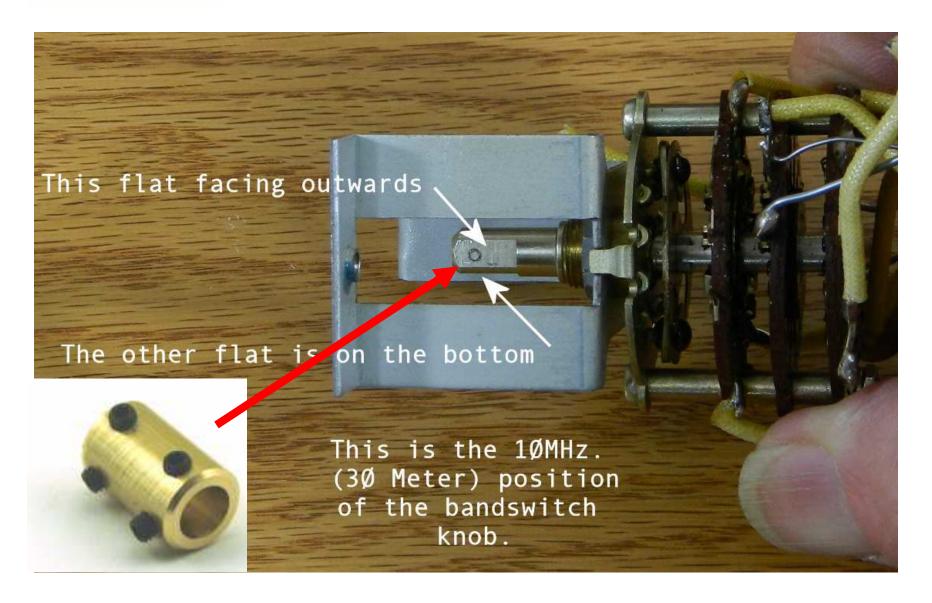
New Coupler Installation (By: W0NTA)

- Install the new coupler on the shaft that has been removed and make sure the set screws are backed out so that the coupler will rotate all the way around the shaft. This will make it much easier to install.
- Now, position the new coupler on the shaft of the final amplifier band switch with one set of screws facing out and the other set facing downward. This is necessary so that the set screws will come into view as you rotate the switch shaft back towards the 160 meter position.
- Start the switch shaft into the front panel with the knob pointer pointing towards the 30 meter position.
- Install the band switch shaft back through each wafers and into the coupler. Position the coupler so that it can be tightened on both shafts.
- Tighten the two visible set screws.
- Rotate the switch back to the 160 meter position and tighten the other two set screws. That is it.

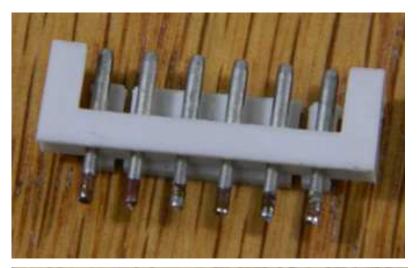
Before Cleaning

- The Kenwood Hybrid radios are full of the Molex connectors. They are on about every board in the radio.
- Poorly soldered connectors can cause many different issues with the way the radio performs.
- The joints can also be broken by rocking the connectors back and forth during cable removal.
- Dick always rock them towards the long end to prevent putting a lot of strain on the joint.
- Full article located at: WWW.WB4HFN.COM

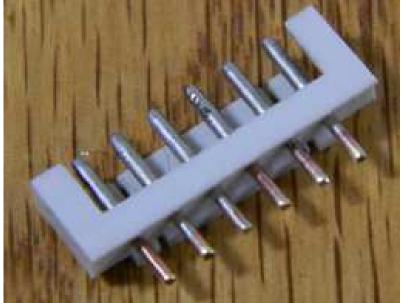
After Cleaning

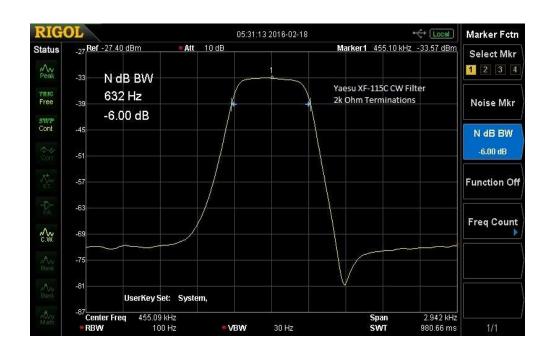
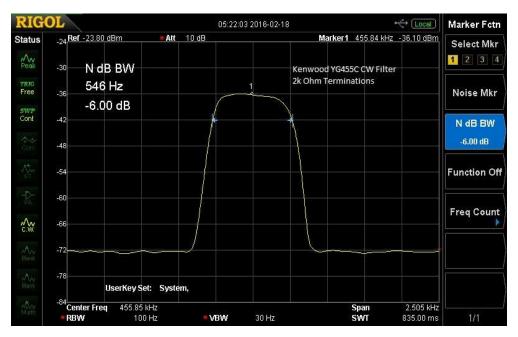
Collins filter has 2.53 dBm less insertion loss

Collins passband ripple negligible

Kenwood filter is 86 Hz narrower at -6 dB; 437 Hz narrower at -60 dB

Kenwood passband ripple negligible

Spectrum analyzer plots by Terry – K9TW

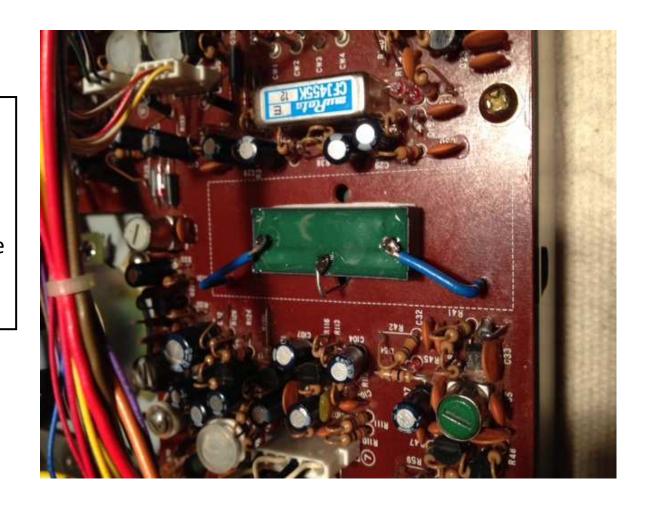
Easy Installation - NO messy mods!

Dead Bug Mounting
- use double back tape

Easy Uninstall

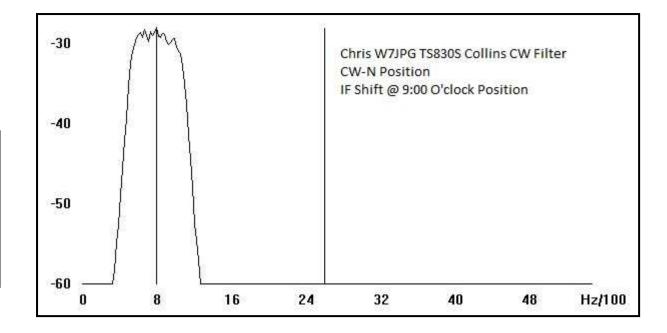
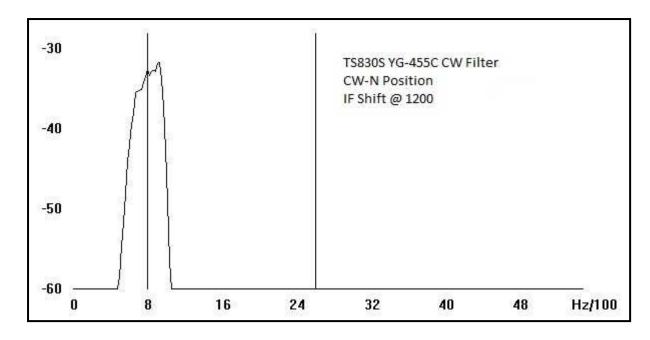
Audio Response

Collins filter has less ripple and better symmetry

Spectrogram plots by Terry - K9TW

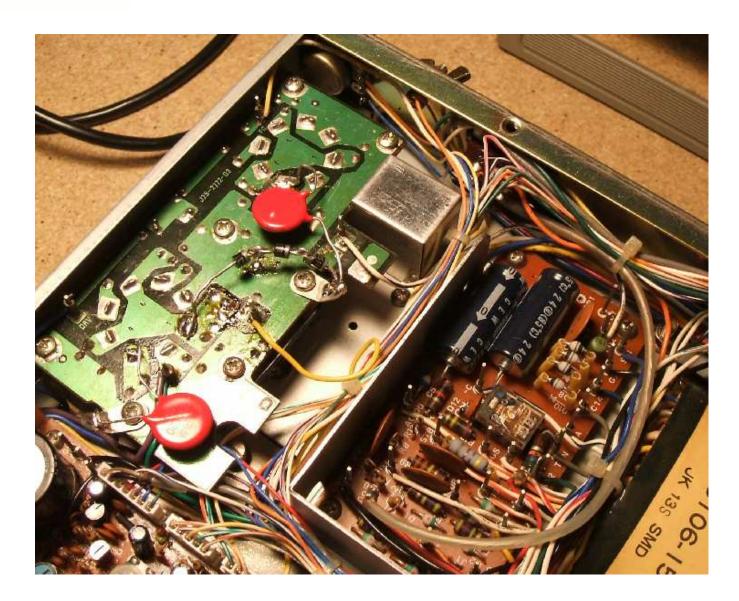
- (All information supplied by Terry Wagoner, K9TW)
- Place 3 1N4007 diodes, Mouser PN: 512-1N4007 in series with the banded end towards ground from pin#1.
 These will limit the cathode voltage to about 2 volts.
- Place a 230Volt Varistor, Mouser PN: 576-V230LA20AP to screen grid, pin#3 to ground. These Varistors will turn on hard and clamp grids to ground at about 300 volts, in an attempt to prevent damage to the screen grids from anode to screen grid shorts.
- Place two 2 watt, 4.7 ohm resistors, Mouser PN: 588-OY-4.7-E in series with the HV output (Red Wire) from the electrolytic. These will limit the power supply short circuit current

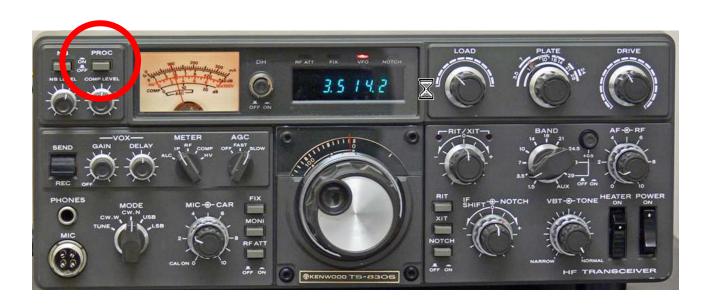
- If ALC levels are normal when the processor switch is depressed, the fix is to take the cover off of the radio.
- Locate the processor switch. There is a cover that protects the rear of the PROC switch..

- •Put the radio on it's back with the rear panel against the table top.
- •One of the switch cover corners needs to be preyed apart enough to spray some DeOxit inside, letting it flow to the rear of the switch.
- Press the PROC switch several dozen times.
- •This should fix the problem if the switch is in fact the problem.

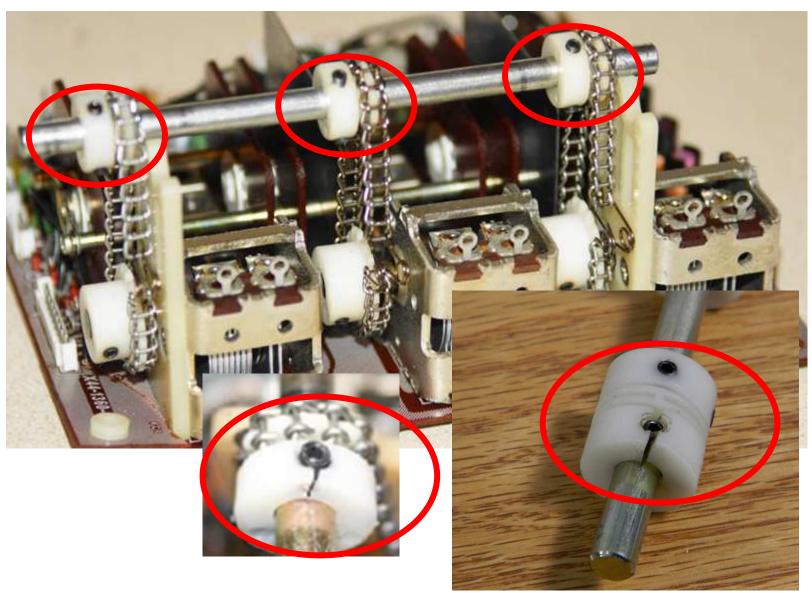
RF board cracked sprockets

- New replacement sprockets are now being manufactured for sale by Greg Graham NR6C at:
- http://www.nr6c.com/sprocket.htm

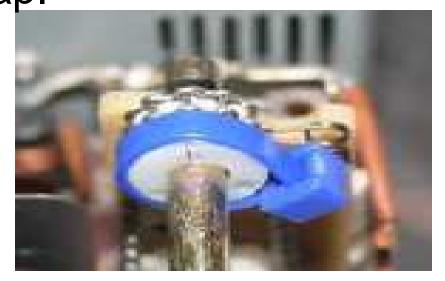
A quick fix that I've used is to use a plastic tie wrap.

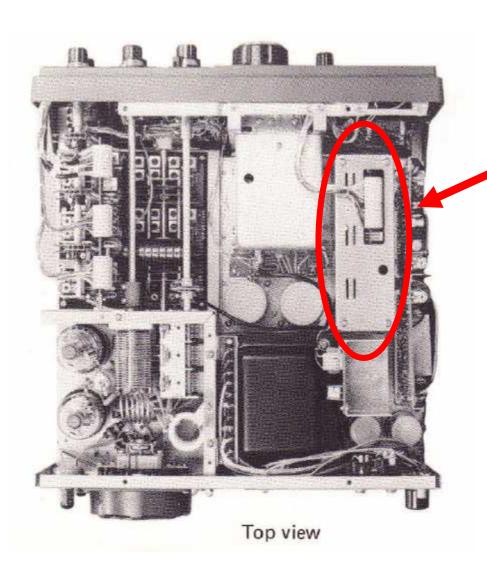
TS-820S DIGITAL DISPLAY

Remove 2
boards from
enclosure and
resolder
connector pins
between the top
& bottom foil
pins.

It is our experience here in the Compton service facility that the vast majority of DG-1 problems are not component failure, but cold solder connections on the digital P.C.B. (X54-1160-00).

Recommended service procedure: Remove both boards. Using a fine point, low wattage iron (less than 45%), and a good quality, low flux content solder, carefully resolder all component side connections plus the print throughs containing no components. (There are 18 of these points - only one is not top accessible, but is located under IC ll and can be resoldered from the bottom). Resolder the Molex connectors. There are 9 print-thru's where solder may not have flowed thru to the component side.
