KENWOOD 2019 Dayton Hamvention Kenwood Forum

Rescuing a Kenwood T599A Transmitter from the Landfill

- The following material was provided by Terry Wagoner, K9TW and myself, WB0IQK.
- <http://www.k9tw.com/>
- Terry has been servicing Kenwood Hybrid radios for just over 13 years.
- Many problems can be fixed by performing a good visual inspection.

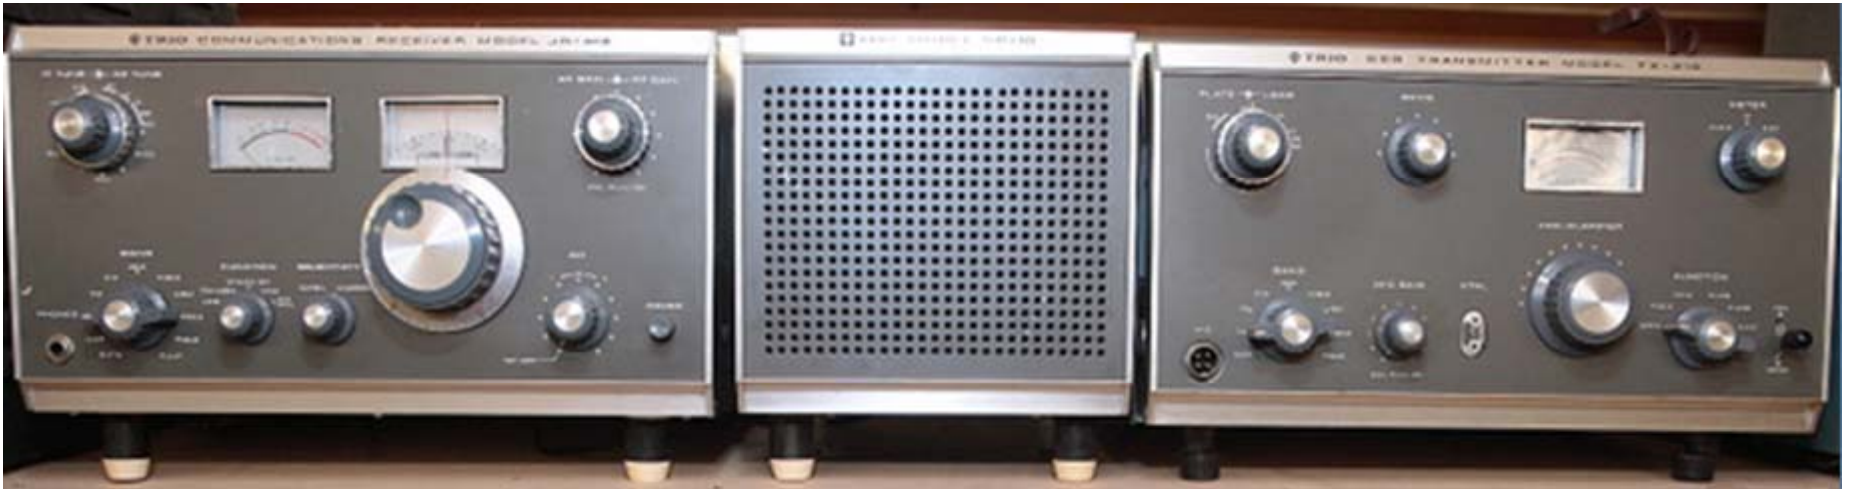
Kenwood Trio Twins TX-310

The Trio TX-310 uses a single Japanese S-2001 final. It does cover 80 through 6 meters and is all mode. Control is either via external VFO or internal crystal oscillator . The matching receiver covers JJY/WWV in addition to 80 thru 6 meters. It is dual conversion with a choice of wide or narrow filtering in the 455 Khz. 2'nd IF. The VFO is typically Kenwood light with a very nice tuning feel.

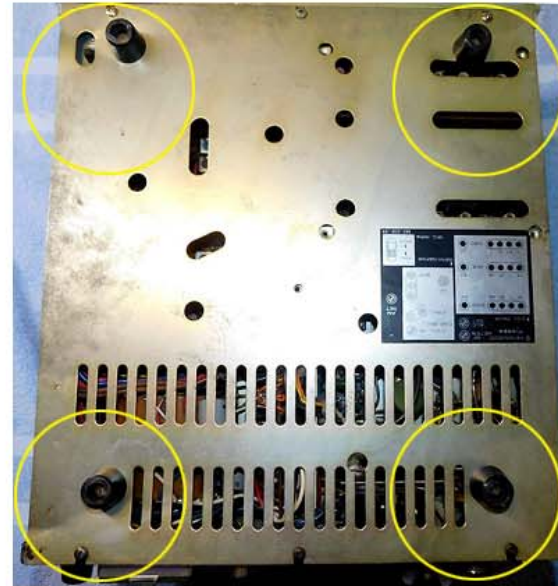
Shipping damage to chassis

All sheet metal straightened

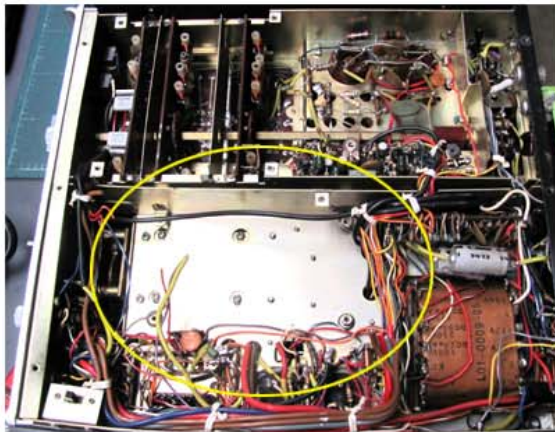
OH..NO! Generator Board is missing

**Someone harvested the board???!
(They thought it was beyond repair?)**

Walter Dilley KD7DNY provided the missing board

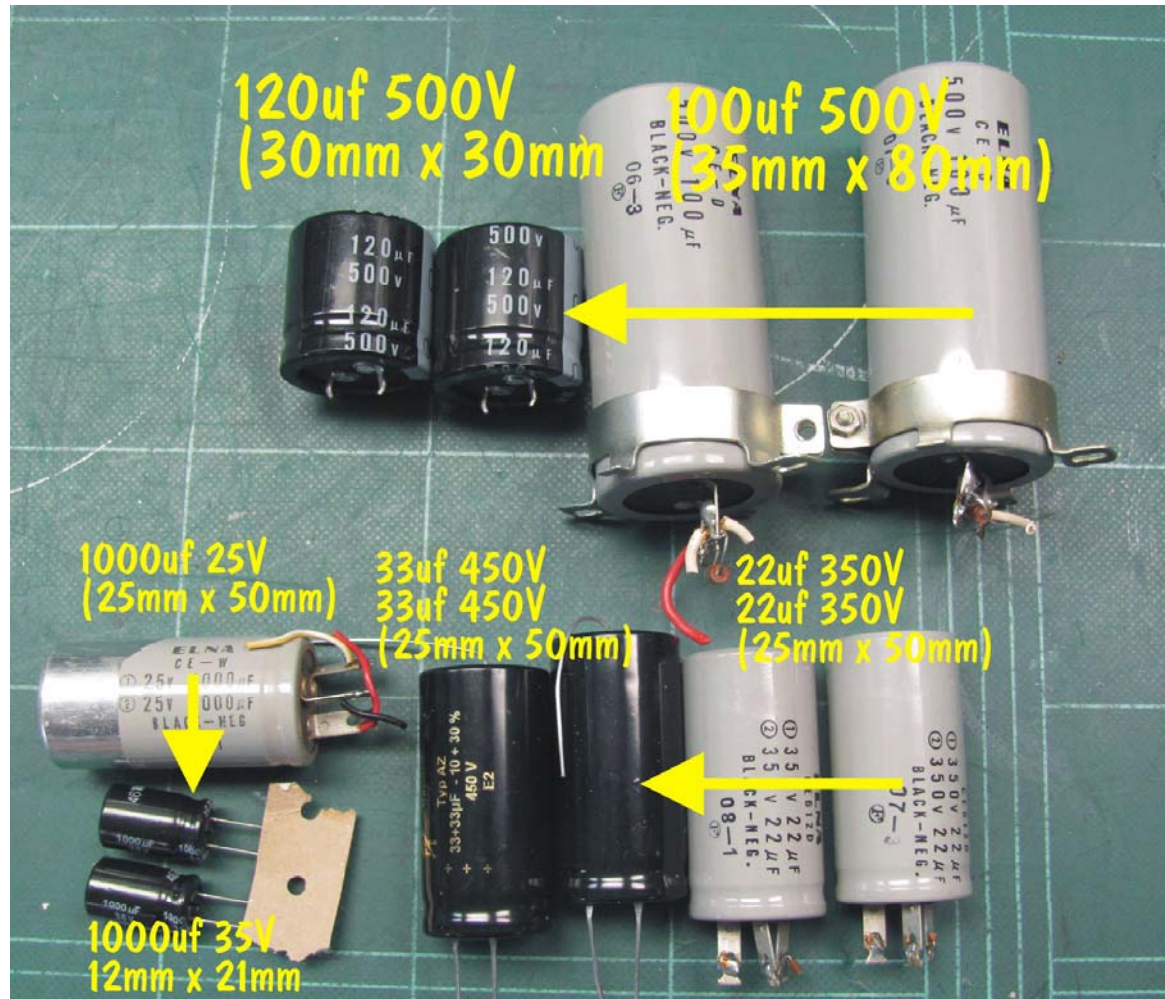
(Dual Section, Screen Capacitor: 33/33 μF @ 450 VDC Antique Electric Supply, p/n 001536, \$9.95)

With those repairs done, let's replace the filter capacitors too

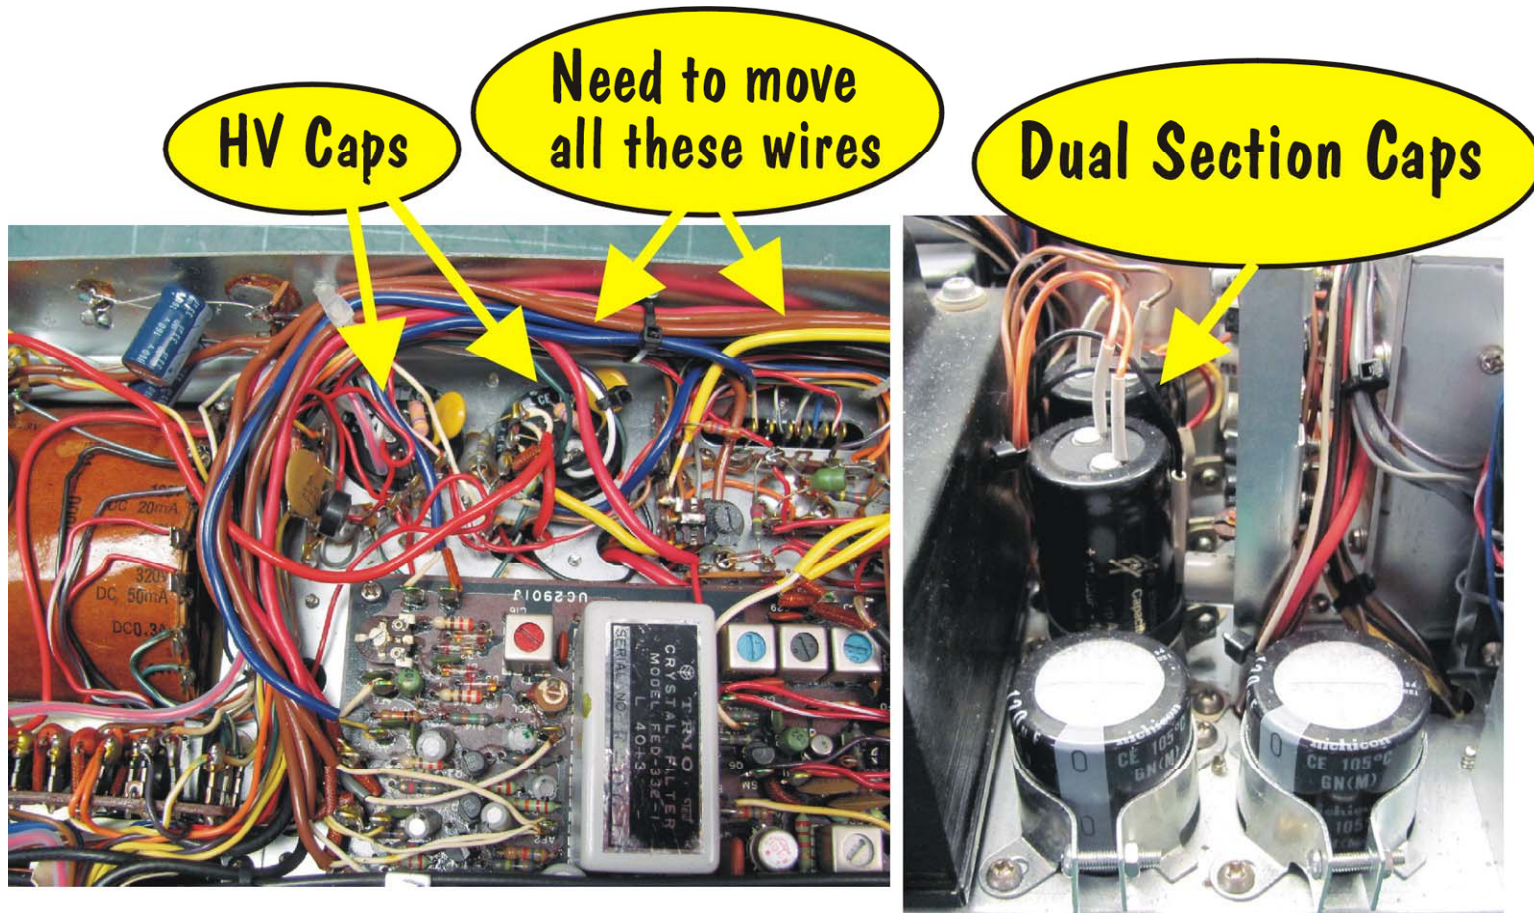
HVPS & LVPS, screen & grid capacitor replacement

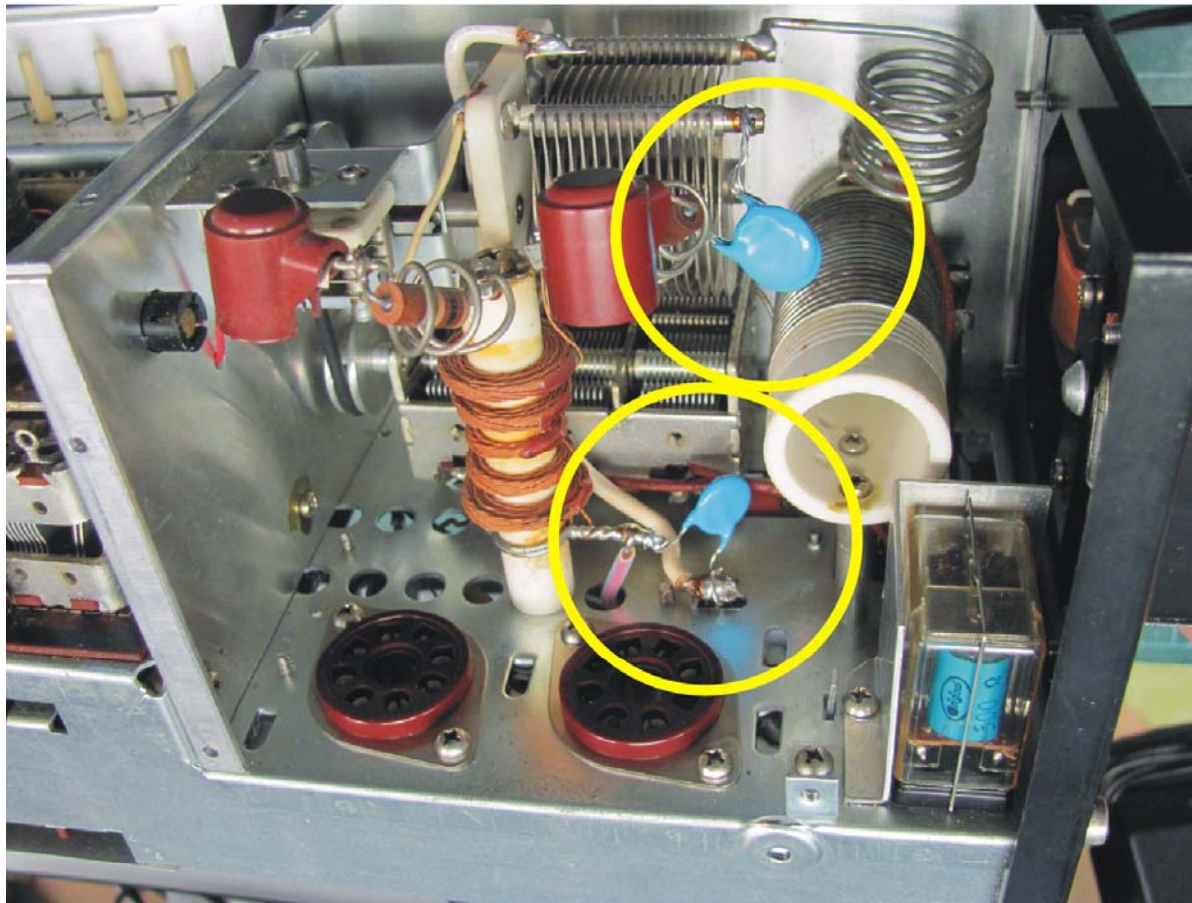
Final PA capacitor replacement

K4EAA's Final Cage Repair Kit - FR-100

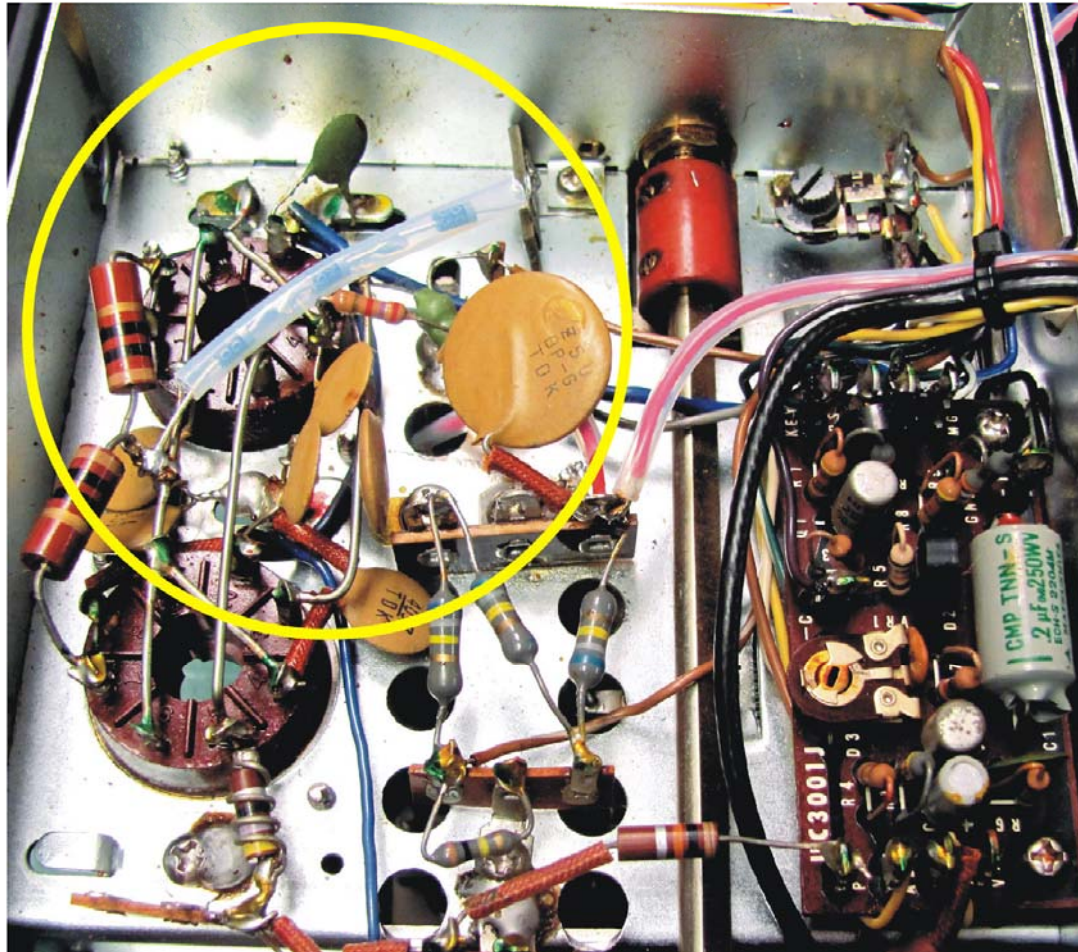
Cathode Resistor Protection Diodes

Three each, 1N4007 diodes; Diode's band to ground

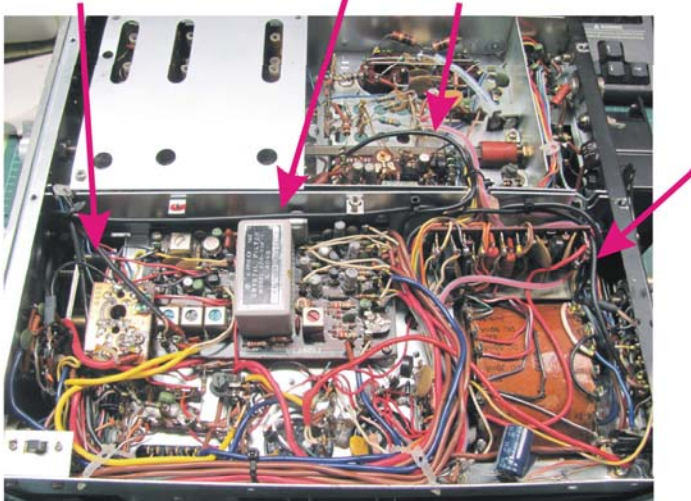
Original coax was fragile and broken; All replaced with RG-174

- Original coax is 75 ohm; 50 ohm seems to work fine
- It's beneficial to replace the bias pot, VR5 50k. Mouser has them for under \$5.
- Follow the sequence 3.5, 28.5, 21, 14, 7 (bands) when tuning the coil packs. They interact together.
- When Transvertor SW is **ON**: Screen voltage is **OFF**

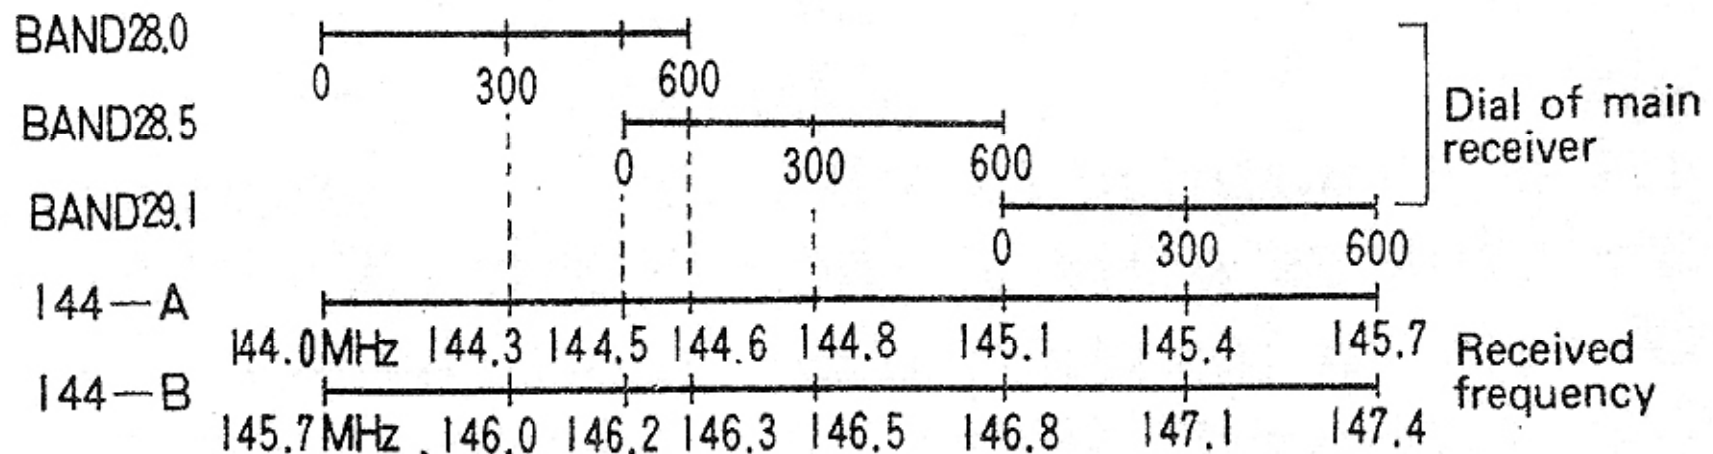
Here is how the converters operate in the R599/A/D receivers

Using the three 10M band selections and two independent LO channels "A" and "B" are necessary to cover the entire VHF band of 2M & 6M. An AGC circuit is used to prevent overload under high input signals (It is also possible to receive without the AGC function)

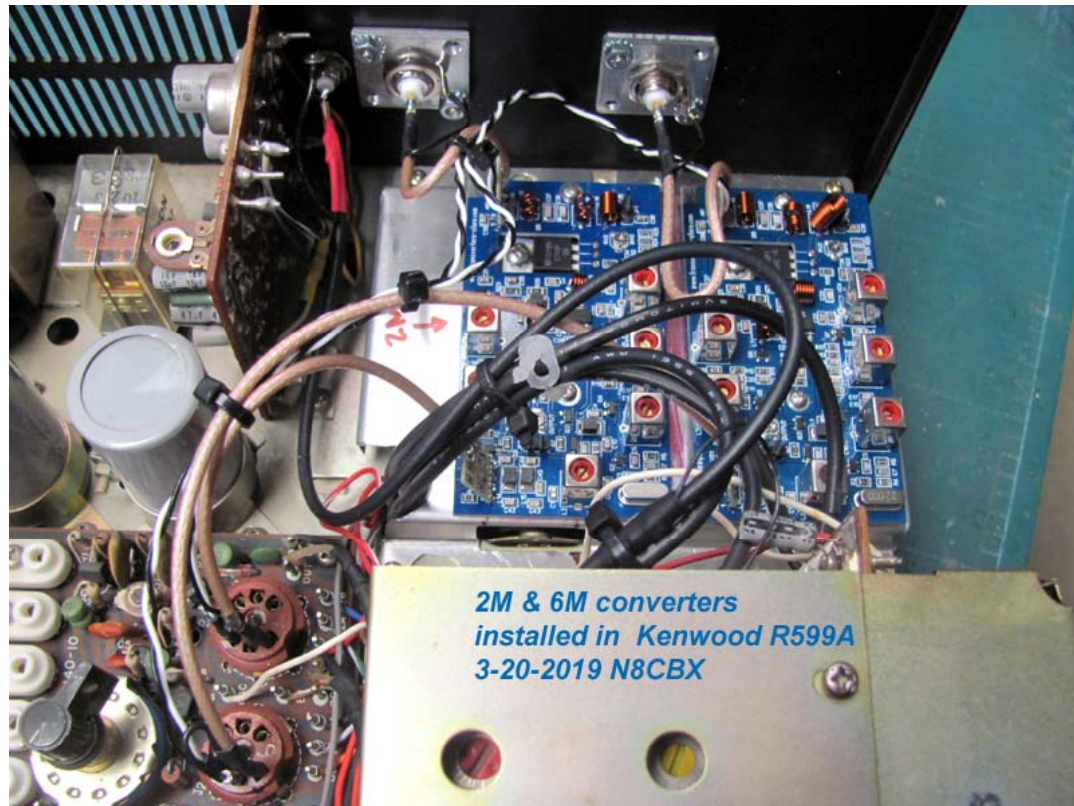
I used some Cannon, gold plated male connector pins (0.180" dia.) to insert into the 7-pin socket for the 28MHz IF signal and for power (+12vdc & GND).

A mounting plate, made of 0.032" aluminum sheet metal, is need to mount the boards to the R599 chassis.

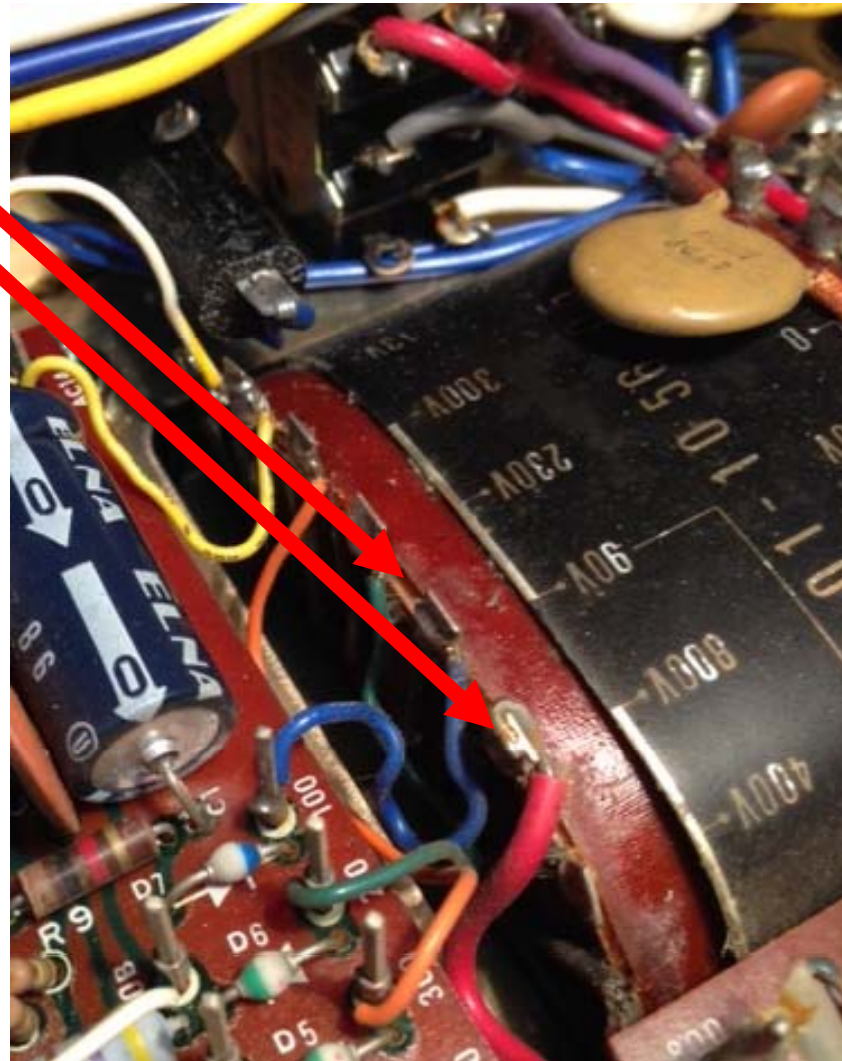
OBSERVING THINGS THAT SHOULD
HAVE BEEN SOLDERED BUT NEVER
WERE.

I FOUND THE
800V & 90V
WIRES ON A
TS820S THAT
WERE
NEVER, EVER
SOLDERED.
NOT A BIT OF
SOLDER ON
THE WIRES
OR LUG

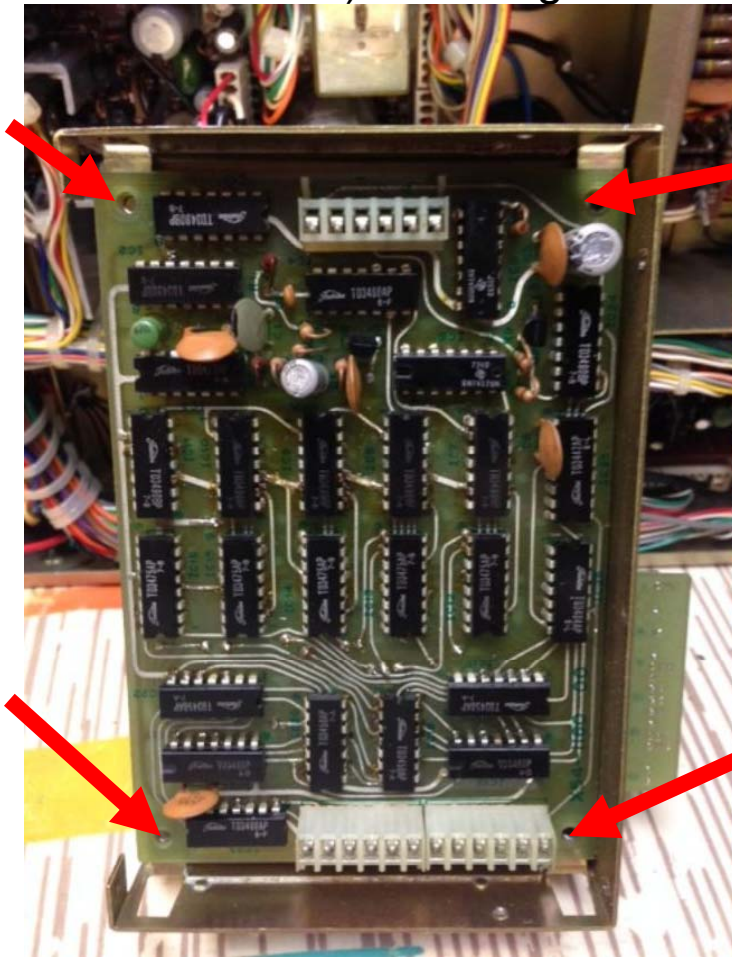
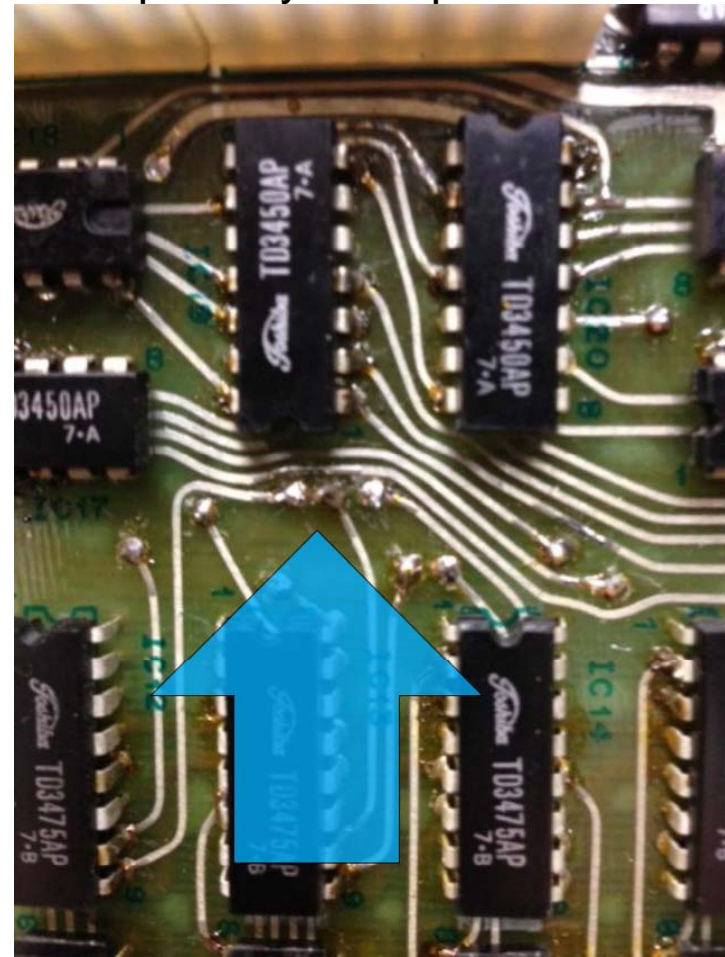
TS-820S DG-1 Digital Display. Previous work poorly performed. Missing pc board hold down screws. Very poor solder reflow of the vias (plated thru holes) including cold solder joints and partially lifted pads.

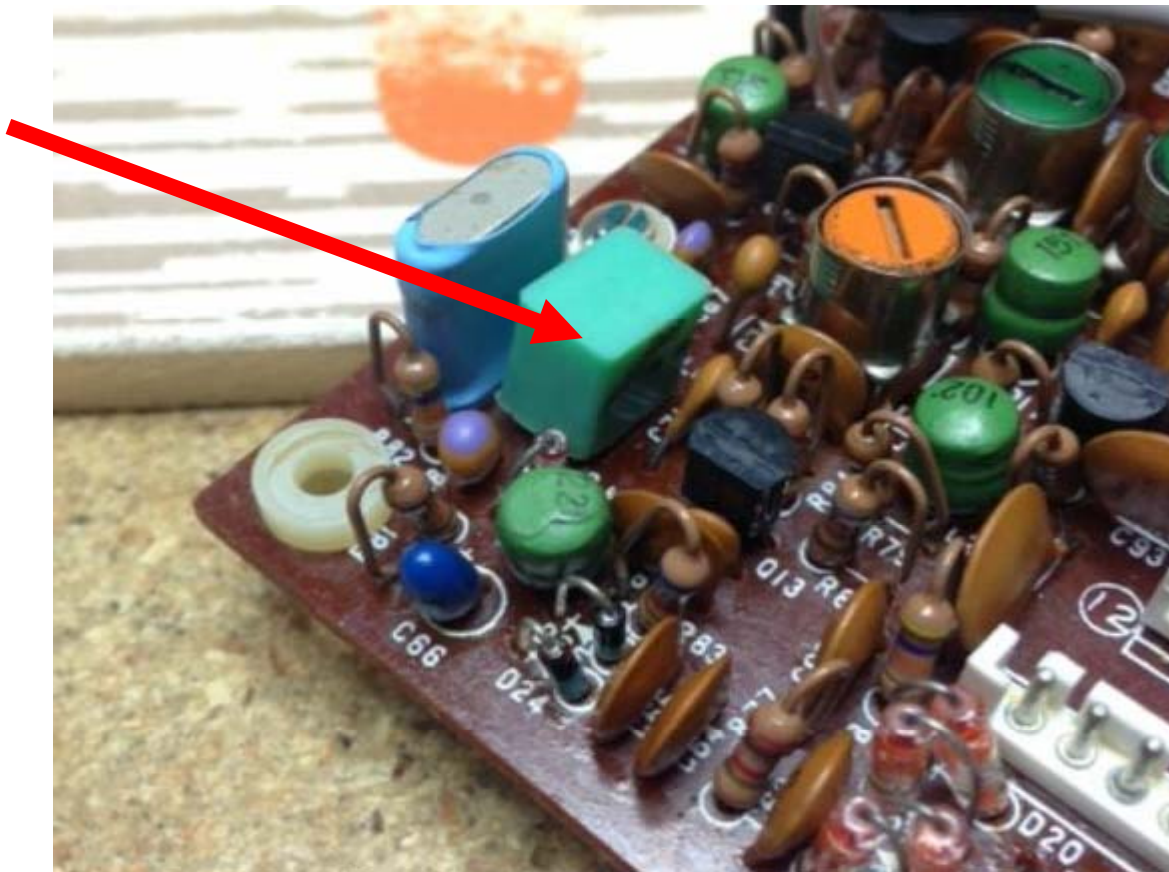
Factory Mistake

- TS-830S VBT 8375 carrier oscillator choke L14 poor as built. Resulting in intermittent Oscillator operation. Vari-cap diode D26 was bent over preventing the full insertion of L14 choke lead thru its pin pad. Had to remove and replace D26 with longer leads to allow L14 to fully seat flush on the board prior to soldering.

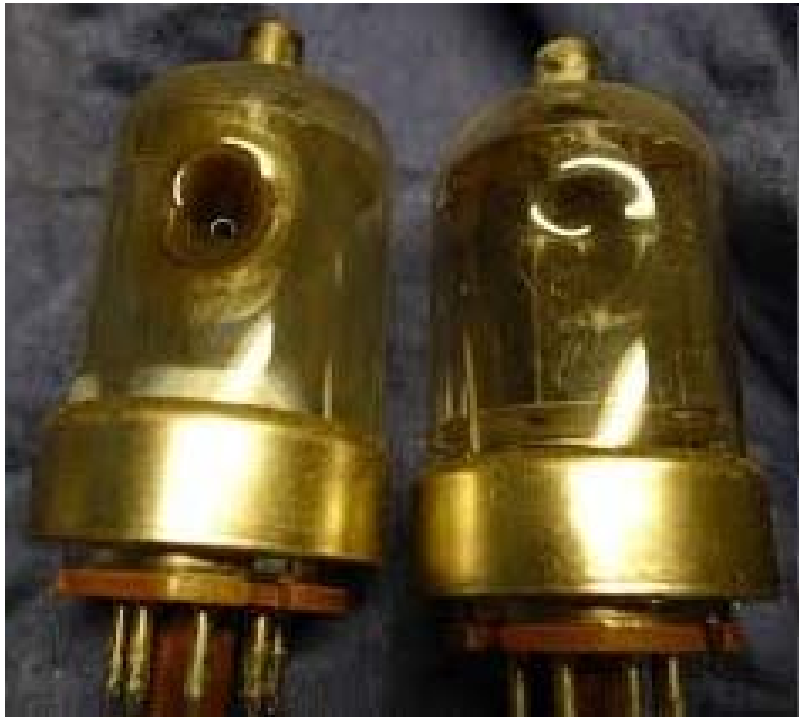
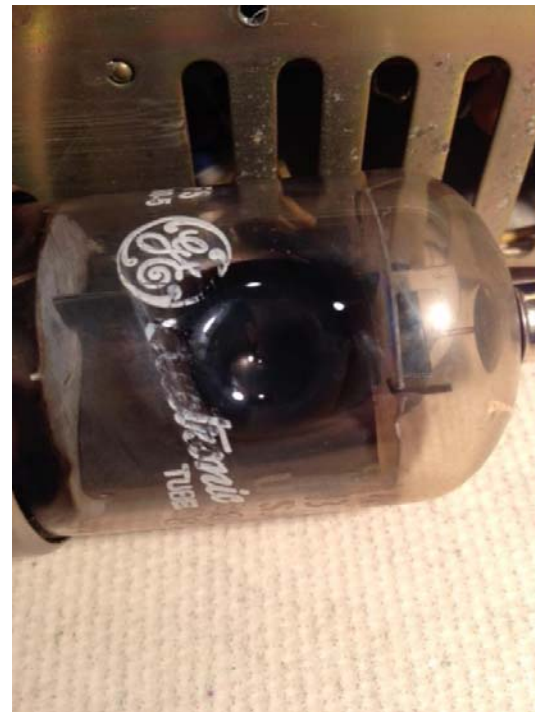
Loss of Bias Damage

- TS830S loss of operating bias voltage. Final tubes draw very heavy plate current, glow bright orange, melt hole in anode surface, soften glass envelope and suck in, and cathode resistors destroyed and pc board substrate with deep carbon track. Must replace the Final board. Loss of operating bias due to dirty/bad rear panel bias voltage adjustment pot.

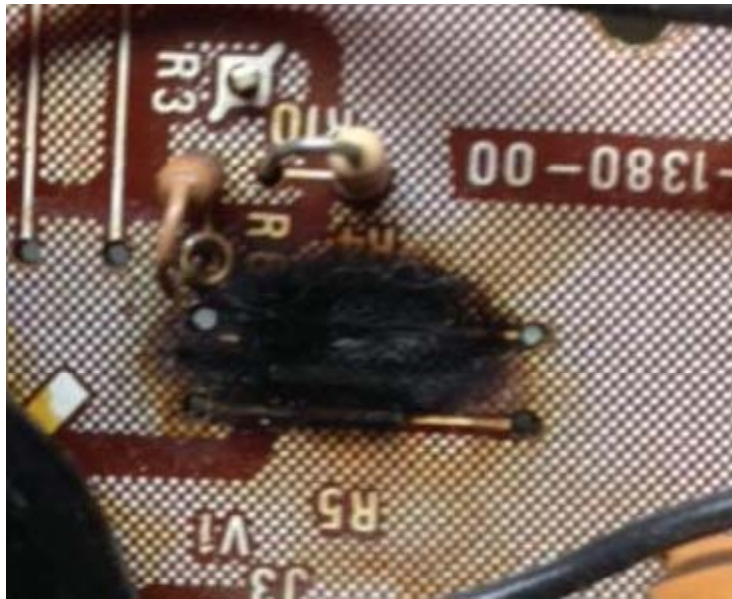
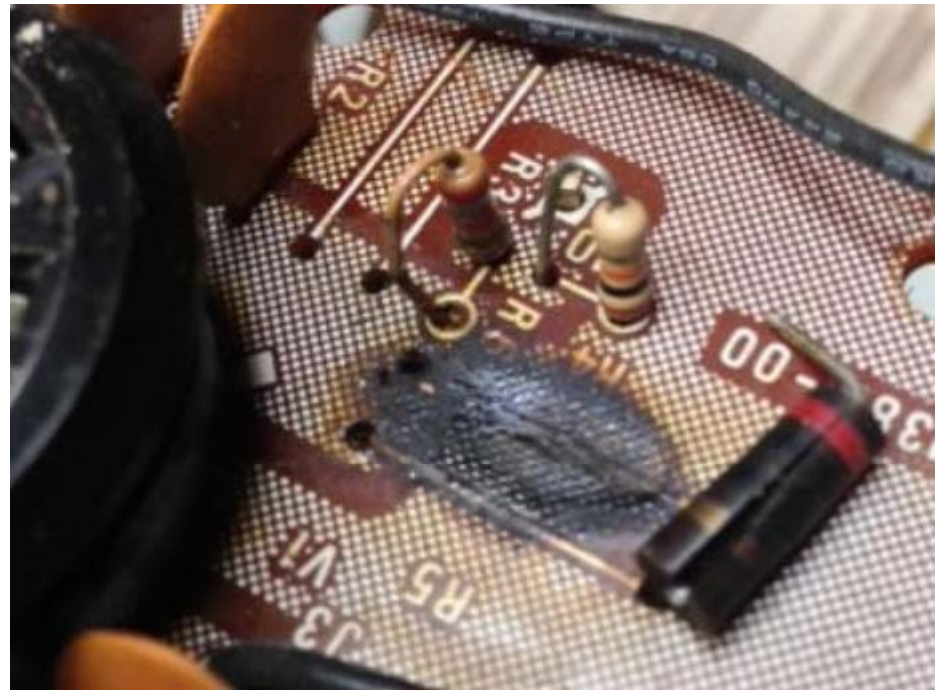
Final Cage Damage

- Bad Cathode resistor caused pcb board damage

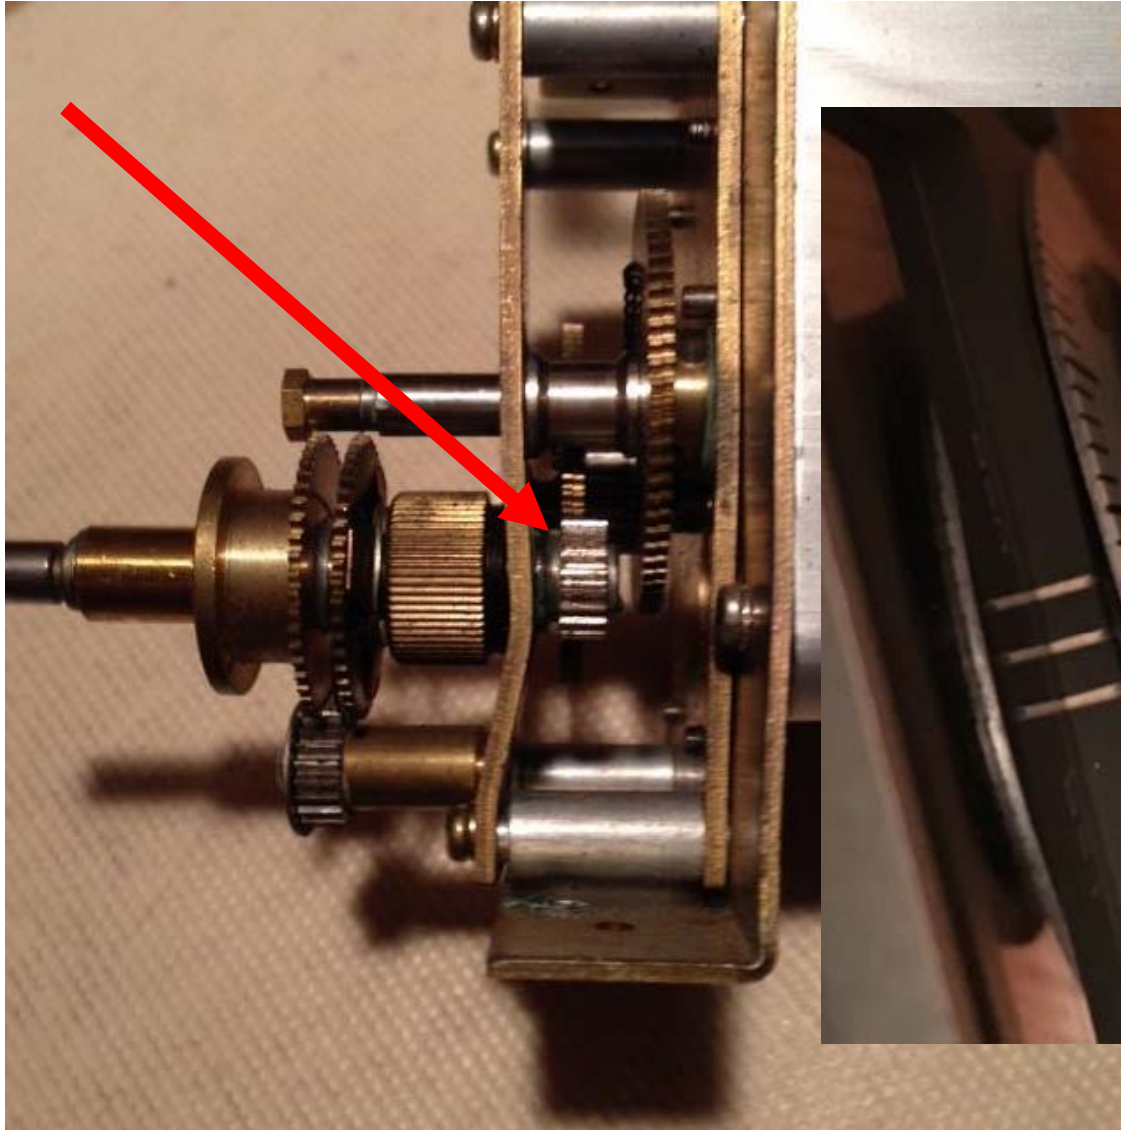
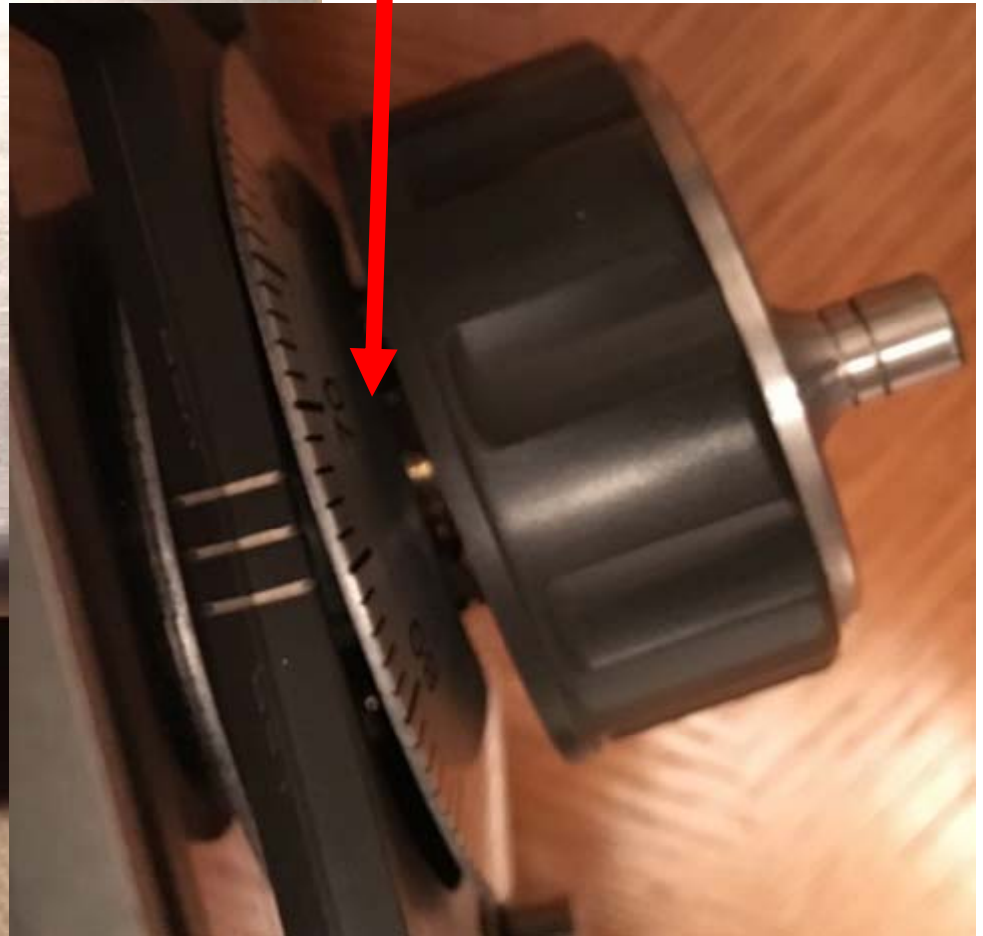
- Poorly packed TS520S results in badly damaged VFO from impact blow to the VFO knob. This blow is transferred to the VFO input shaft and the reduction gear train and bends the frame.

Shipping damage

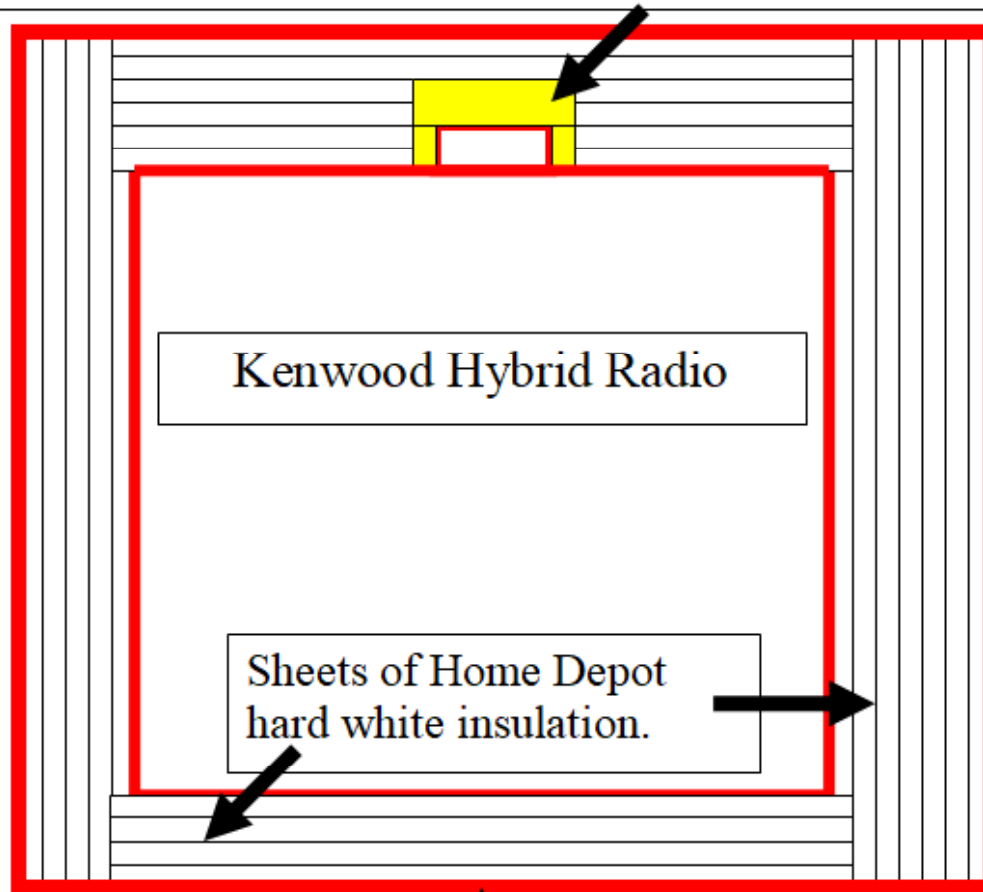
Proper Shipping Method

Recessed Area Stuffed with foam shipping pellets

Federal Express Box :23 x 17 x 12

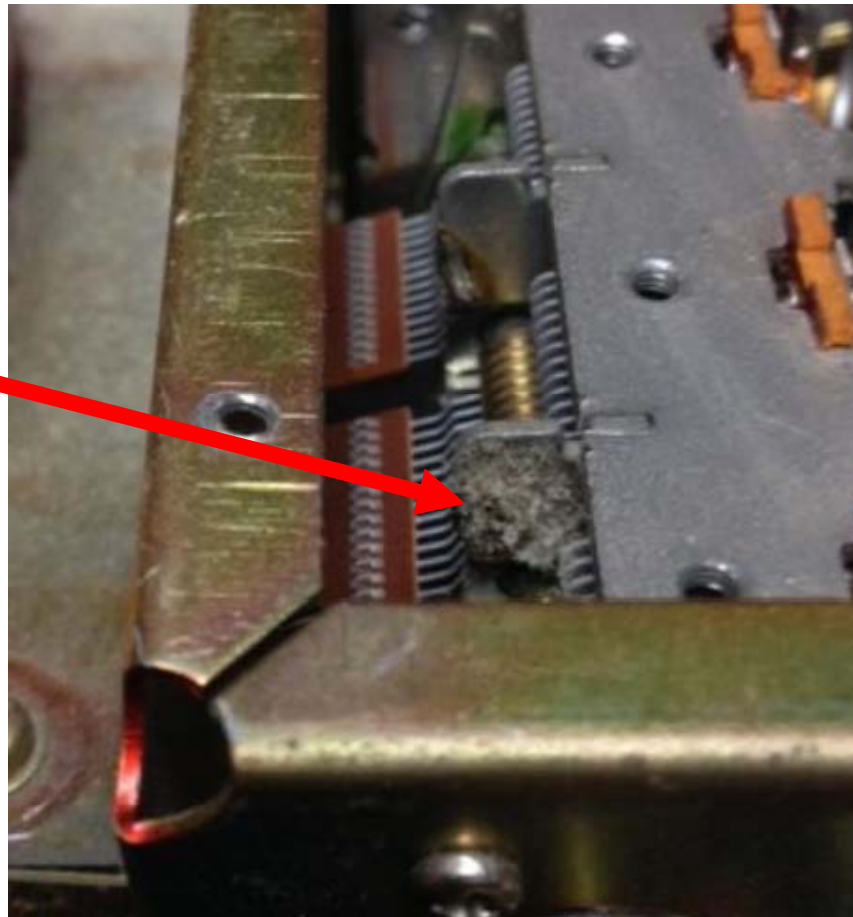
- Wasp nest/egg casing bridging Plate Load capacitor plates of TS-830S

5 minute
inspection
would have
corrected.

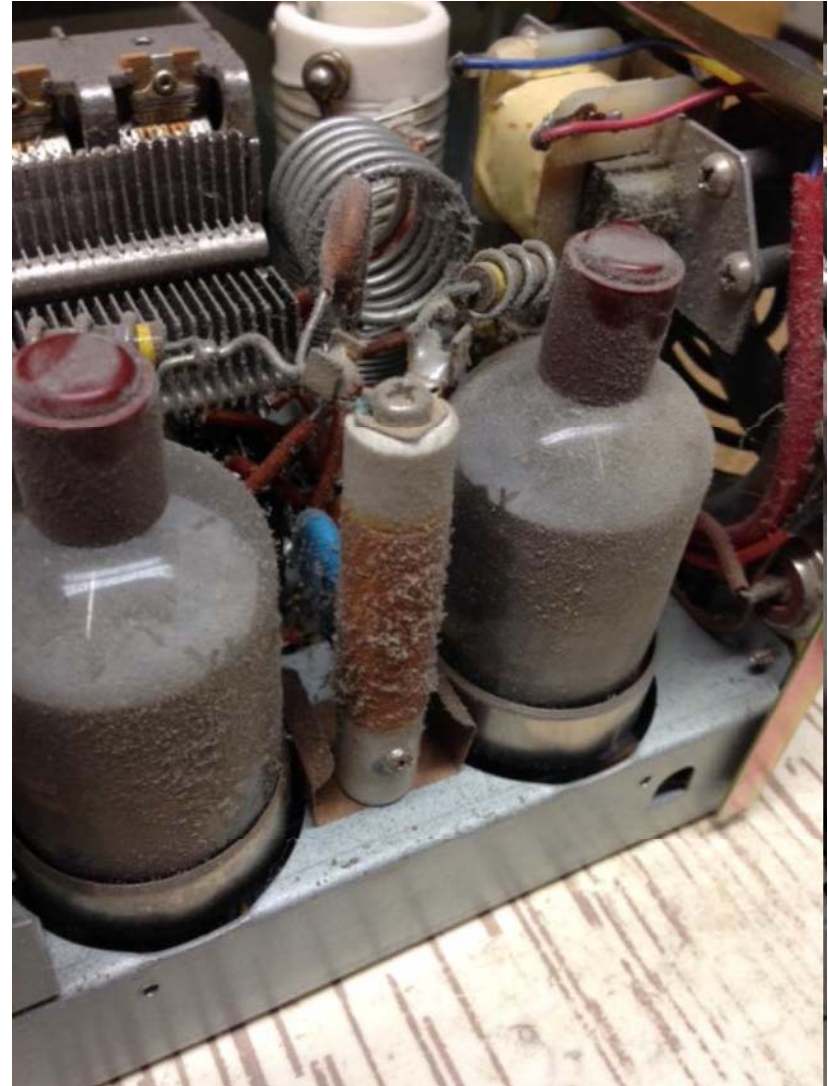
Dust & Dirt

- TS-830S PA Cage dirt, dust, animal hairs, cob webs. Real good way to have Plate Tank and Plate Load cap arc overs!

5 minute
inspection
would have
corrected.

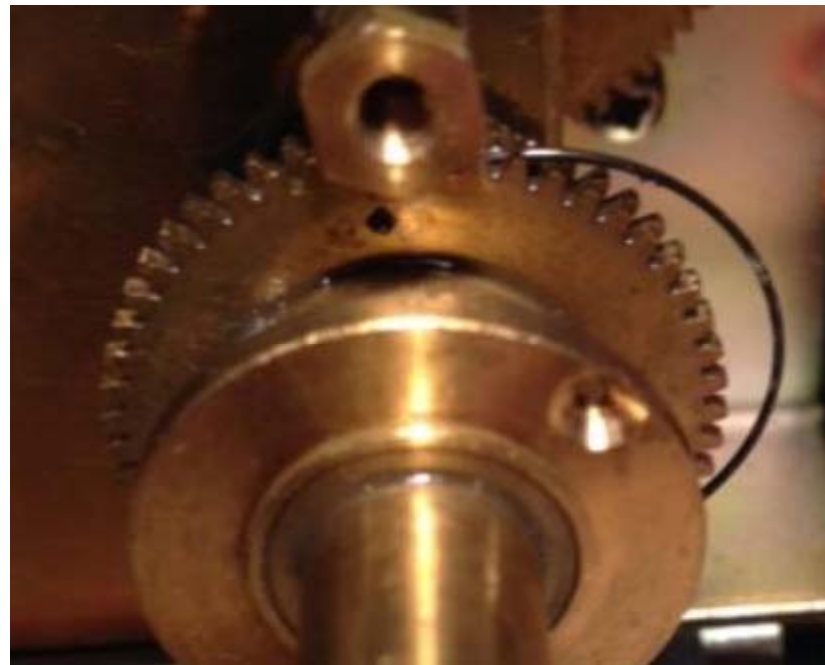
- TS-820S VFO with hard obstruction encountered when turning the VFO knob. Anti-back lash spring not properly installed when gear train was dis-assembled to change analog dial lamp. Spring is inserted in small holes drilled in two gear faces and gears turned to introduce spring tension and then gears mated with pinion gear and secured in place. No need to remove this assembly to change analog dial lamp.

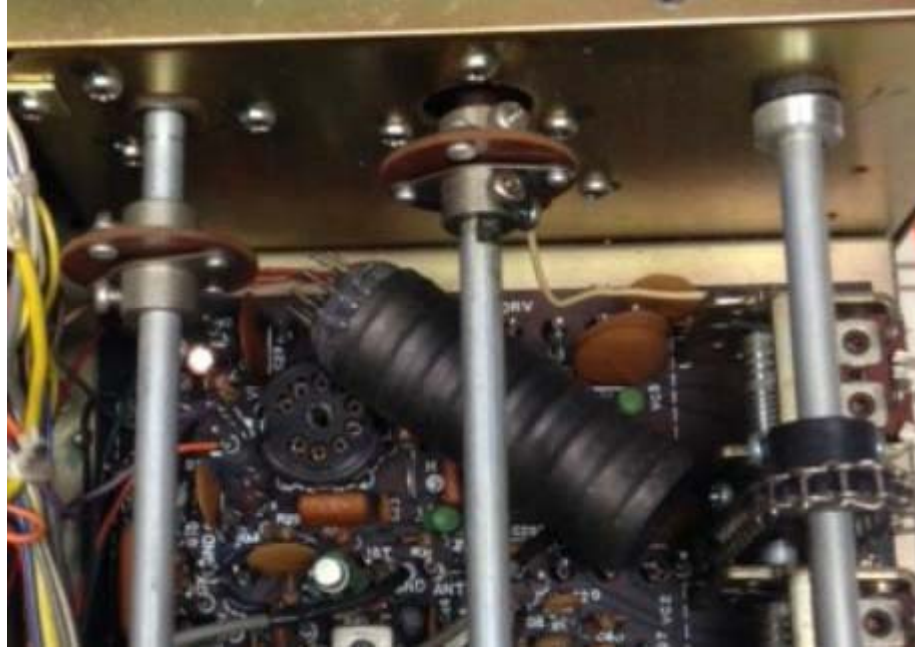
Incorrect Packing Material

- TS830S 12BY7A Driver tube ejected during shipping. Little to no energy absorbing materials on all 6 sides of this radio. Crushed news print is worthless. Up Arrow Signs and Fragile signs on the carton are meaningless.

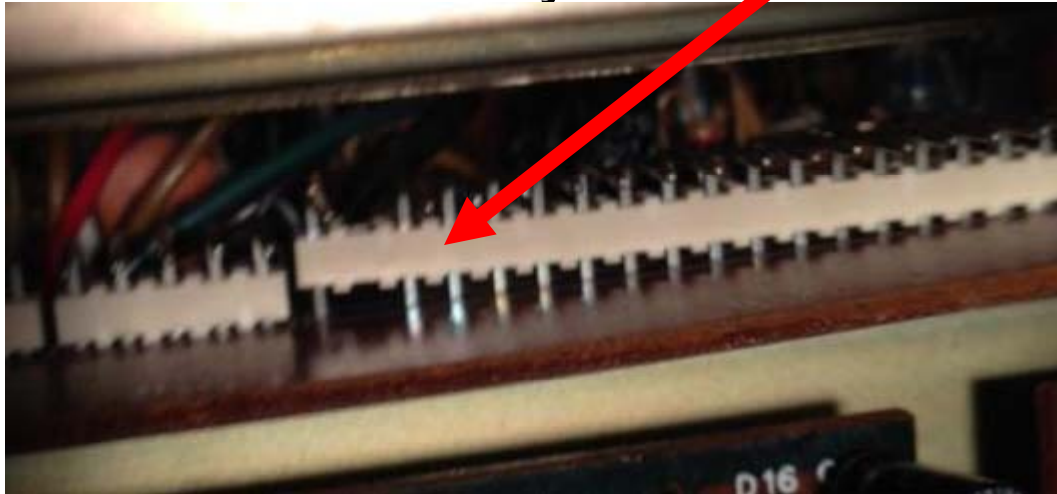
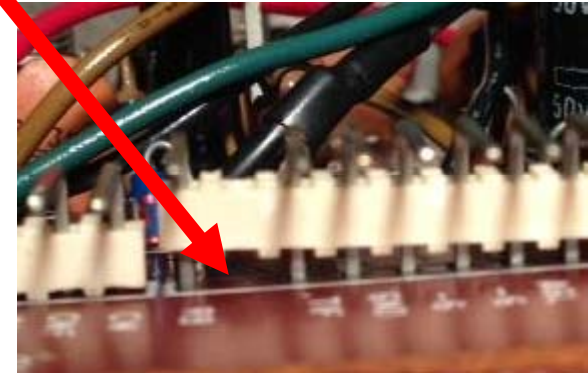
Bad Factory Assembly

- TS-820S Poor as-built. Molex connectors not fully seated prior to soldering at factory. Ultimately will end up presenting intermittent condition. TS-820S is worst for all kinds of molex connector problems including what you see here, bad crimps on lead wire connectors, weak spring temper on taper wedge crimp connectors, broken off taper wedge floating inside the molex connector body etc.

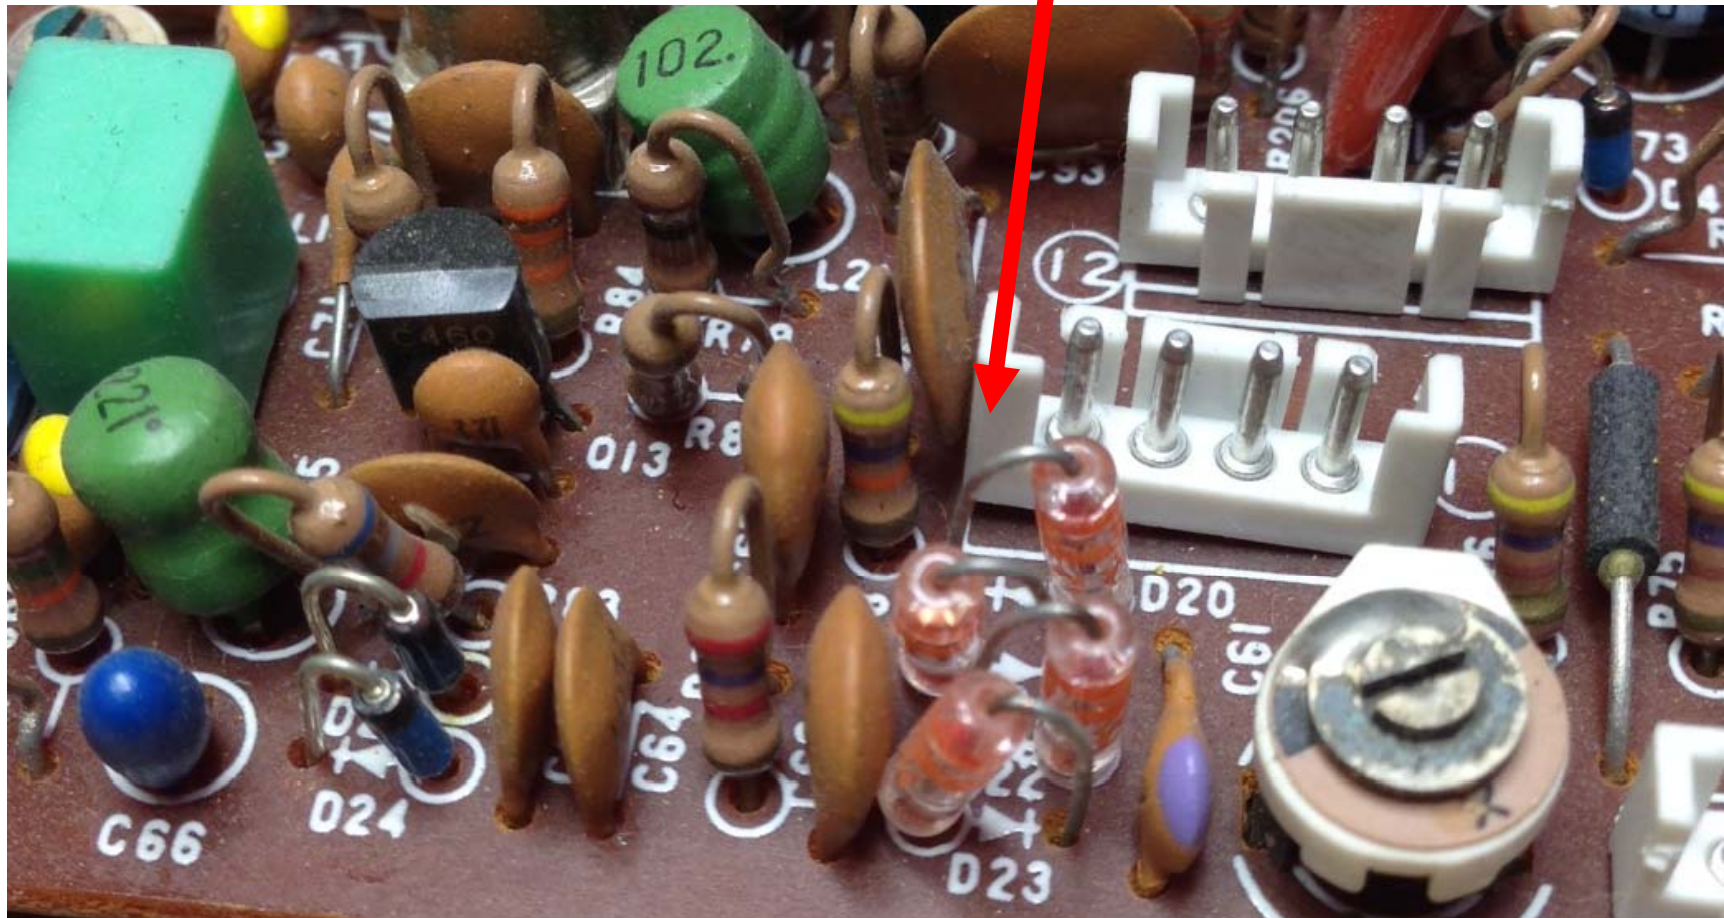
Bad As Built Molex connector not flush on board
before soldering
