KENWOOD 2019 Dayton Hamvention Kenwood Forum

Rescuing a Kenwood T599A Transmitter from the Landfill

- The following material was provided by Terry Wagoner, K9TW and myself, WB0IQK.
- <http://www.k9tw.com/>
- Terry has been servicing Kenwood Hybrid radios for just over 13 years.
- Many problems can be fixed by performing a good visual inspection.

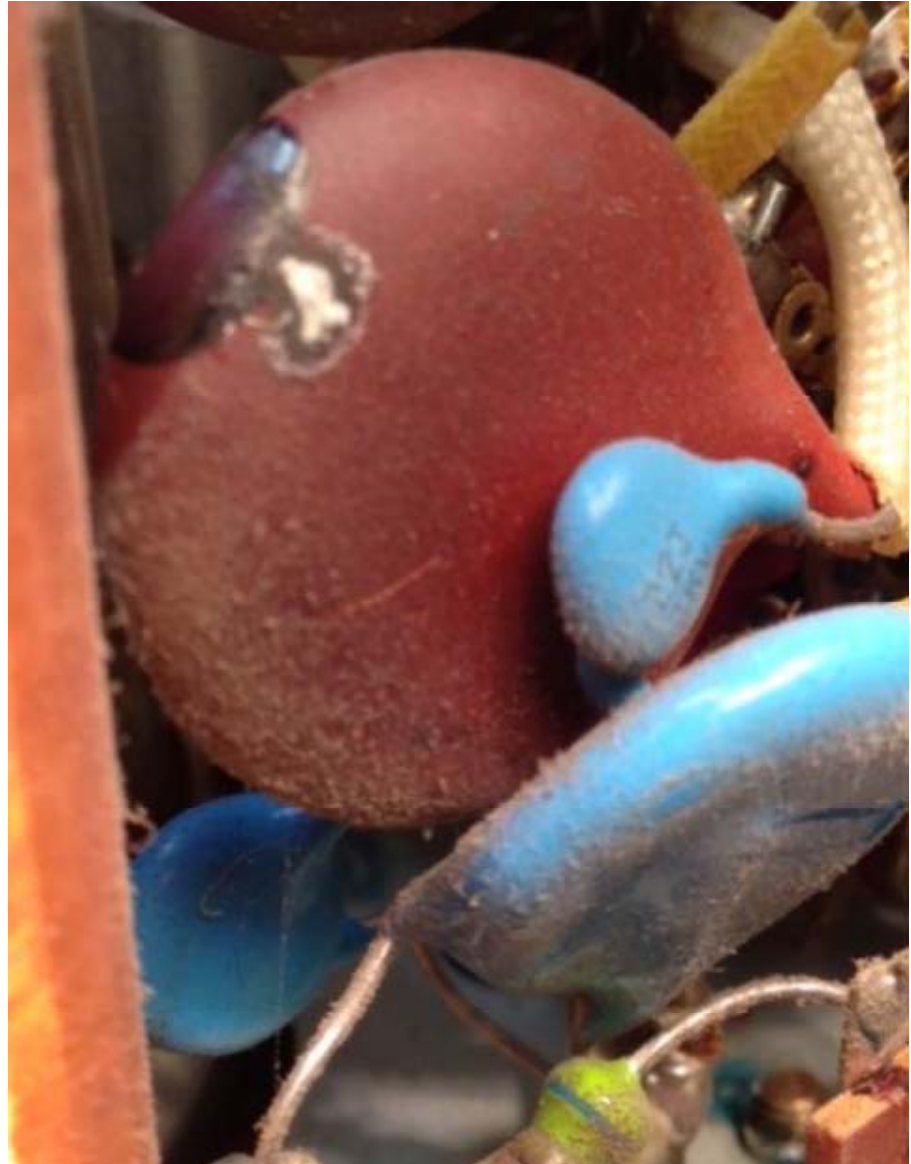
Final Cage Damaged Cap

- Bad Padder Cap

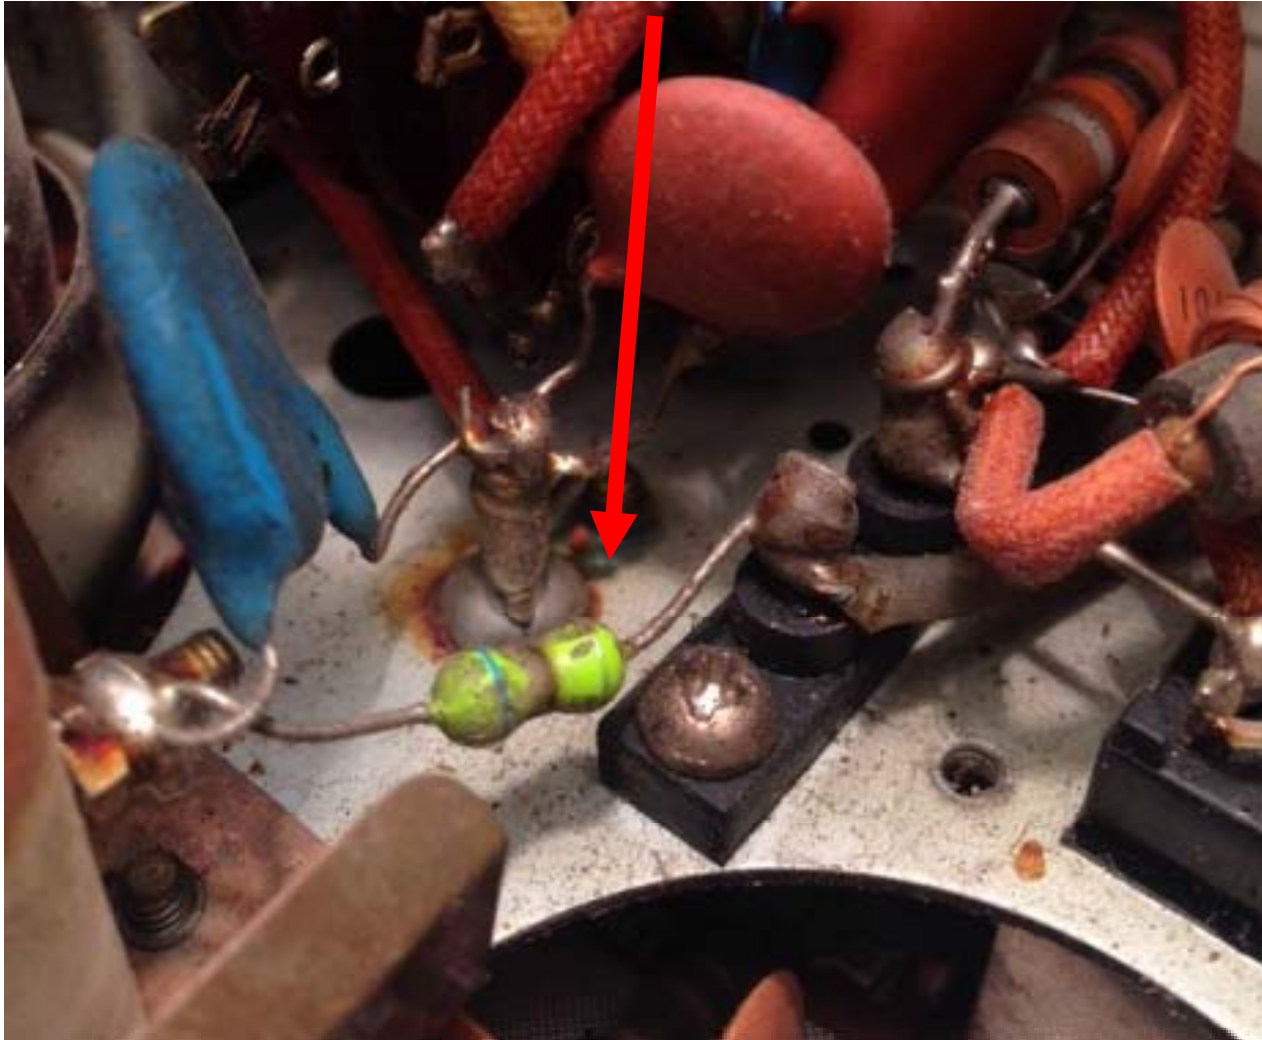
BAD VHF CHOKE

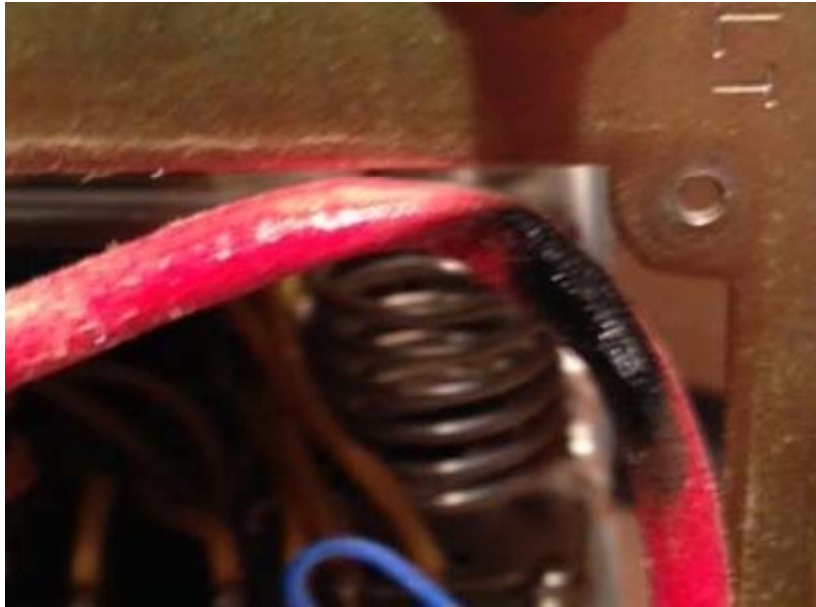
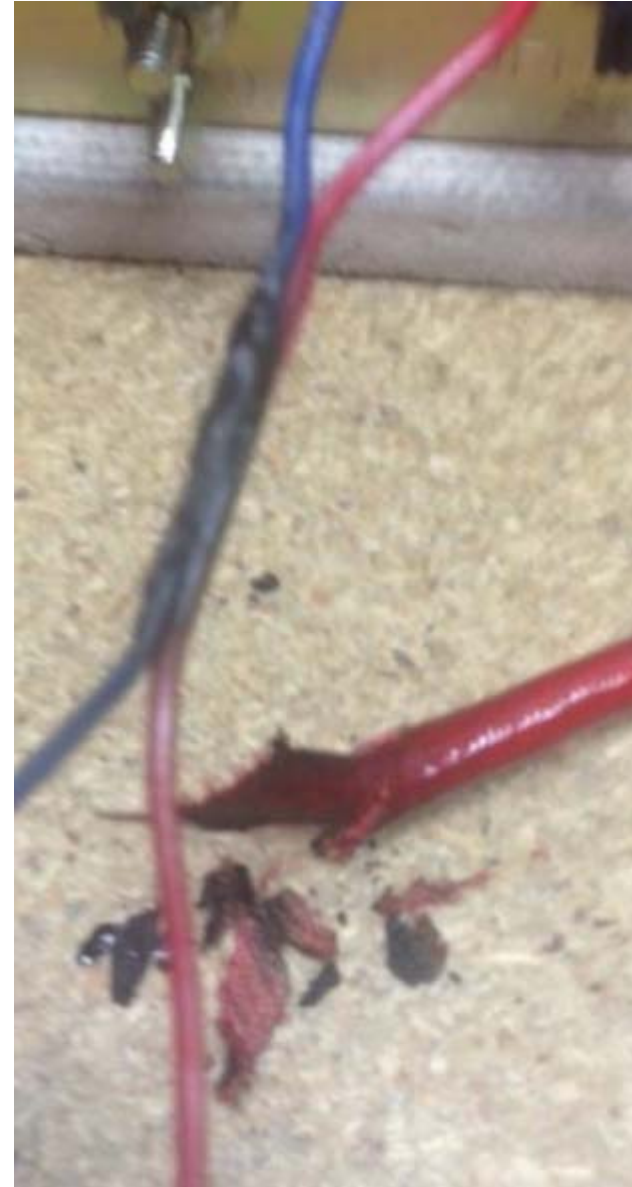
Final Cage Cooling Fan Motor Leads

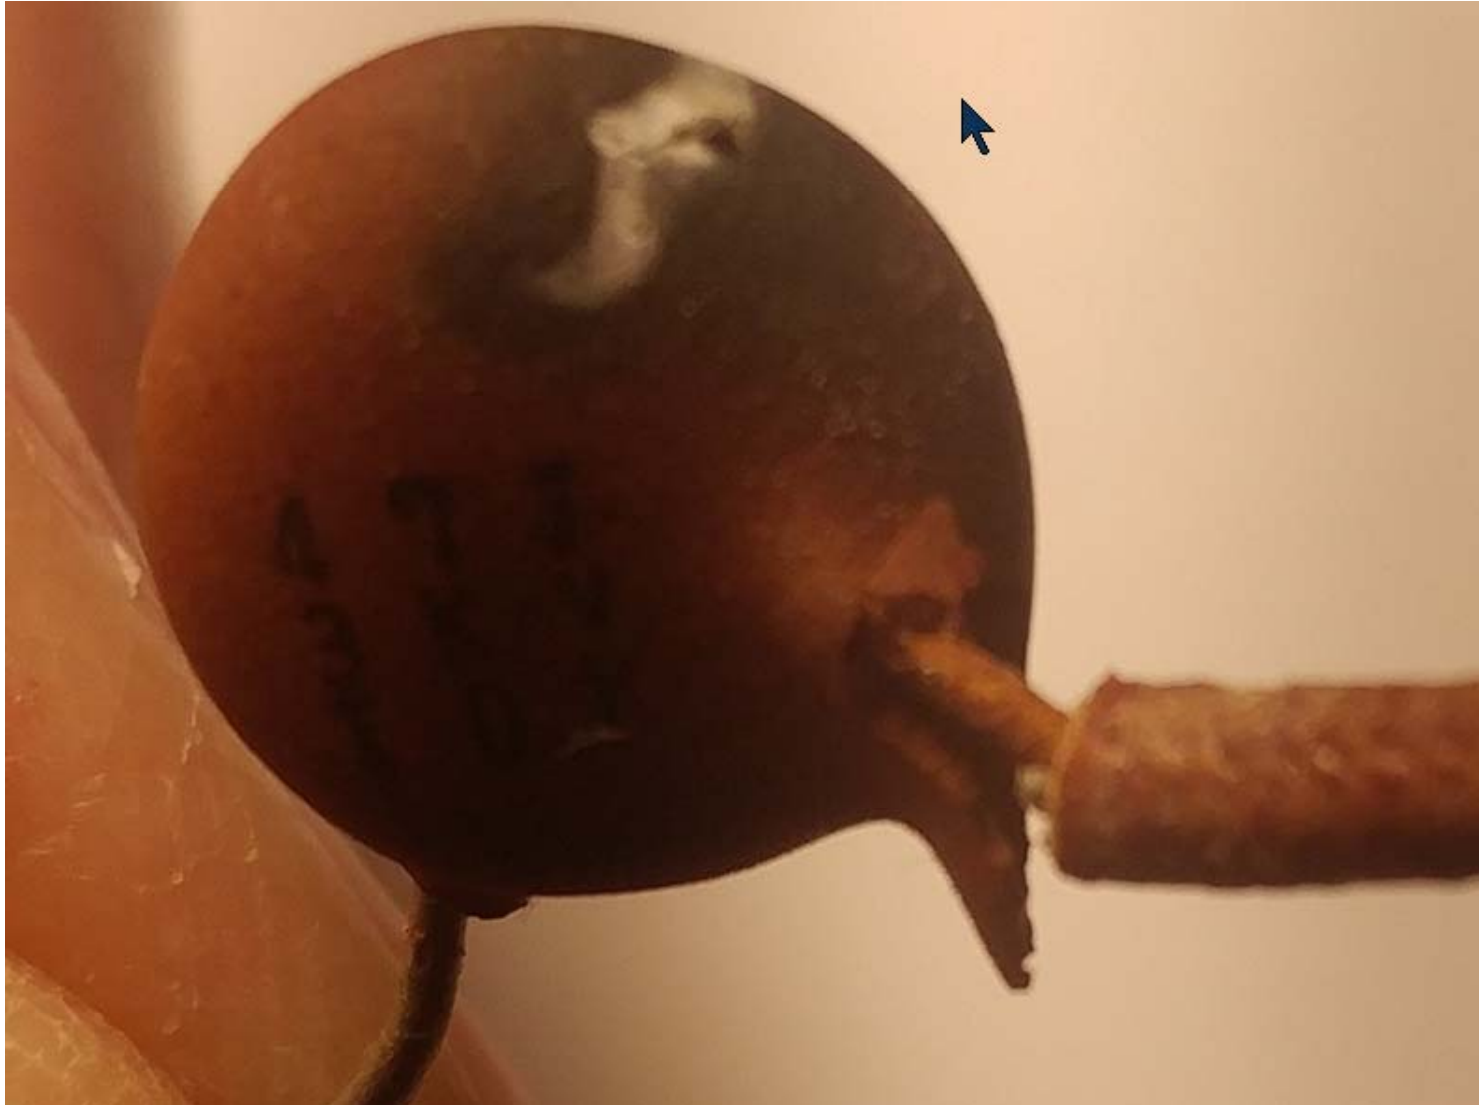
Damaged 80/40 meter band switch
padder capacitor

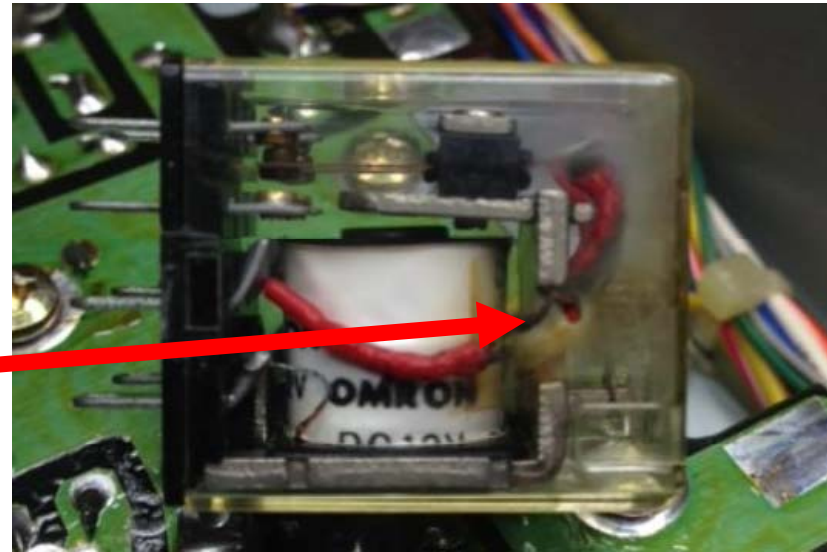
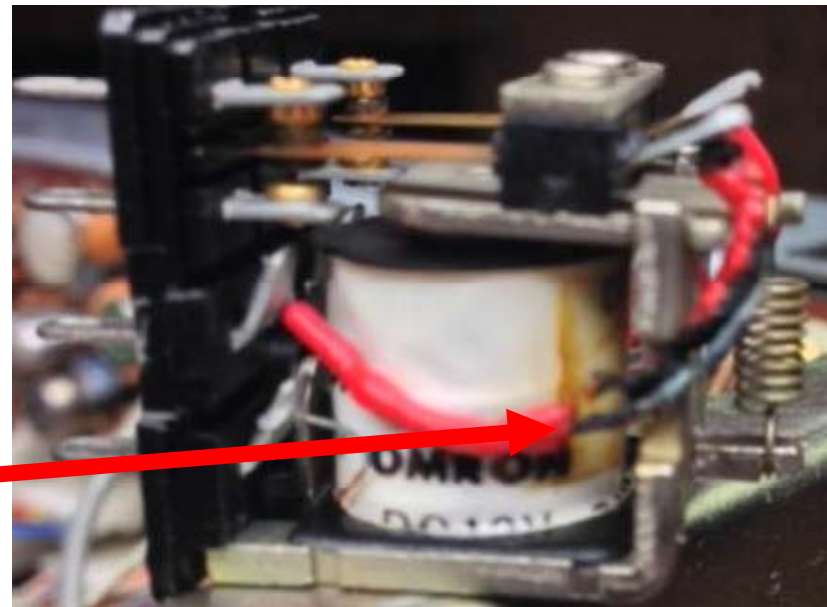
Excess RF Feed into Antenna Connector

- Heres what happens when you bring home that hamfest linear and hook it up on bench and accidentally back feed your TS830S SO-239 antenna connector. The Omron MX-2P Ant TR relay wont like it not to mention your L41 Ant step up transformer

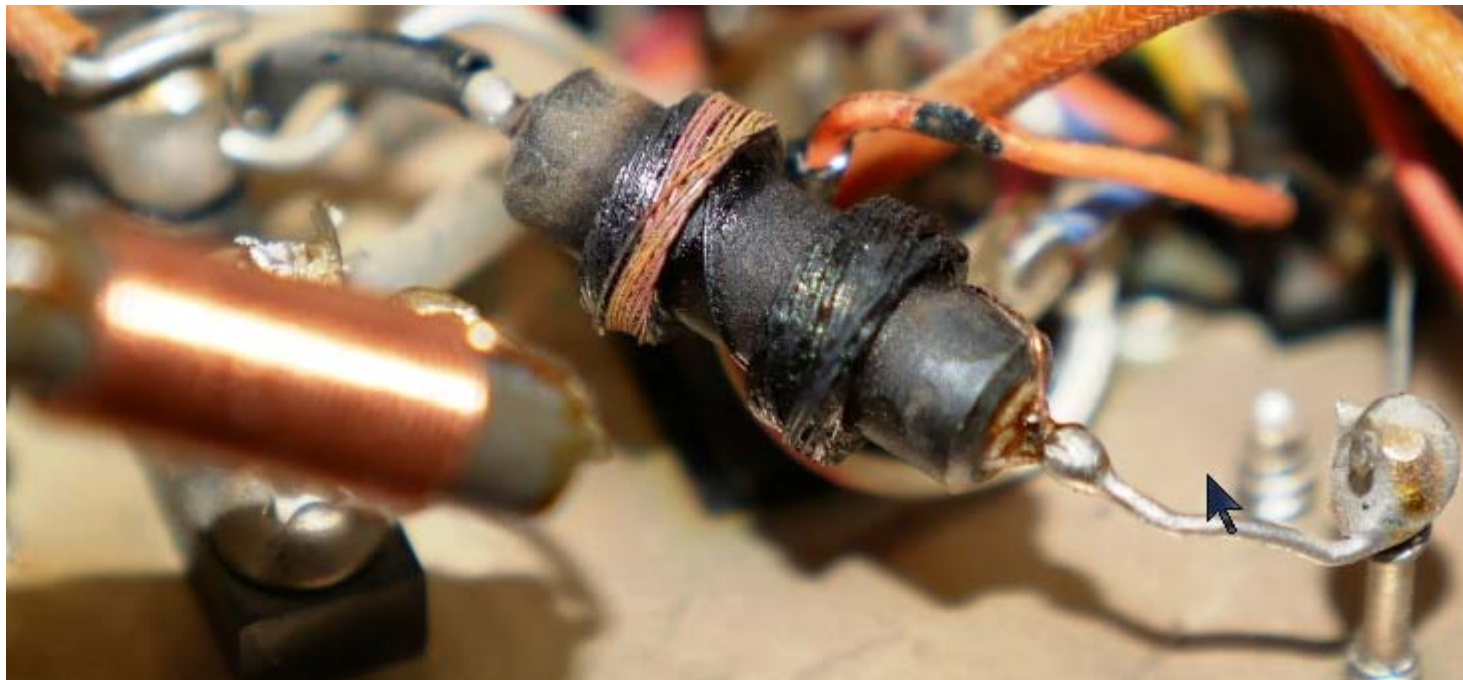
Pi-network Plate Block Cap

- Here is what happens when the Pi-network Plate Block Capacitor fails shorted and supplies 900vdc to your SO-239 connector. Better the "Safety Choke" than you fingers or heart screwing on the antenna coax PL-259. That would be a real nasty surprise. Question is what size fuse did owner have?

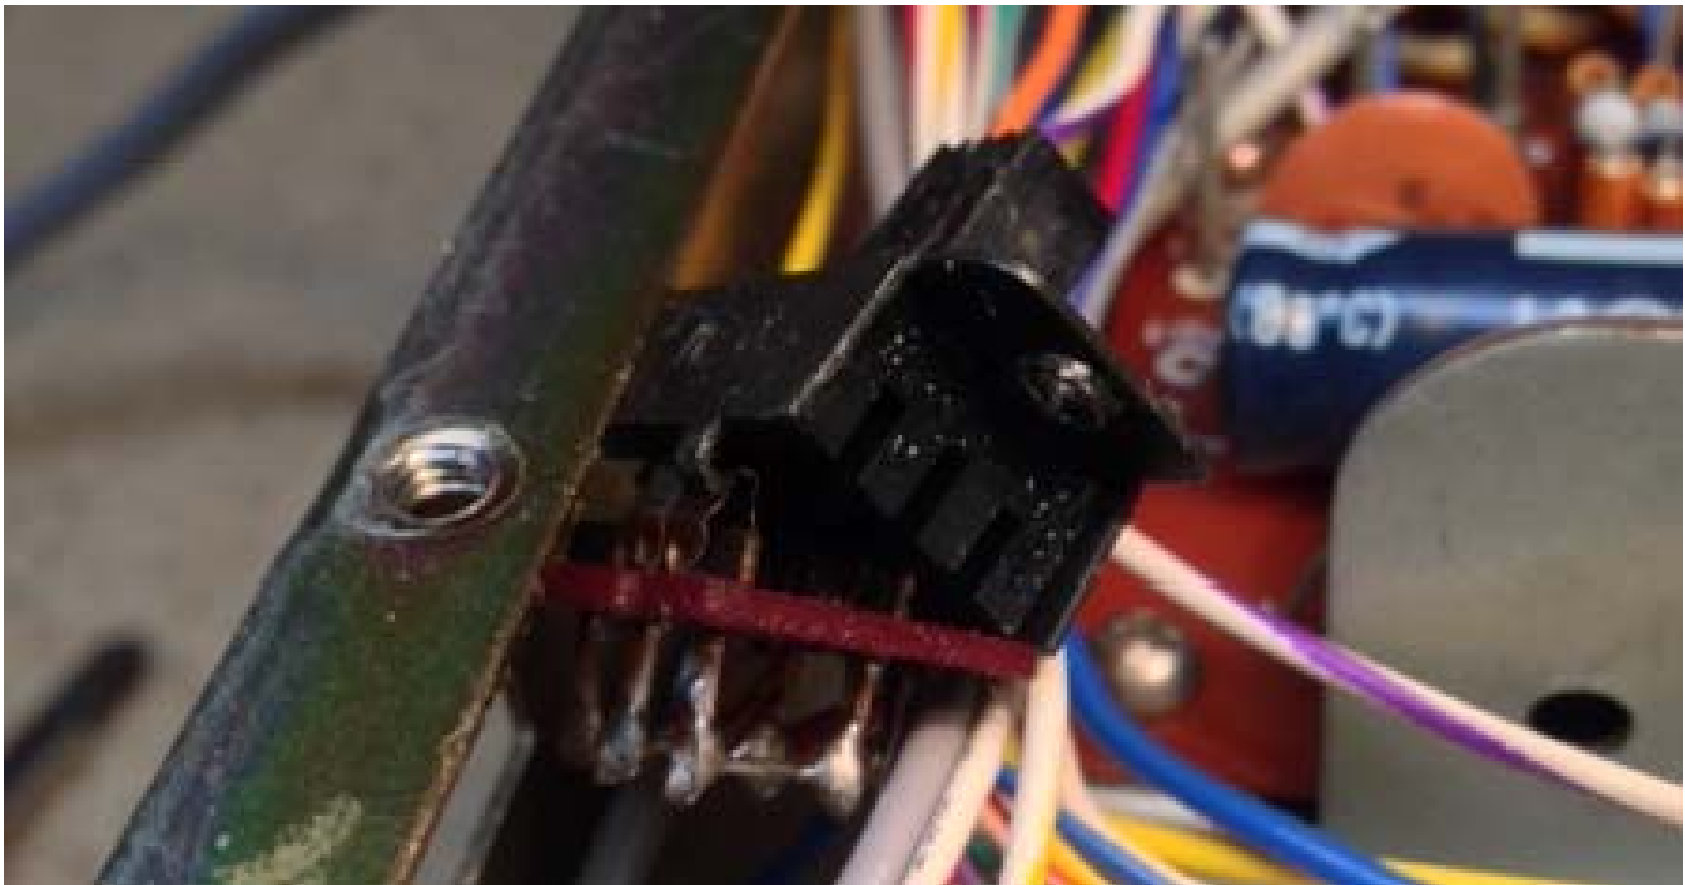
Broke SG Switch

- How do you drop your radio and hit the screen grid switch slide actuator?

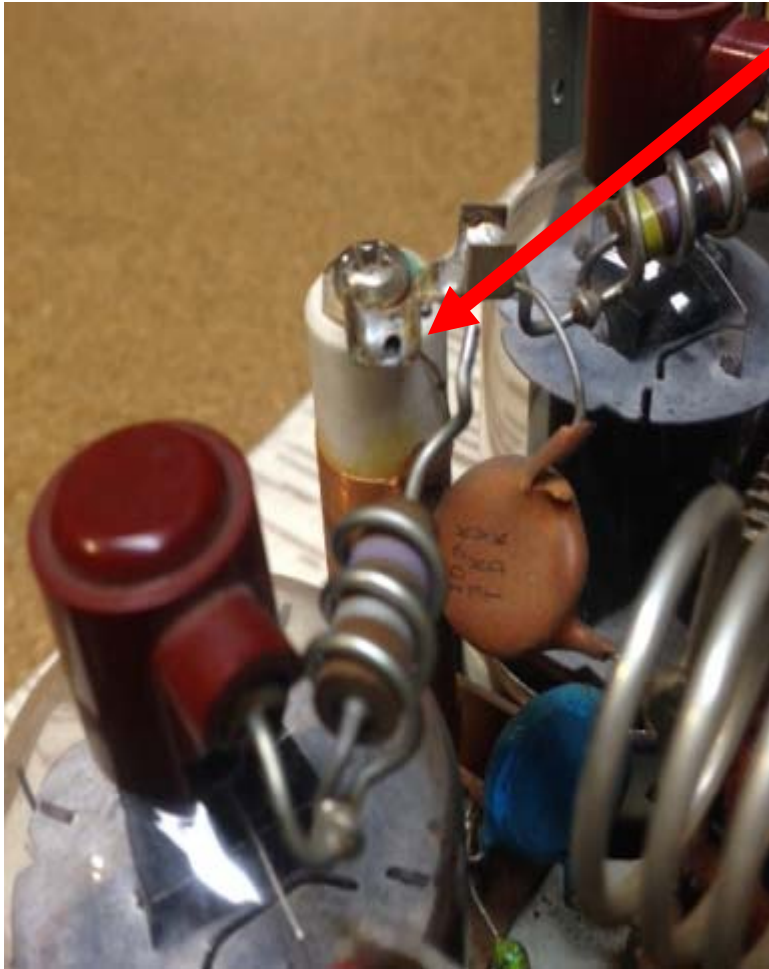
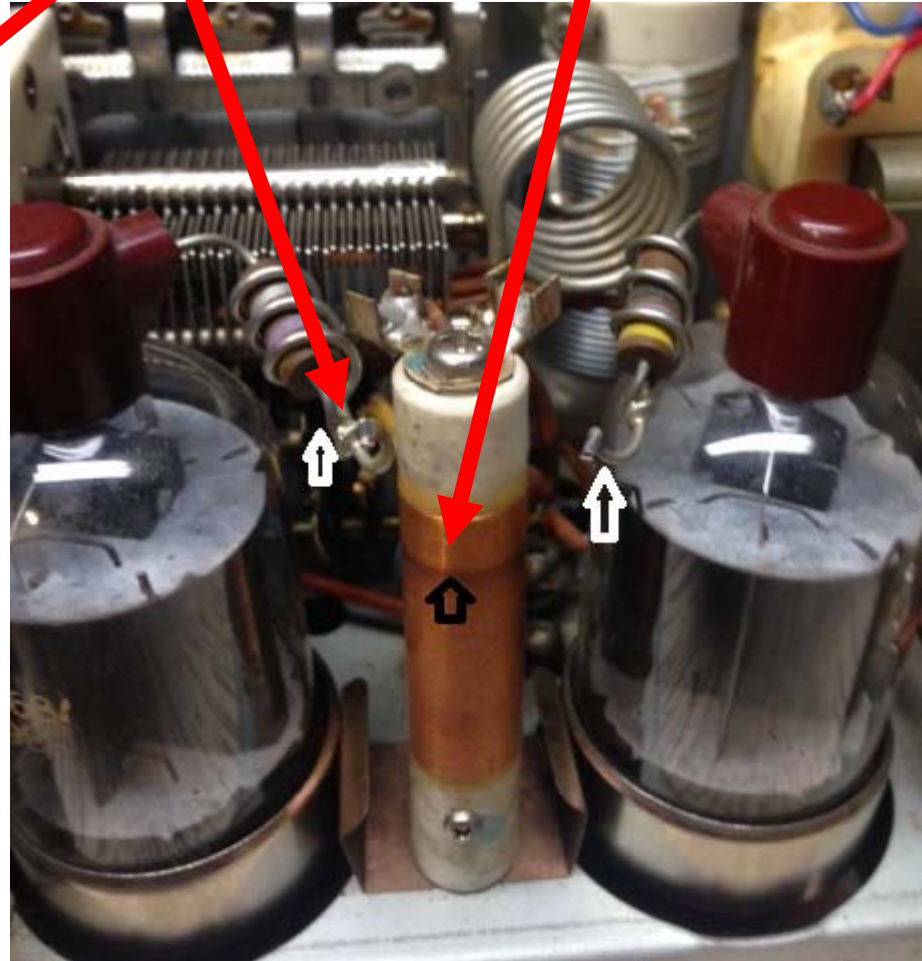
KENWOOD PART NOT SOLDERED

BAD RF CHOKE

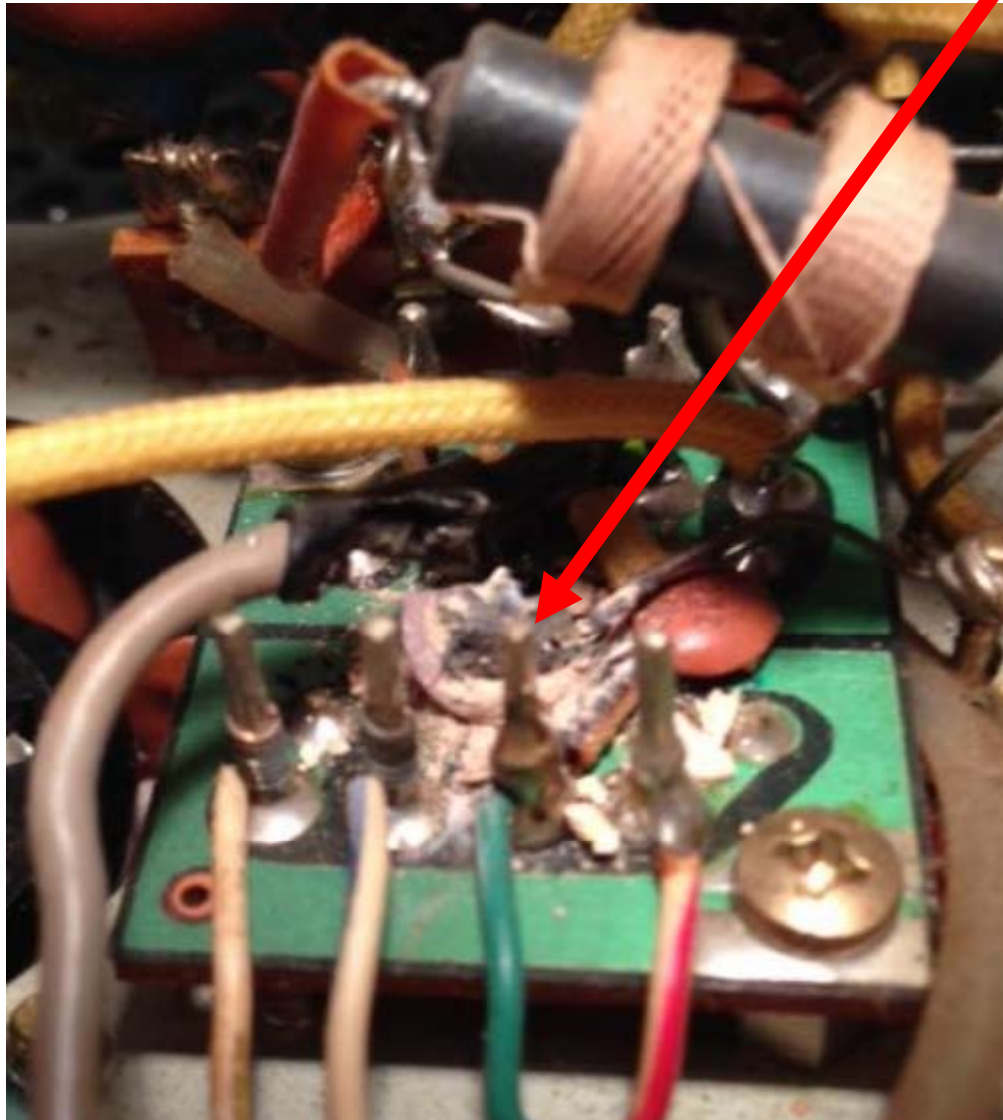
TS530S with blown RF bypass cap on the Ant TR relay PCB

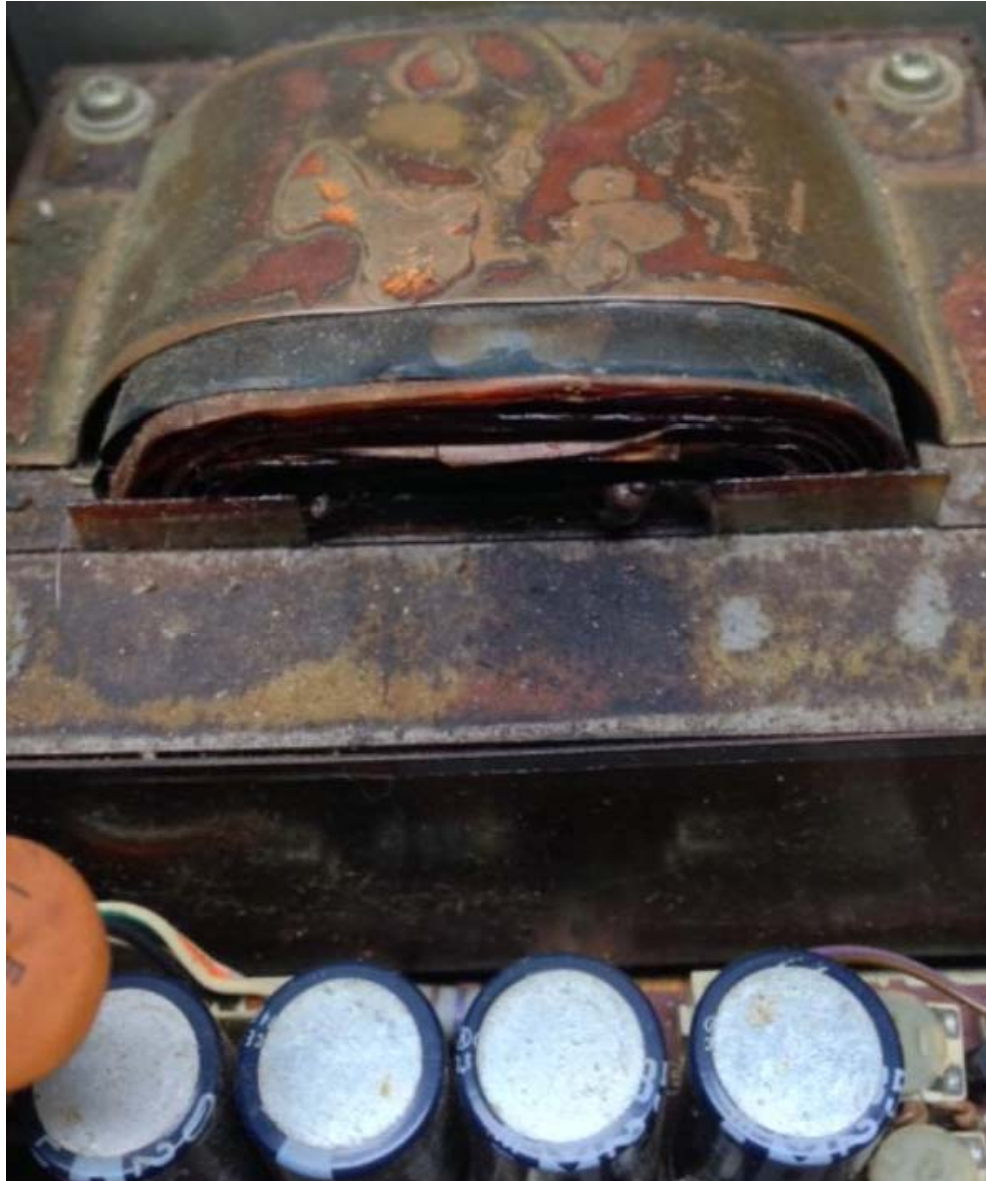
A Transformer Failure, The Ultimate Failure

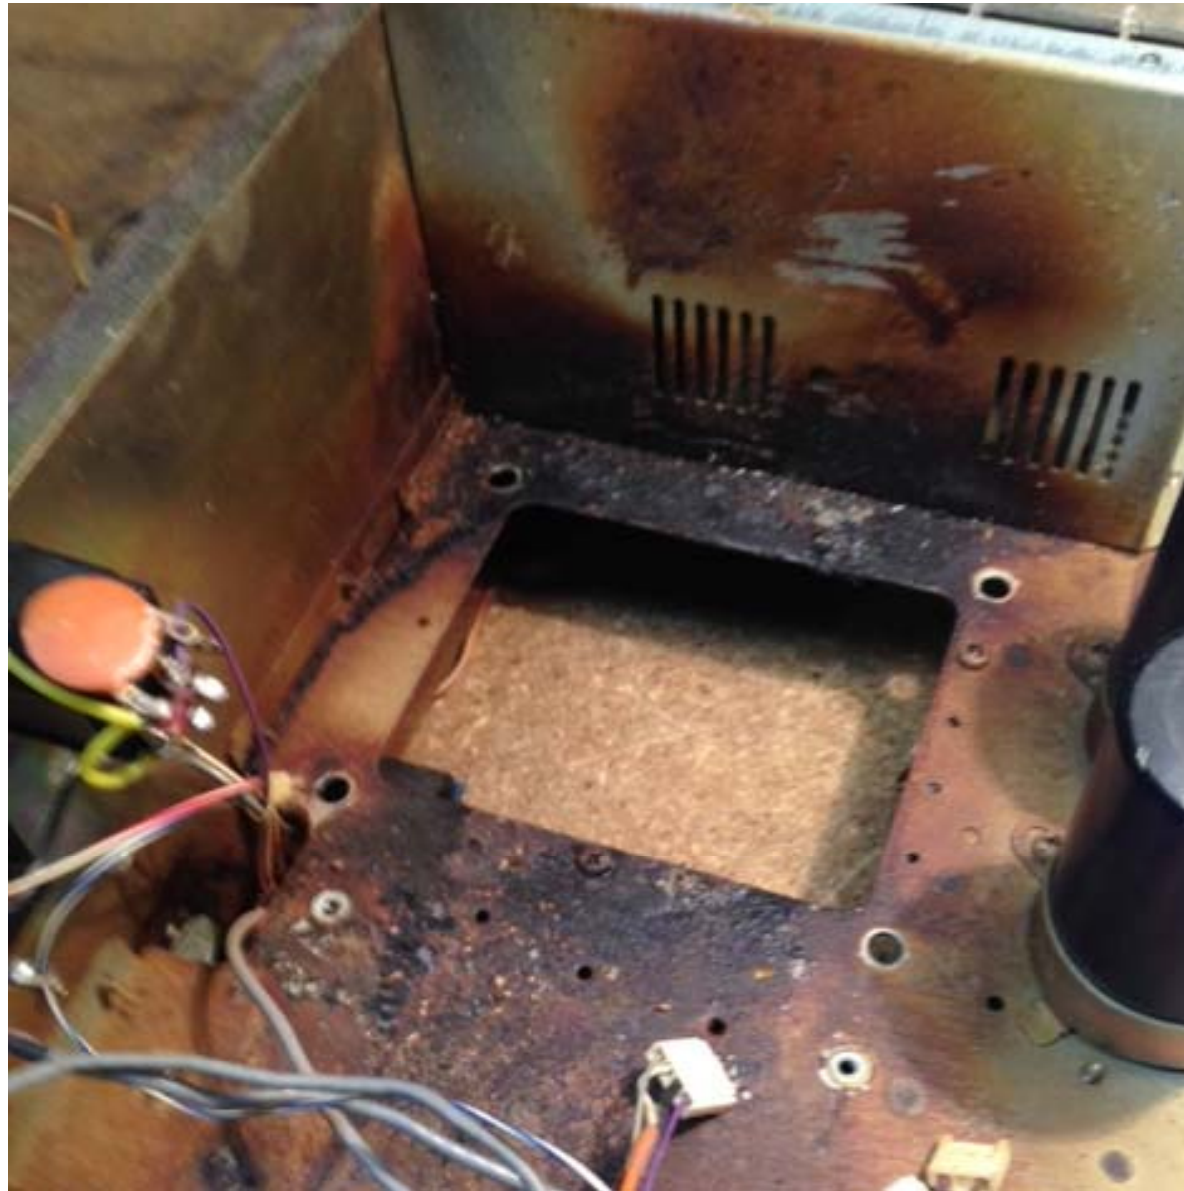
A Transformer Failure, The Ultimate Failure

Save your
money.
Don't bother
sending this
out for
repair.

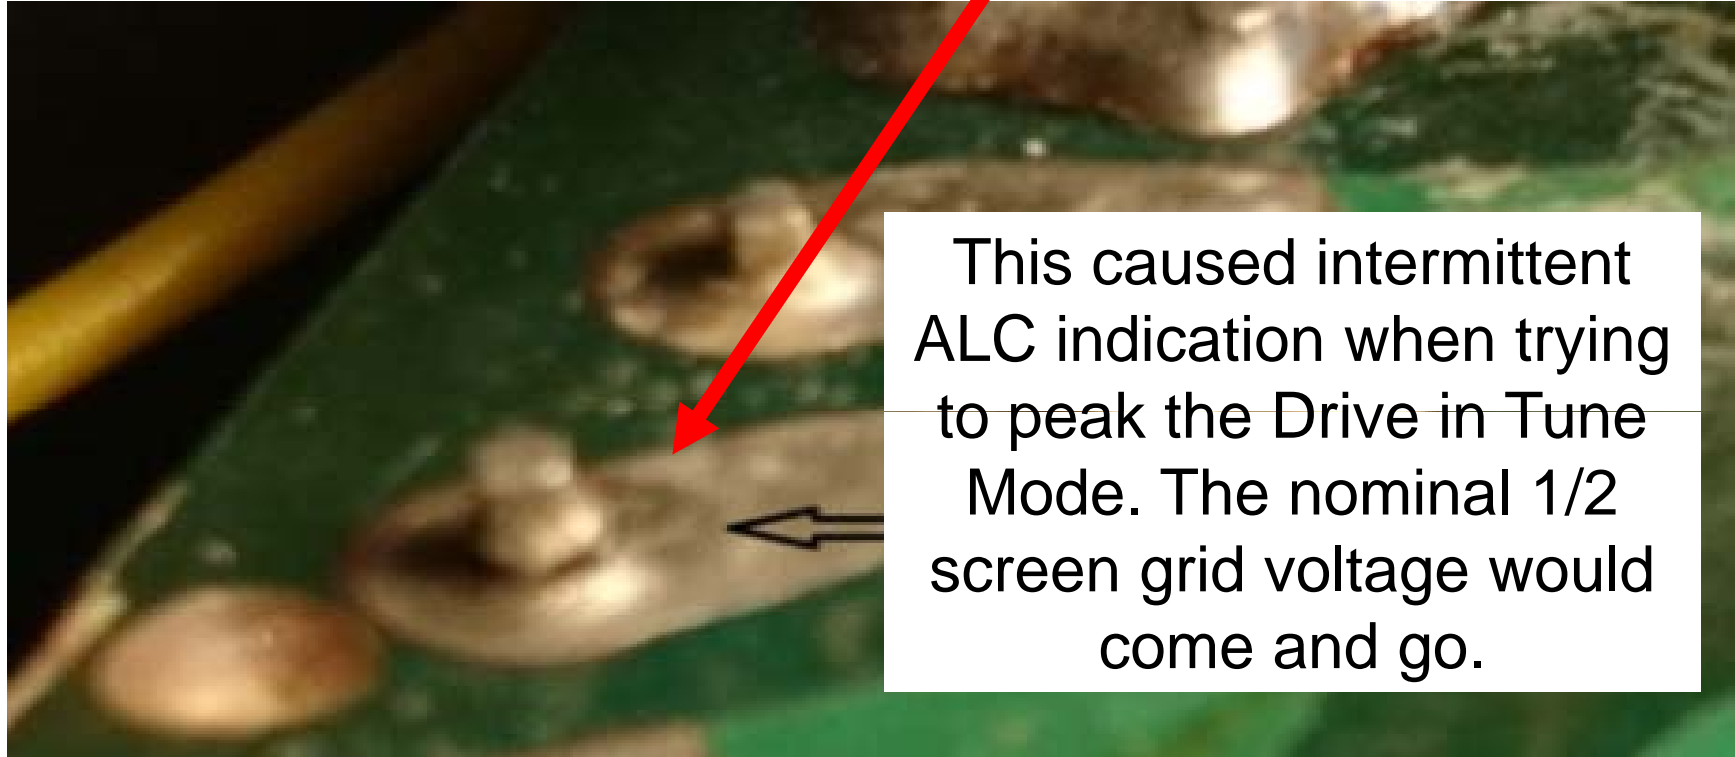
Cracked solder on the TUNE post on a TS830S

This caused intermittent ALC indication when trying to peak the Drive in Tune Mode. The nominal 1/2 screen grid voltage would come and go.

With radio unplugged and caps discharged grasp each wire wrap terminal post with fingers and gently try to rock back and forth. Should be no movement. If there is movement have to roll board over and best to remove old solder and apply new.

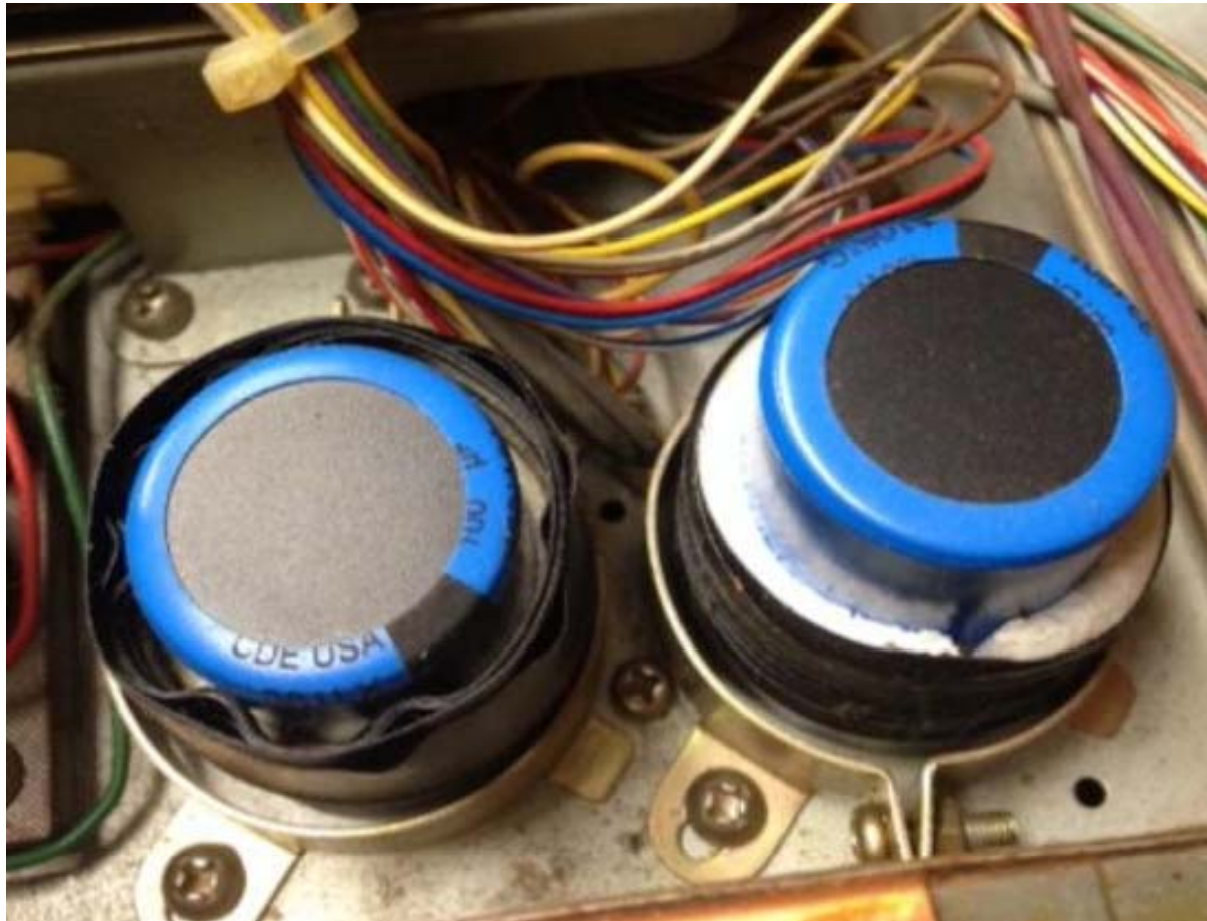
Here is "Hill Billy" HV capacitor replacement! Generous use of black plastic electrical tape and Styrofoam shim. A real KW tech would have used duct tape!

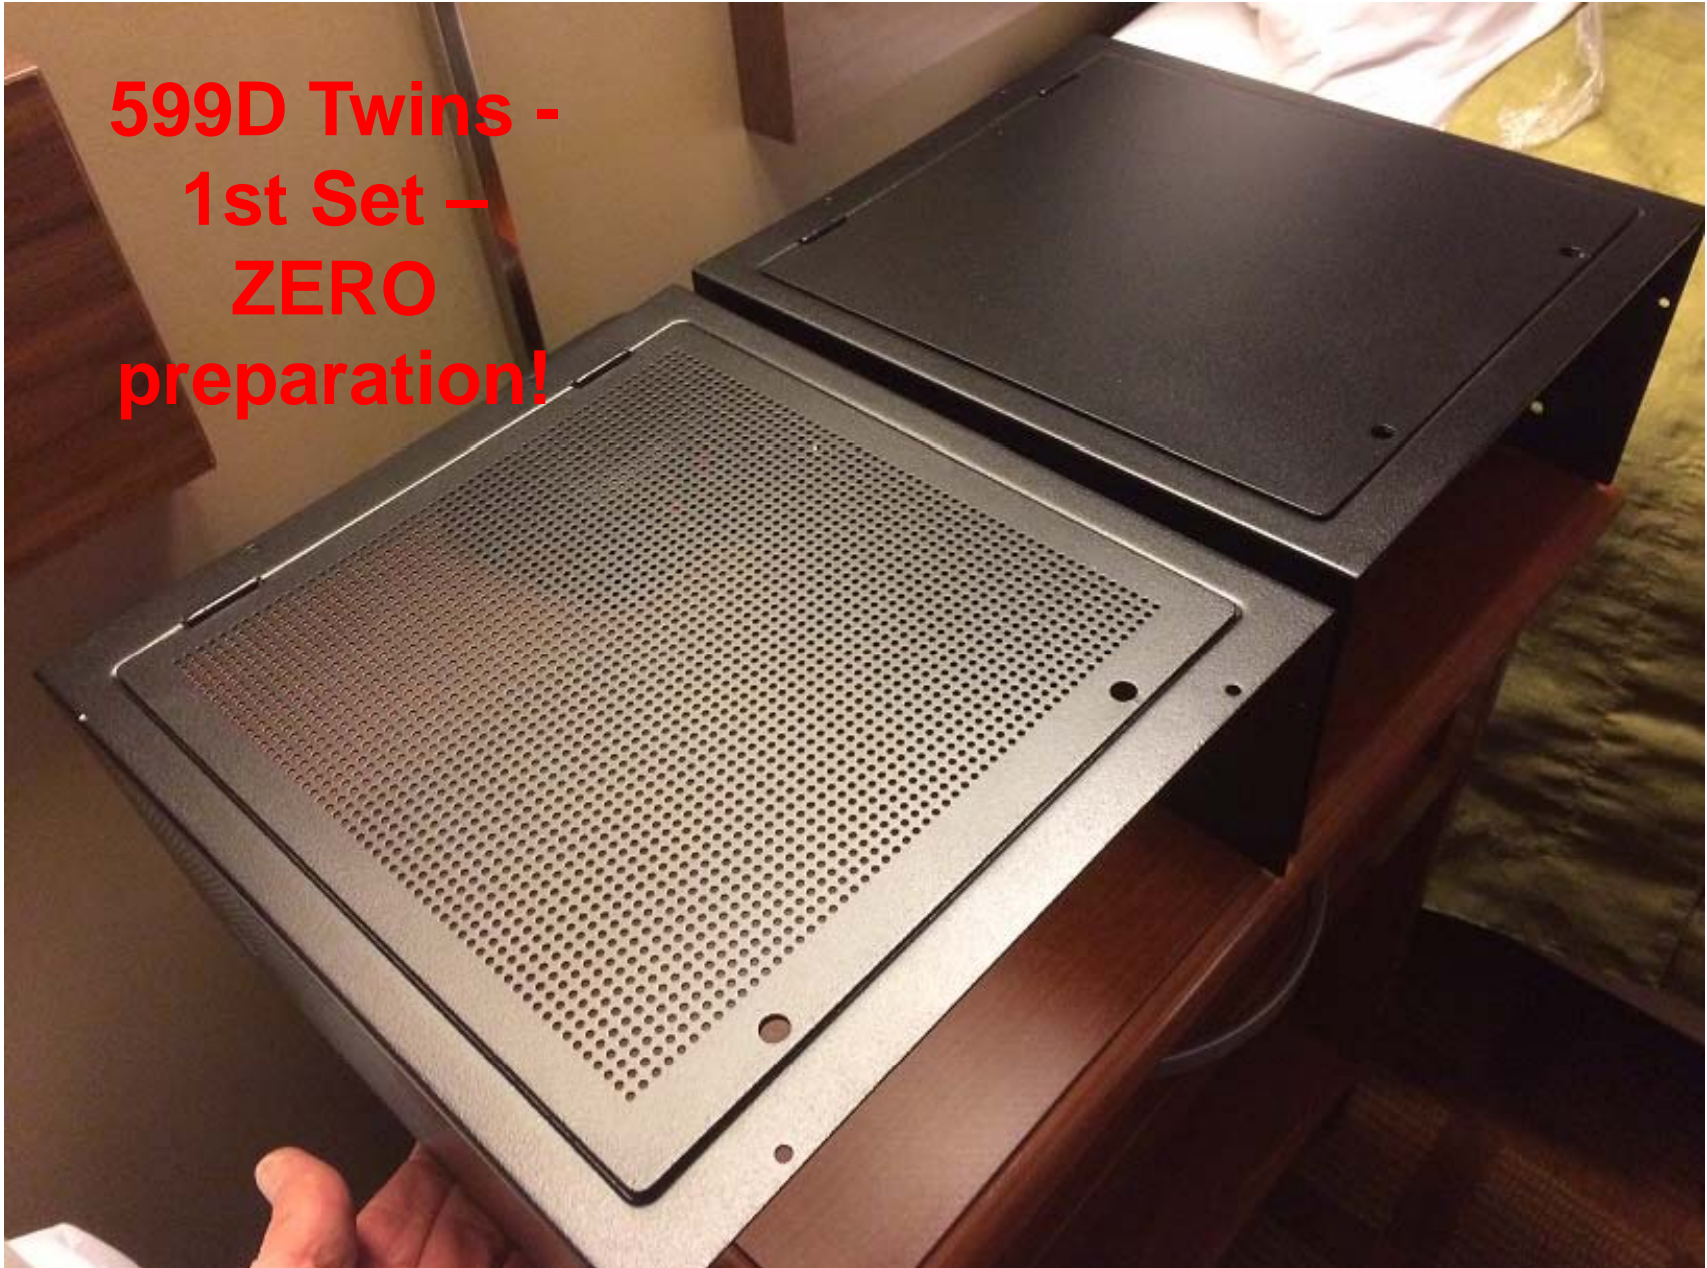
**599D Twins -
1st Set –
ZERO
preparation!**

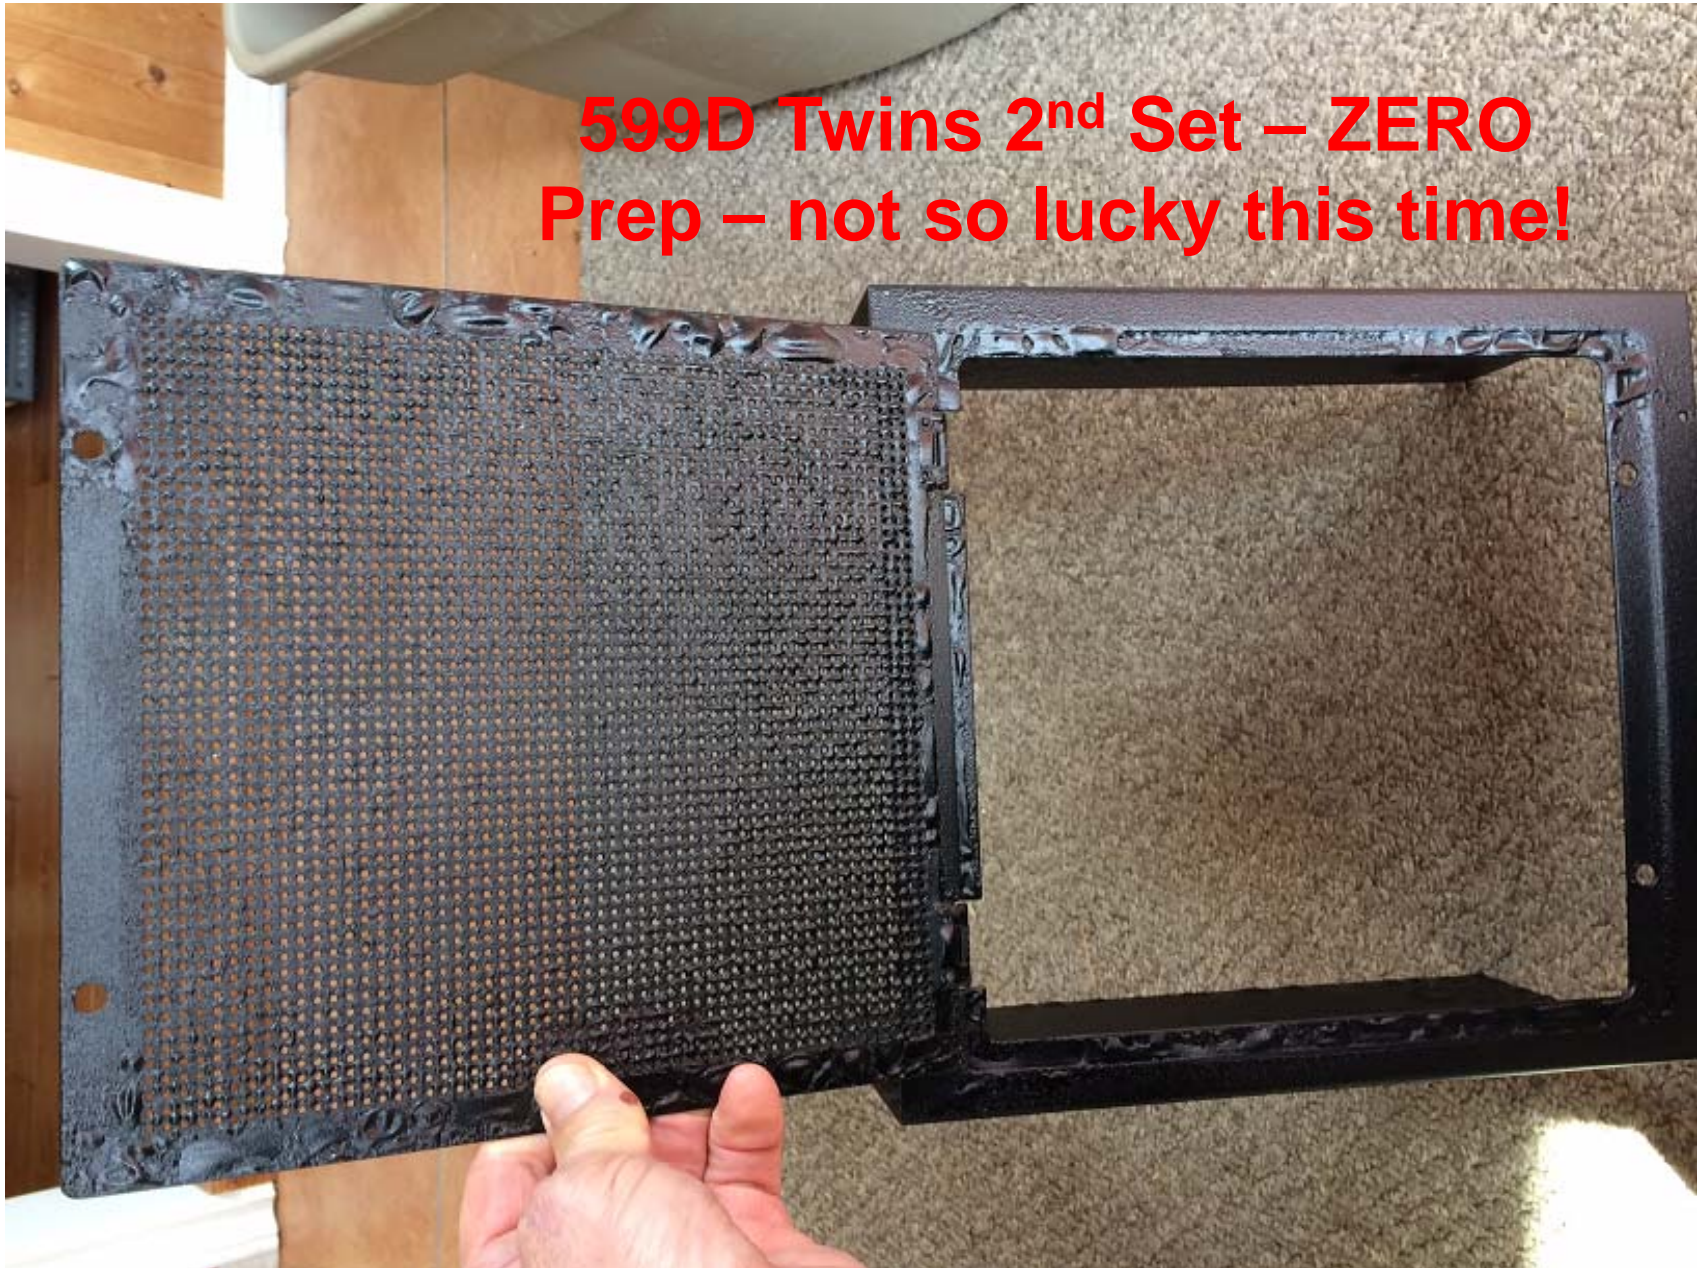
**599D Twins 2nd Set – ZERO
Prep – not so lucky this time!**

- Not sure why some bubble up – moisture related? Seepage through original paint during prep at shop not fully drying?
- Some, but not all, that have bubbled have shown evidence of rust under the paint after stripping.
- 100% success rate when cabinet stripped to bare metal and sanded.
- Drake 4-line gear has been about a 70% success without stripping the cabinet.
- YMMV!!!
