KENWOOD 2019 Dayton Hamvention Kenwood Forum

Rescuing a Kenwood T599A Transmitter from the Landfill

- The following material was provided by Terry Wagoner, K9TW and myself, WB0IQK.
- <http://www.k9tw.com/>
- Terry has been servicing Kenwood Hybrid radios for just over 13 years.
- Many problems can be fixed by performing a good visual inspection.

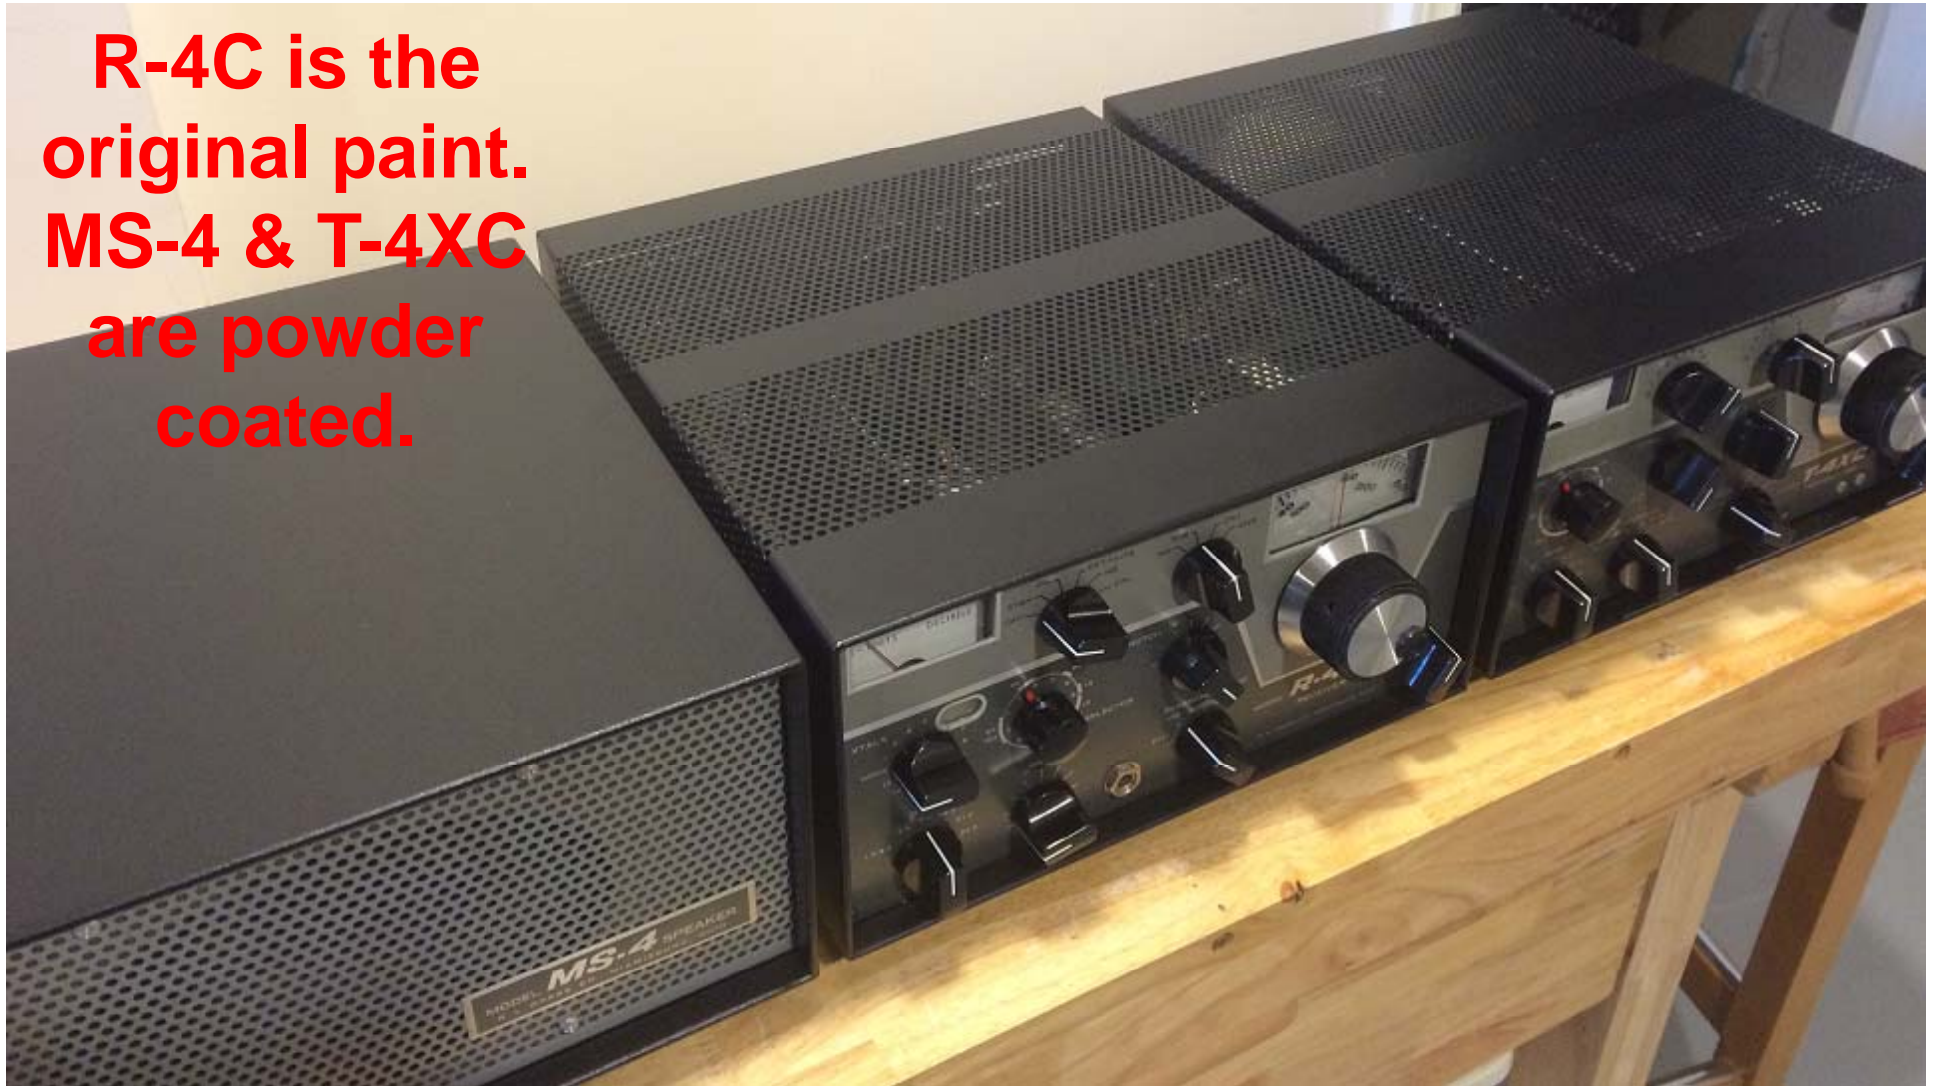
**R-4C is the
original paint.
MS-4 & T-4XC
are powder
coated.**

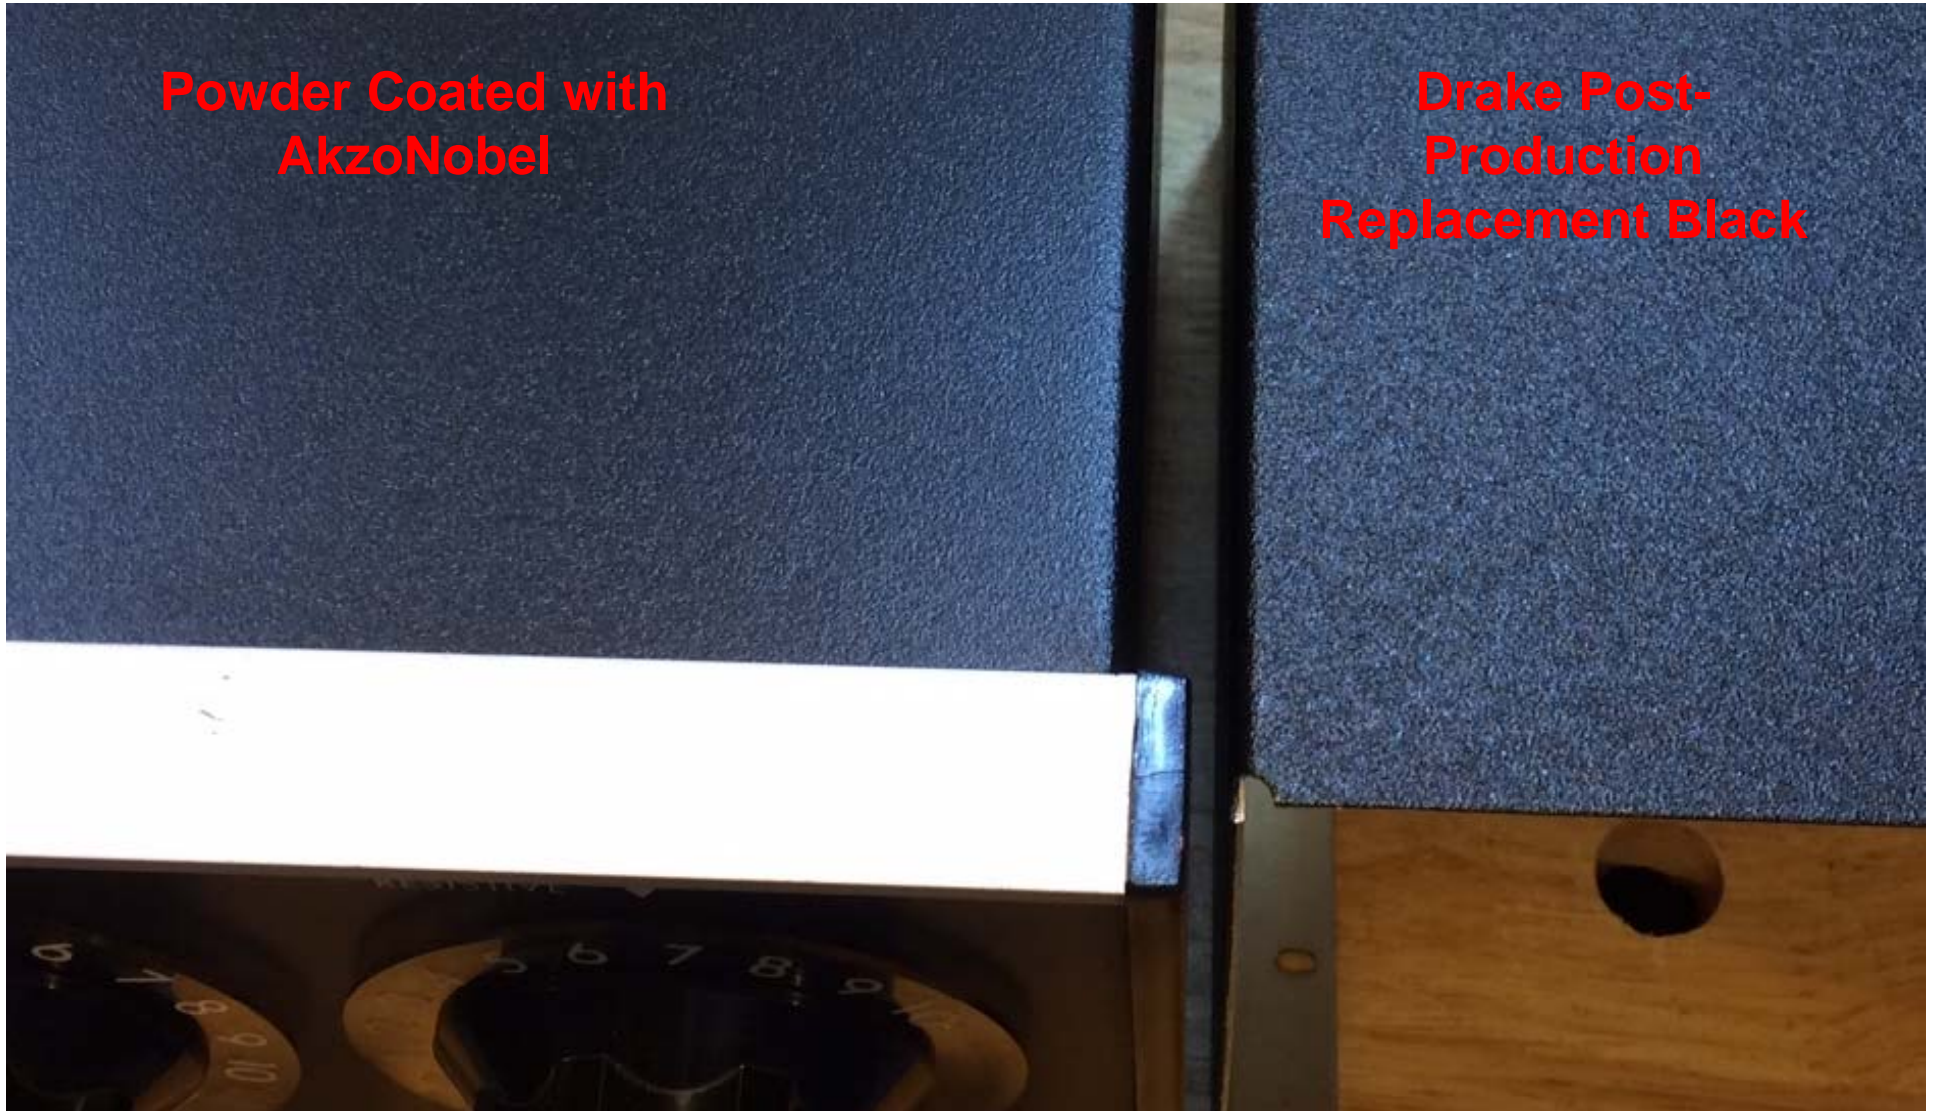
**Powder Coated with
AkzoNobel**

**Drake Post-
Production
Replacement Black**

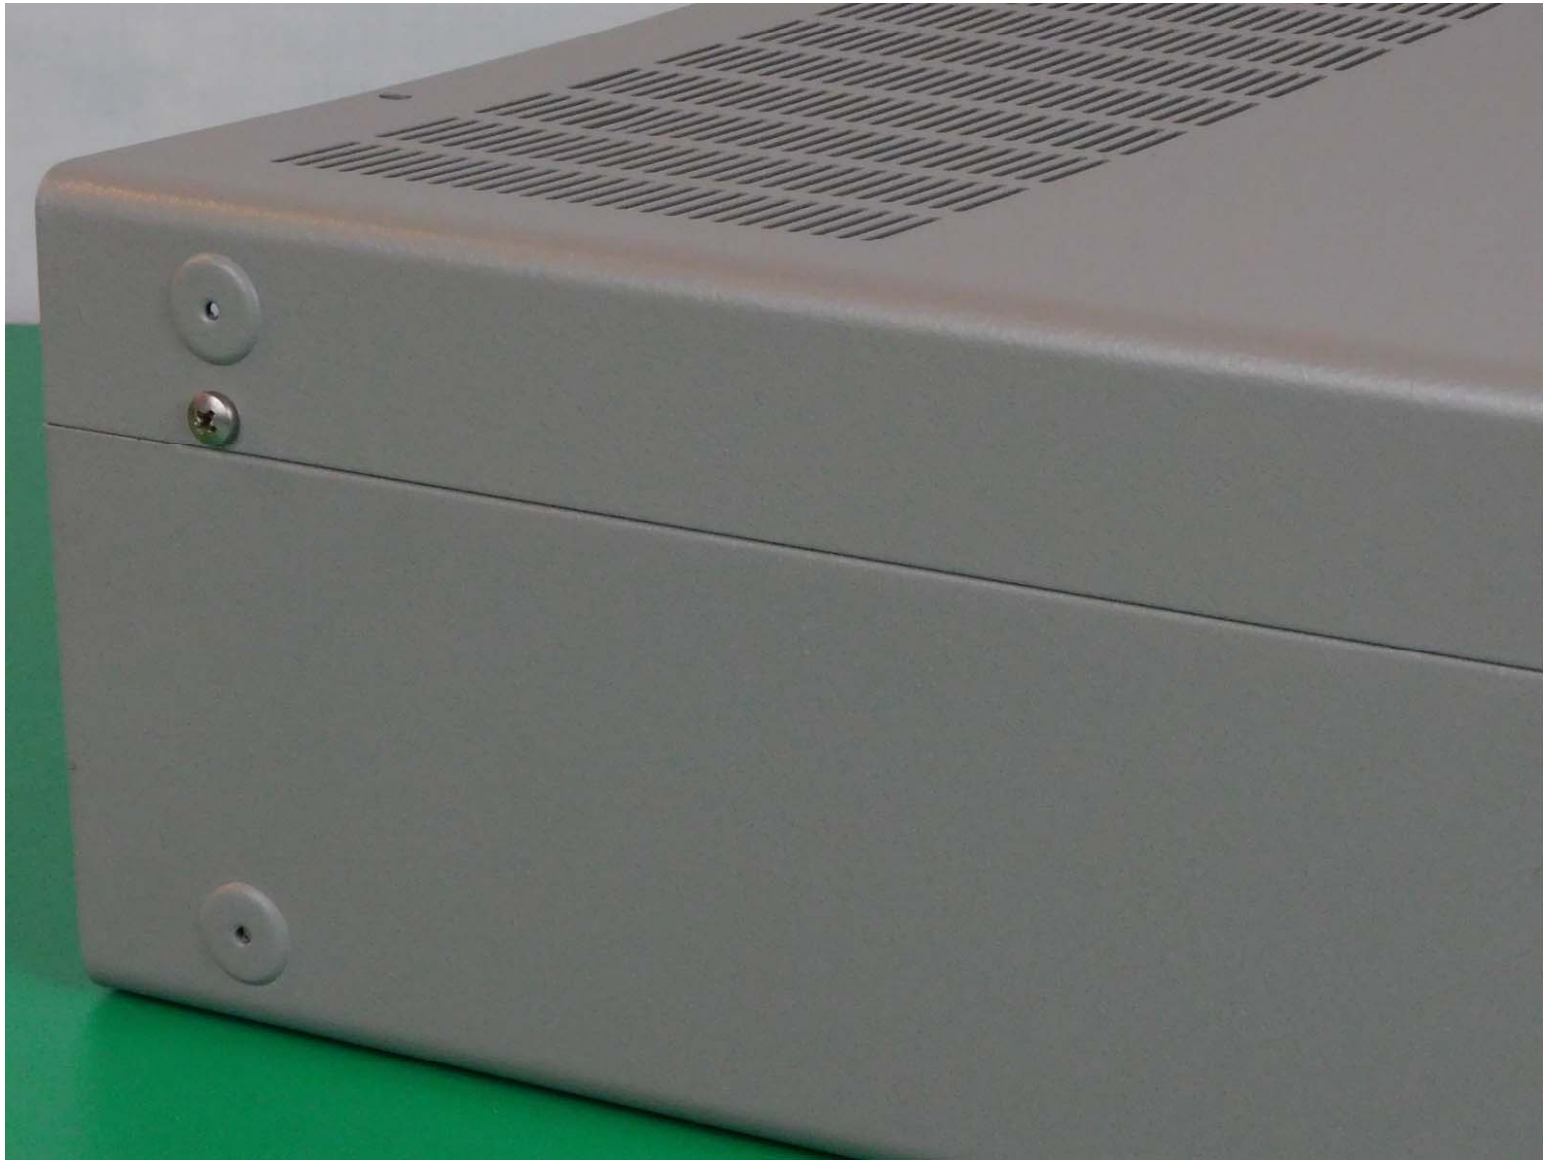
Original Bottom – Repainted Top
