SERVICE BULLETIN

from: TRIO-KENWOOD COMMUNICATIONS, INC.

SUBJECT: SERVICE NOTE ON DG-1

SUBJECT: DG-1 STANDARD SERVICE PROCEDURE

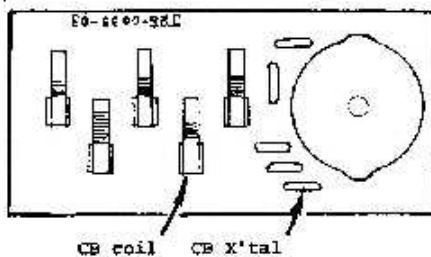
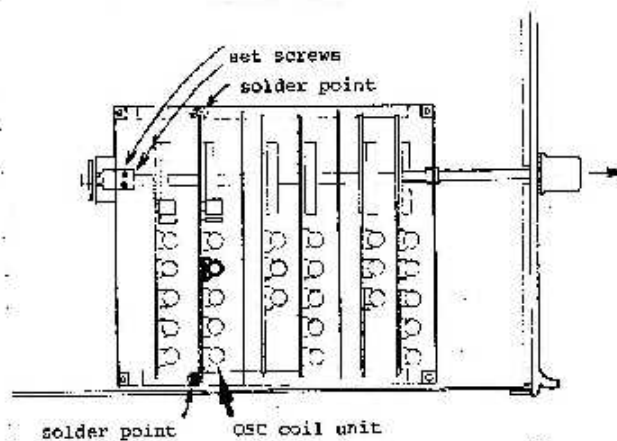
This ruling also applies to any used R-599A or R-599D receiver you may have in stock. The following instructions are for removing the CB band. This will satisfy the FCC and make the receiver saleable.

1. Remove top cover.
2. Remove bottom cover.
3. Remove shield plate from coil pack.
4. Set band switch to 14MHz.
5. Remove the black wire from the OSC Coil Unit. (This wire is on the top side.)
6. Loosen screws on shaft coupling and slide shaft out about 2 inches.
7. Unsolder the OSC Coil Unit from the mounting bracket and remove it from the coil pack.
8. Unsolder and remove the CB coil and crystal.
9. Replace the OSC Coil Unit and solder it in.
10. Slide the band switch shaft in place, making sure that each wafer is properly indexed.
11. Resolder the black wire to the OSC Coil Unit.
12. Replace all covers.
13. Check for proper operation.

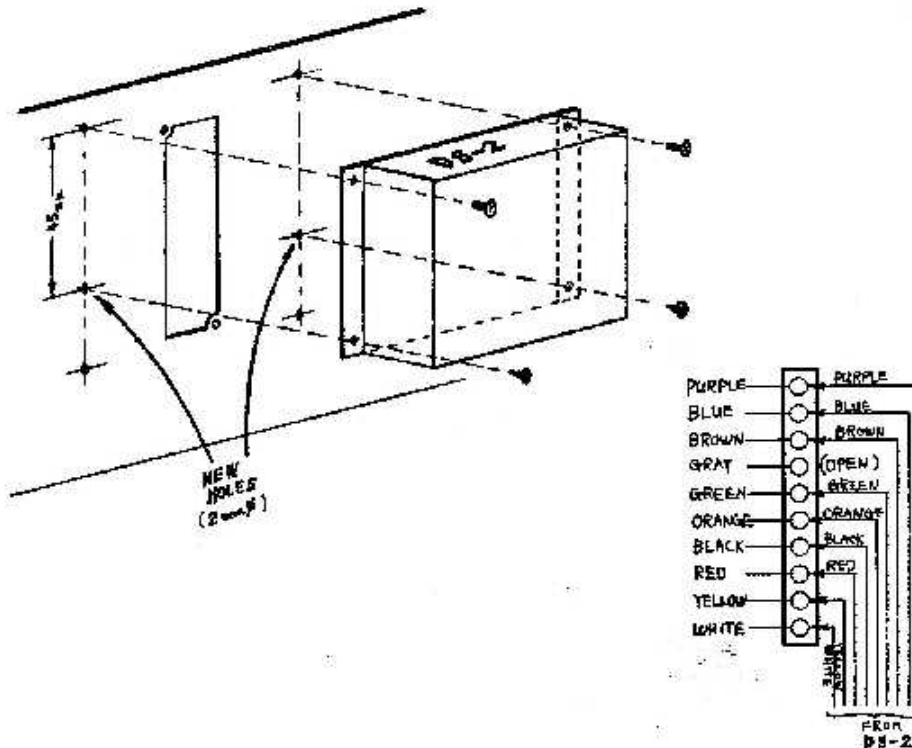
The DS-1A DC-DC converter for the TS-820 series and TS-520/S has been replaced by a new model, the DS-2. Wiring color code is the same. Physical size is smaller. Two additional mounting holes must be drilled in the transceiver rear panel.

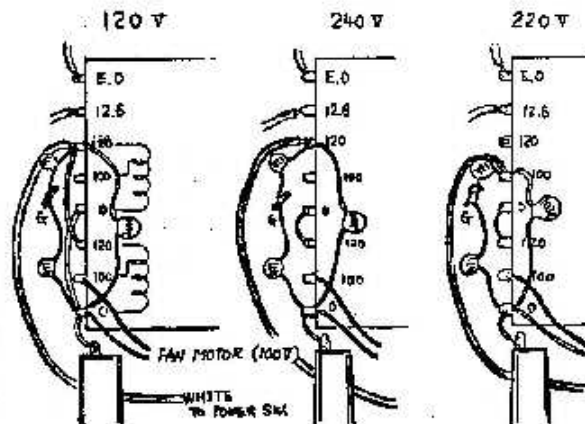
To operate the TS-830S on 240V AC, the power transformer split primaries must be rewired from parallel to series connection.

1. Unplug the AC power cable.
2. Remove the bottom cover.
3. Remove the jumper wires between the two 0 terminals and two 120 terminals on the bottom of the power transformer.
4. Connect the adjacent 120 and 0 terminals at the middle of the transformer. This will provide 240V AC operation.
For 220V A. operation, connect the adjacent 100 to 0 winding.
5. Change the AC fuse from 6A to 4A. Tag the power cord at the back of the radio to indicate that the transformer is strapped for 240V AC, and the power fuse should be 4A, and not 6A.
6. Replace the bottom cover and reconnect power to verify your work.
