SERVICE BULLETIN

from: TRIO-KENWOOD COMMUNICATIONS, INC.

SUBJECT: TS-180S DFC HUM WITH PS-30

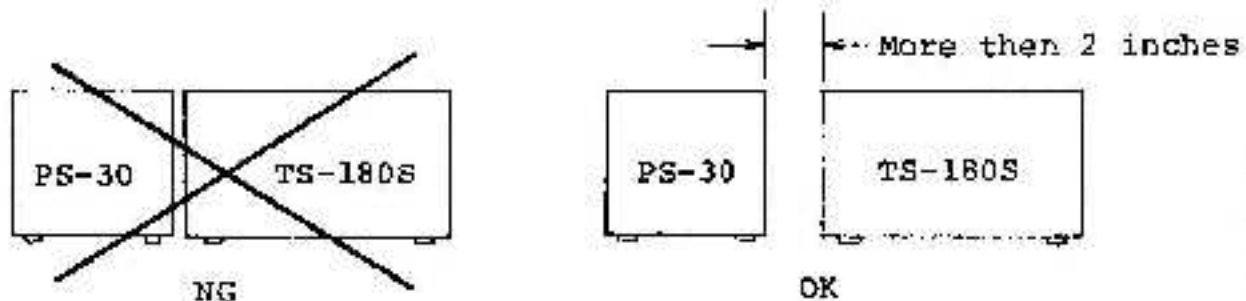
Some TS-180S users may report erratic DFC, and audio hum. You will find they have placed the PS-30 to the left of the transceiver. Hum is induced from the PS-30 into the DFC.

We are awaiting modification and production changes. Mean while, please be aware of this problem. Temporarily moving the PS-30 to the right hand side of the transceiver will cure the problem. Spacing the two units with the SP-180, or just separating at least two inches will also cure the hum. When full information is available, we will follow up.
