SERVICE BULLETIN

from: TRIO-KENWOOD COMMUNICATIONS, INC.

SUBJECT: SERVICE NOTES ON TS-820

DATE 10-25-77

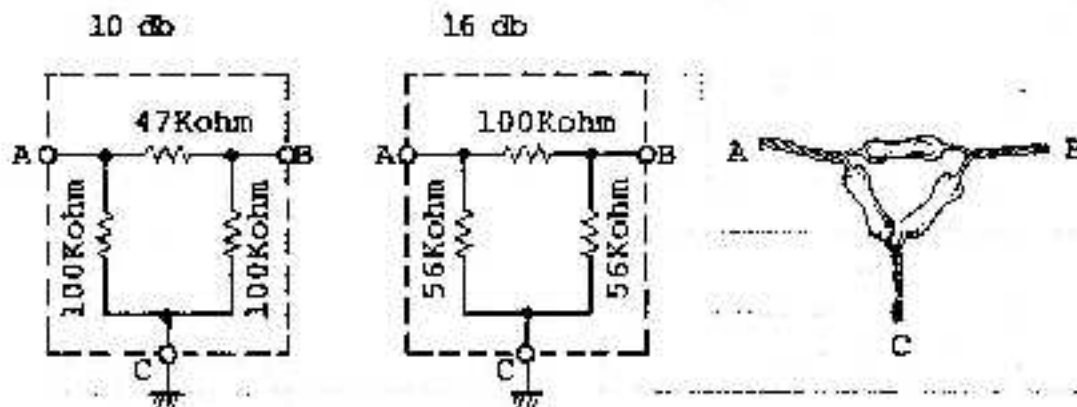
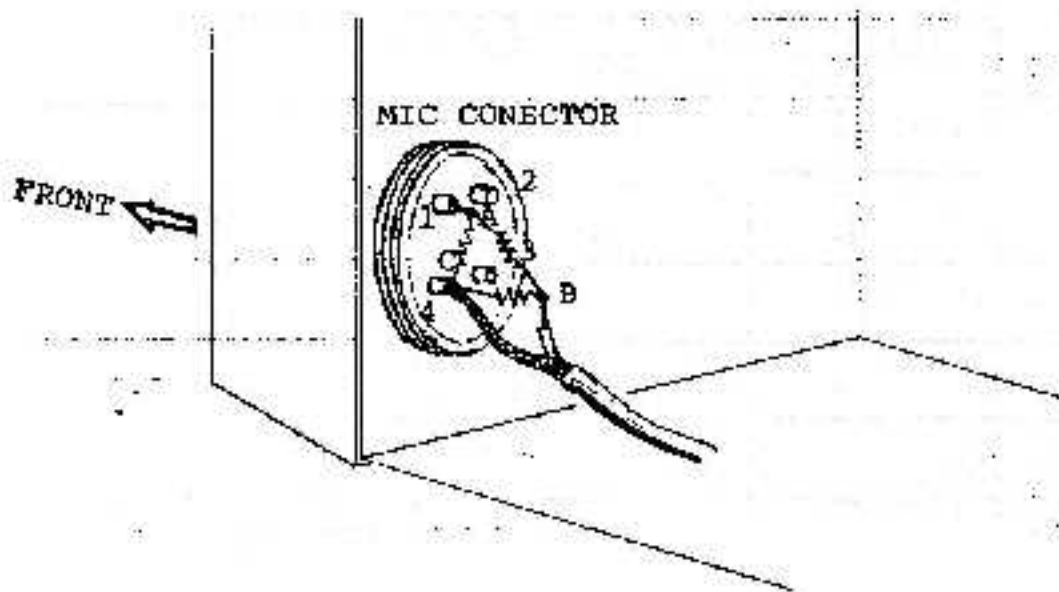
When using a high output microphone (i.e. Shure 444), it is very likely that there will be distortion of the transmitted audio if the processor is used. The reason the distortion occurs is because the processor is between the first microphone amplifier and the microphone gain control. The installation of one of the attenuators shown below will reduce the microphone input to a level that will not cause RF speech processor distortion. The attenuator figures are approximate.
