NO ALC IN TUNE

K9TW - DRIVER STAGE TESTING DOCUMENT.
www.k9tw.com/how-to-guides

BASIC TROUBLE SHOOTING

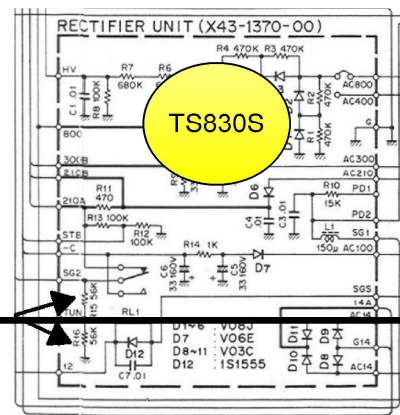
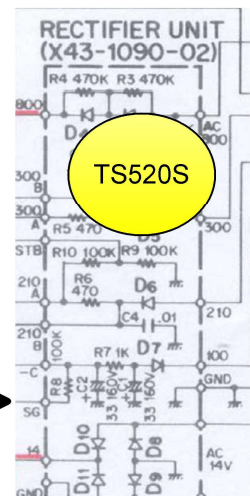
- 1) Connect 50 ohm dummy load
- 2) Power switch = ON
- 3) Heater Switch = ON
- 5) MODE switch to TUNE
- 6) Meter Switch to ALC
- 7) Carrier Control = CW
- 8) STAND-BY switch = SEND
- 9) Adjust BIAS (60ma resting current) with BIAS control on rear to 60ma

TS-830 - Check R15 & R16 resistance.
TS-520 - Check R8 & R7 resistance.

REPLACE BOTH RESISTERS EVEN IF ONLY ONE IS BAD.

TS530 & 830, Check Rectifier Board RL1 relay contacts.

Jim did not say which Mode he has lost ALC in so I'm going to assume he loss ALC in "TUNE mode. I suggestion Jim check R15 and R16, both are 56K 1/2 watt reach. If either resistor has gone high in resistance then replace both resistors with new 56K 1/2 watt resistors and check for normal ALC in TUNE mode.

Before checking the resistors as you noted it is OK to place mode switch in CW and attempt to tune the tank to resonance (dip the plate current). Has to be done relatively quickly as plate current can initially be pretty high with full 250vdc screen grid voltage available. Can also load in CW mode until can obtain replacement resistors. Just have to make that initial plate current dip relatively quickly and best to preset the Plate Tune cap close to the white band indication on the arc.
