KENWOOD 2022 Dayton Hamvention Kenwood Forum

- Agenda:
 - Introduction Mark Gilger (WB0IQK)
 - Updating & repairing Hybrid- Jan Servaites (N8CBX)
 - Common Equipment Problems Terry Wagoner (K9TW)
 - Kenwood Legacy Equipment Resources Mark Gilger (WB0IQK)
 - Questions and Answer Session-
 - Jan Servaites (N8CBX),
 - Terry Wagoner (K8TW),
 - Mark Gilger (WB0IQK)

Hybrid Transceivers Common & Model Specific Problems

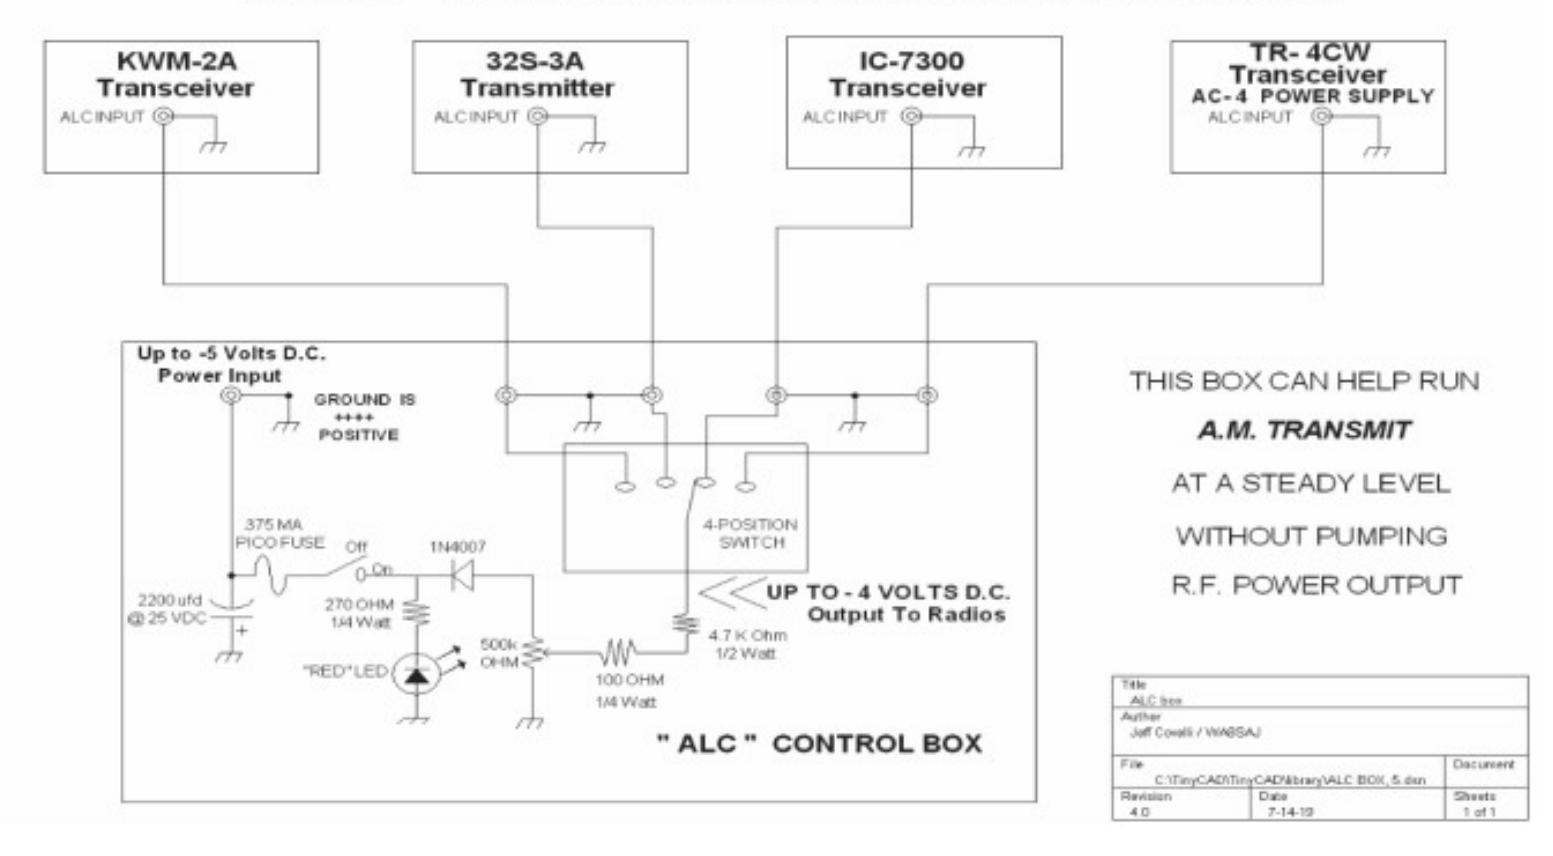
KENWOOD ALC CONTROL BOX BY: WA8SAJ

" ALC " CONTROL BOX FOR HOLDING TRANSMITTER POWER OUTPUT "STEADY" FOR DRIVING LOW EXCITATION AMPLIFIERS

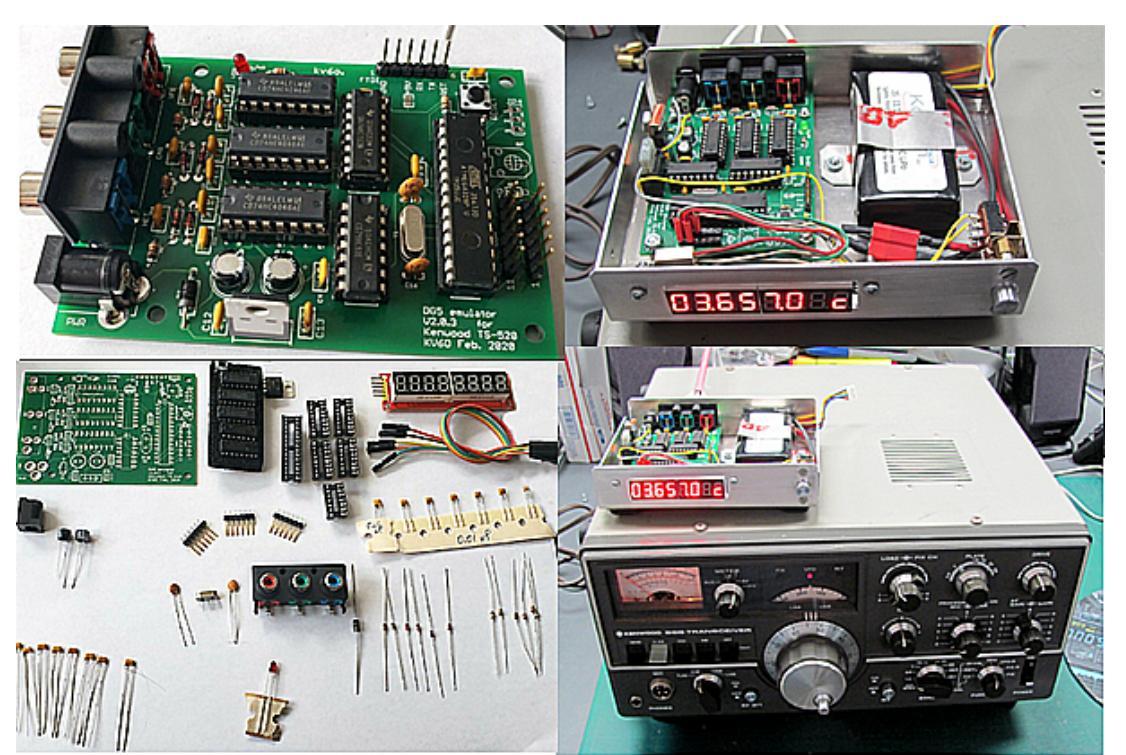
KV60 DG-5 Emulator kit to replace the Kenwood DG-5 digital readout for the TS-520S N8CBX 05-06-2020

DG-5 Emulator kits available from KV6O, Stephen Leander, for \$75. Uses 6 chips, including the Atmel 328P microcontroller, same one used in the "Arduino". Kits were available in 2020, but shipments are suspended due to part shortages (as of 4/03/2022)

Signal Levels Needed

Measured levels (TS520S) at RCA jacks and works fine

HET - 0.620Vpp

CAR - 0.750Vpp

VFO – 0.670Vpp

As a general rule, signal levels of 400mVpp or higher are fine

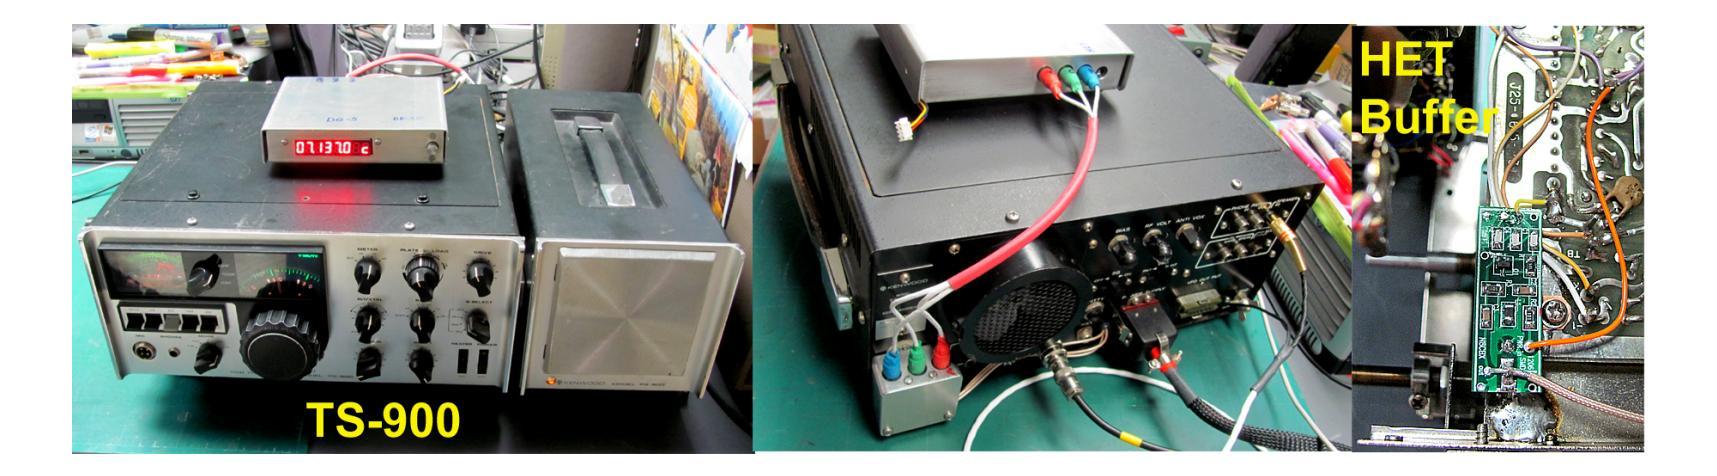
KENWOOD Kenwood TS-900

•The TS900's HET freq. requires a single-stage buffer amplifier
•The buffer board is mounted as close to the RF board as possible.
•VFO & CAR no buffering required

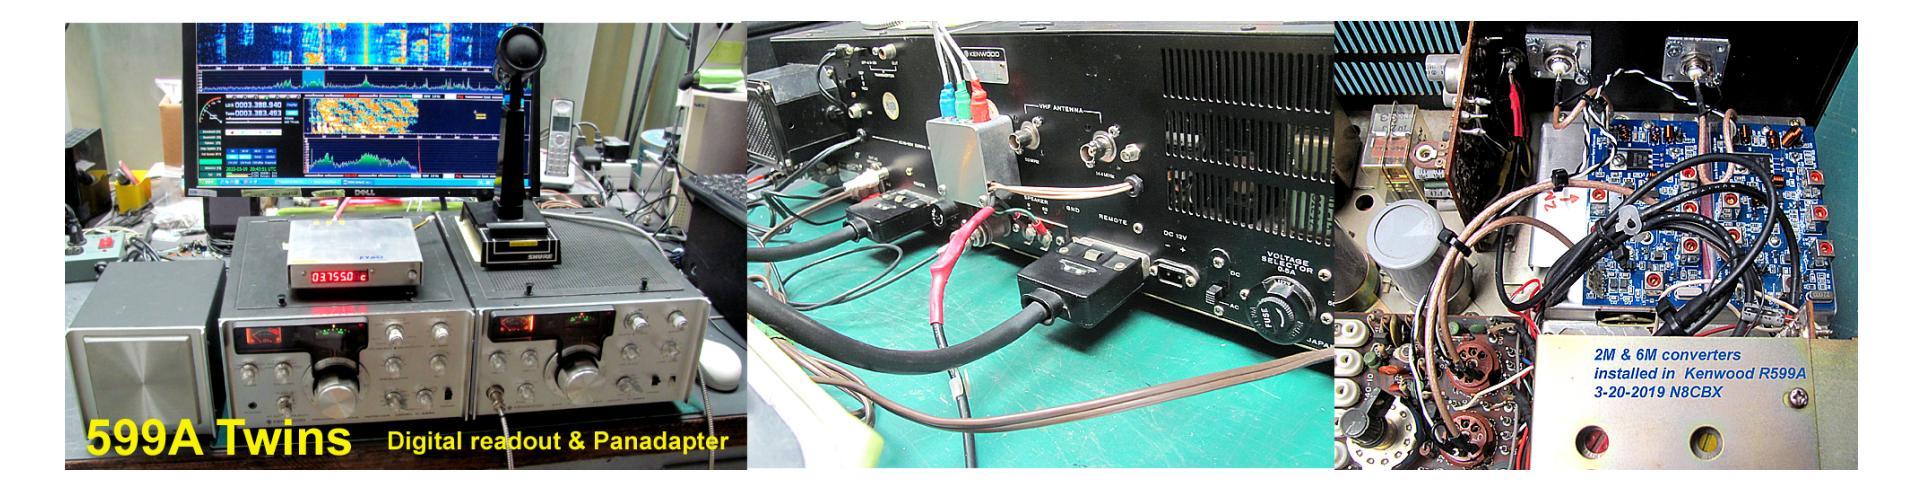
KENWOOD Kenwood 599A Twins

•The R599 needs no HET buffer; Connect directly with coax cable

- •The R599 is the easiest of all Kenwood radios to modify, and works great
- •My R599A was upgraded to have modern radio features to include:
 - •Digital frequency readout
 - •2M & 6M transverters
 - •Panadapter display An IF tap to bring out the 3.395 MHz IF freq.
 - •(The IF tap is explained in the SM-220 manual)

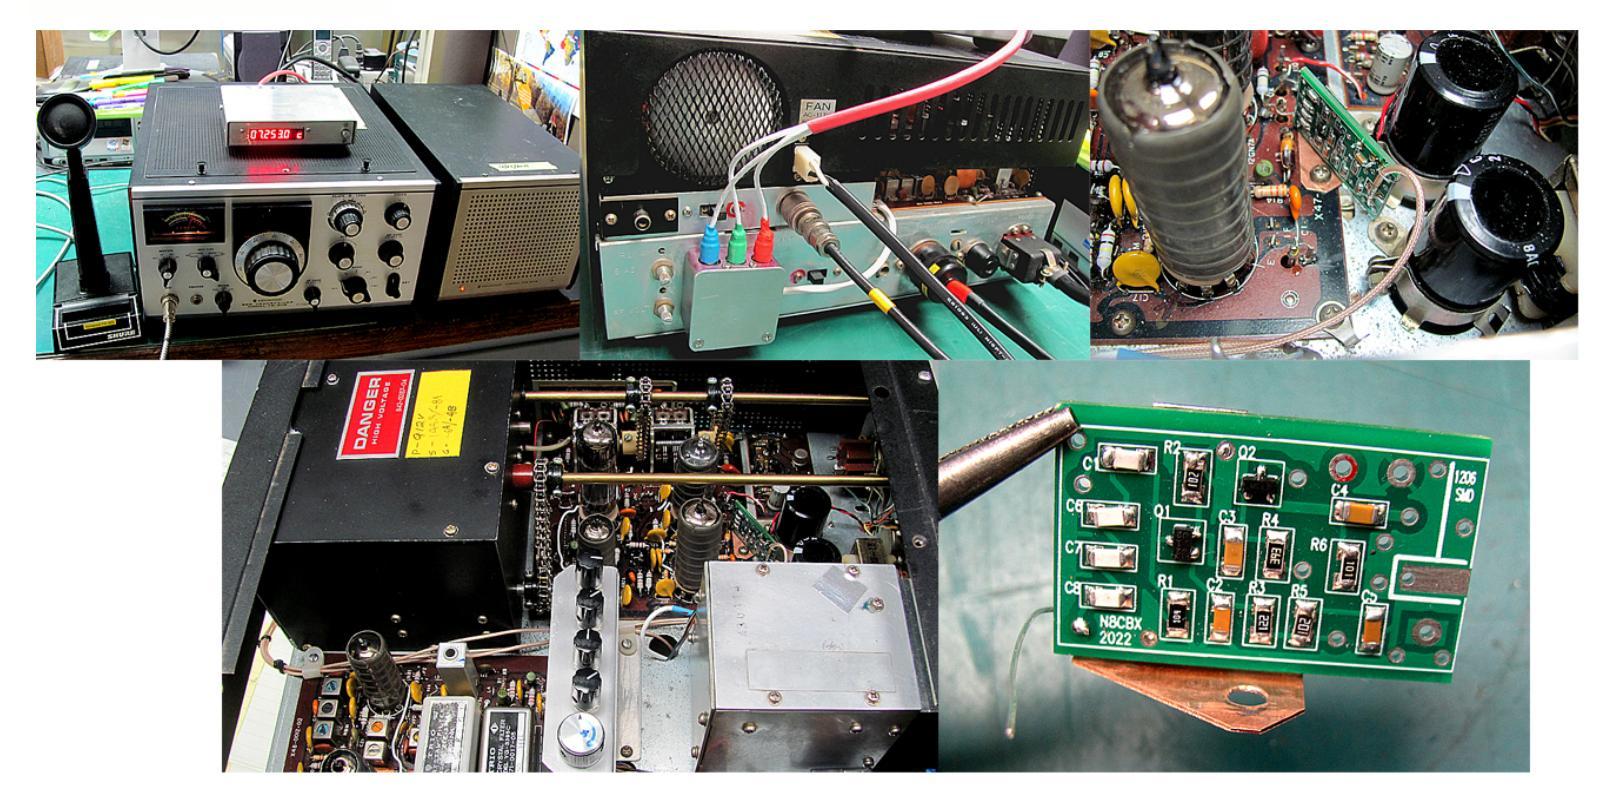
Kenwood TS-511S

The TS511's HET freq. requires a <u>dual-stage buffer</u> amplifier
The buffer board is mounted as close to the RF board as possible.
VFO & CAR no buffering required

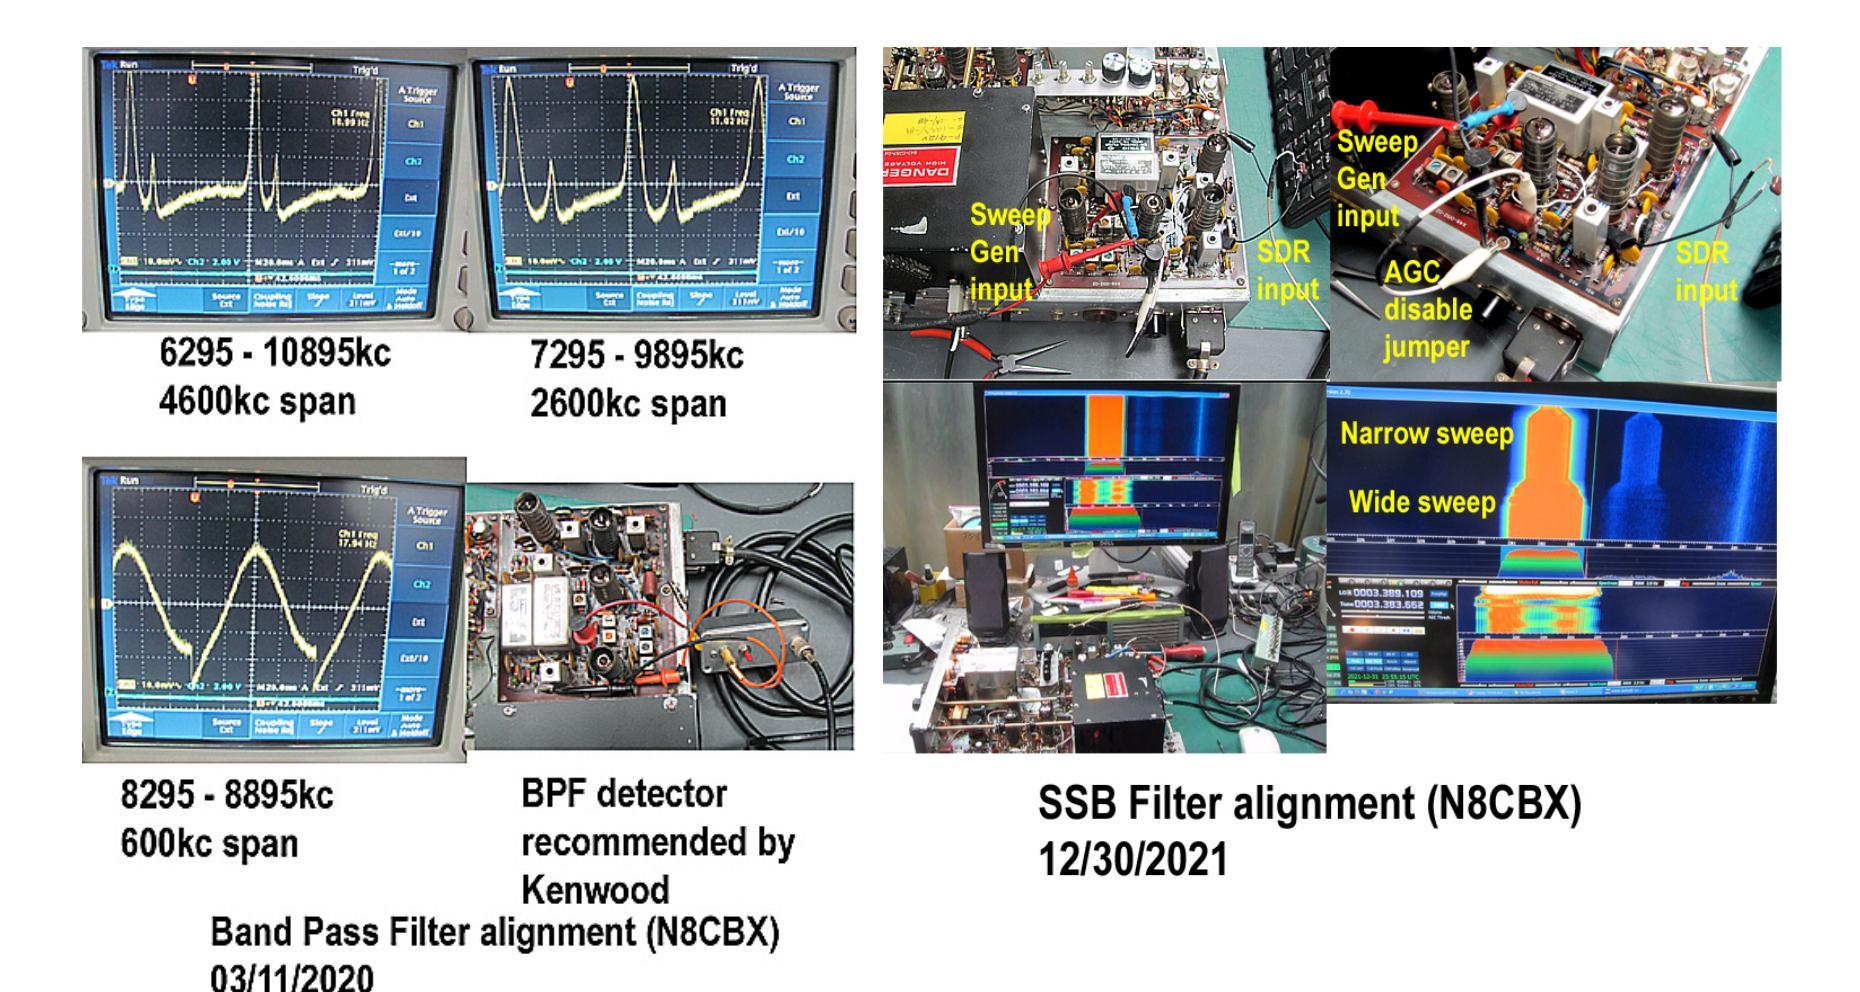
Those early Kenwood servicing procedures are written for 1960s test equipment. I experimented with my own procedures using modern tools. (SDR Panadapter using Softrock & HDSDR software) BPF & SSB filter alignment -

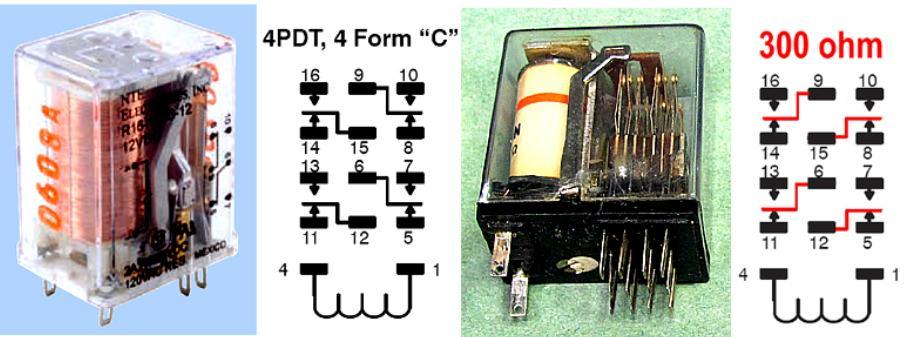
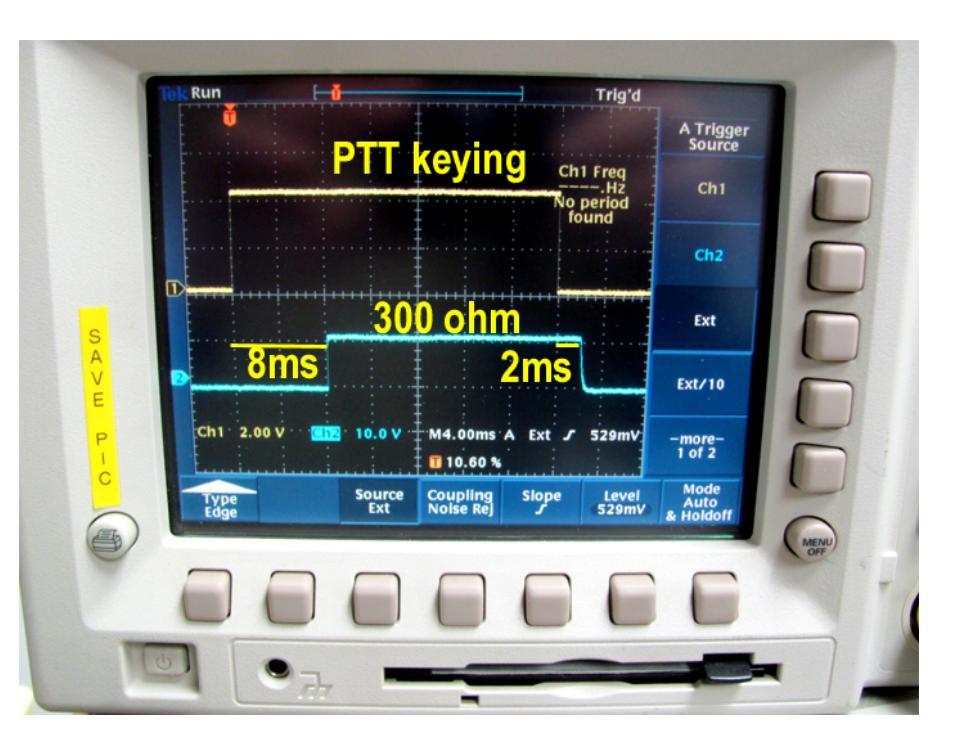
KENWOOD Modern T/R Relay for the 300ohm Relay

Relay - NTE R16-17D5-12 (4P-DT 5A-12VDC coil These relays are getting hard to find anymore
Socket – TYCO Electronics 27E126
Coil resistance – 180 ohms
Relay requires moving 4 wires
New socket is higher quality

2-3 hrs operation with new relay, working fine

Relay Timing Comparisons				
Relay	Operate time	Release time		
385	10ms	2ms		
300	8ms	2ms		
NTE	5ms	1.5ms

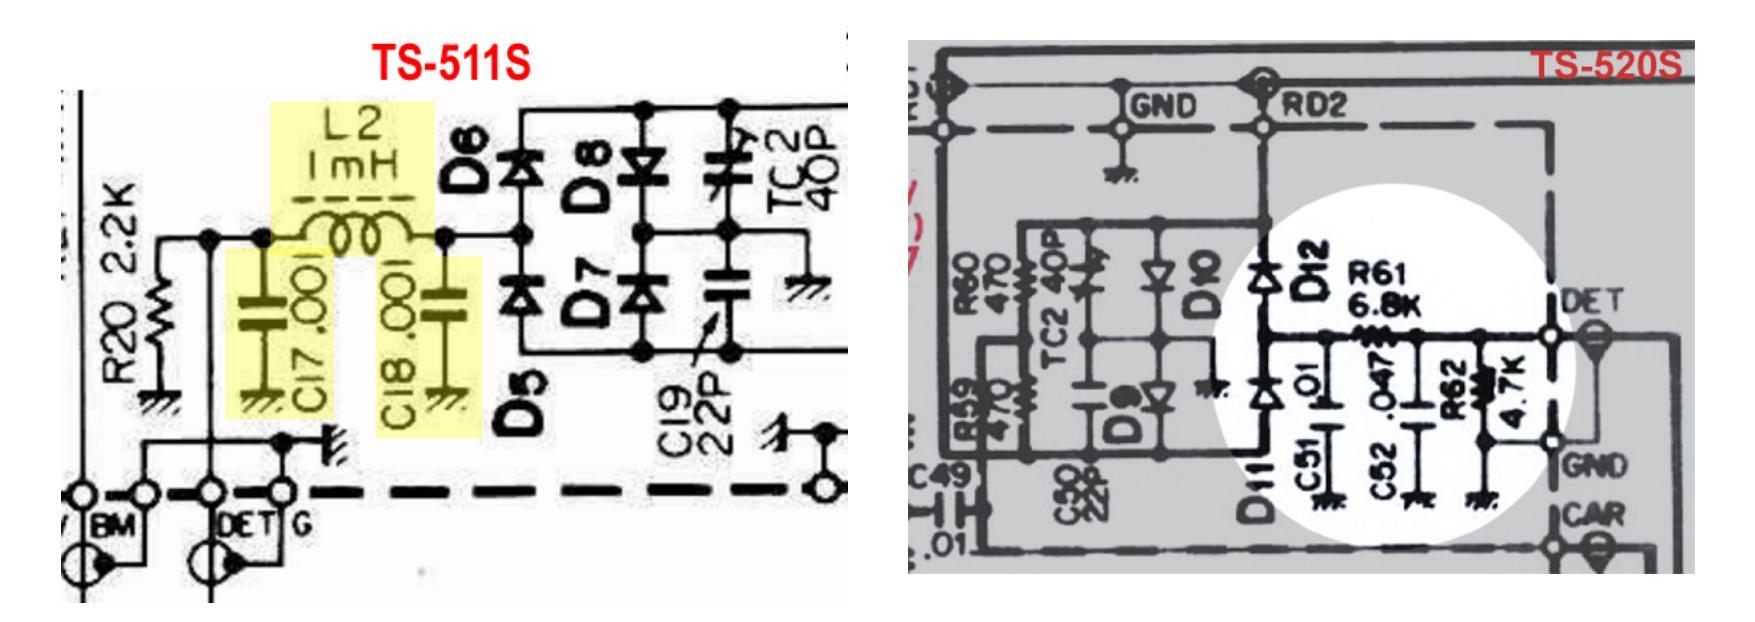
KENWOOD 511S Tips & Hints

Improved Audio – Masa Yamamoto AB9MQ says how to improve the TS-511S audio characteristics for a more mellow sound and providing more lows. This mod was realized by the TS-520S component changes. Locate the Pi audio filter on the X52-0010-00 Generator Unit and remove (L2, C17, C18)

Replace L2 with a 6.8K resistor

Replace C17 with a 0,047 capacitor (plastic film style)

Replace C18 with a 0.01 ceramic capacitor

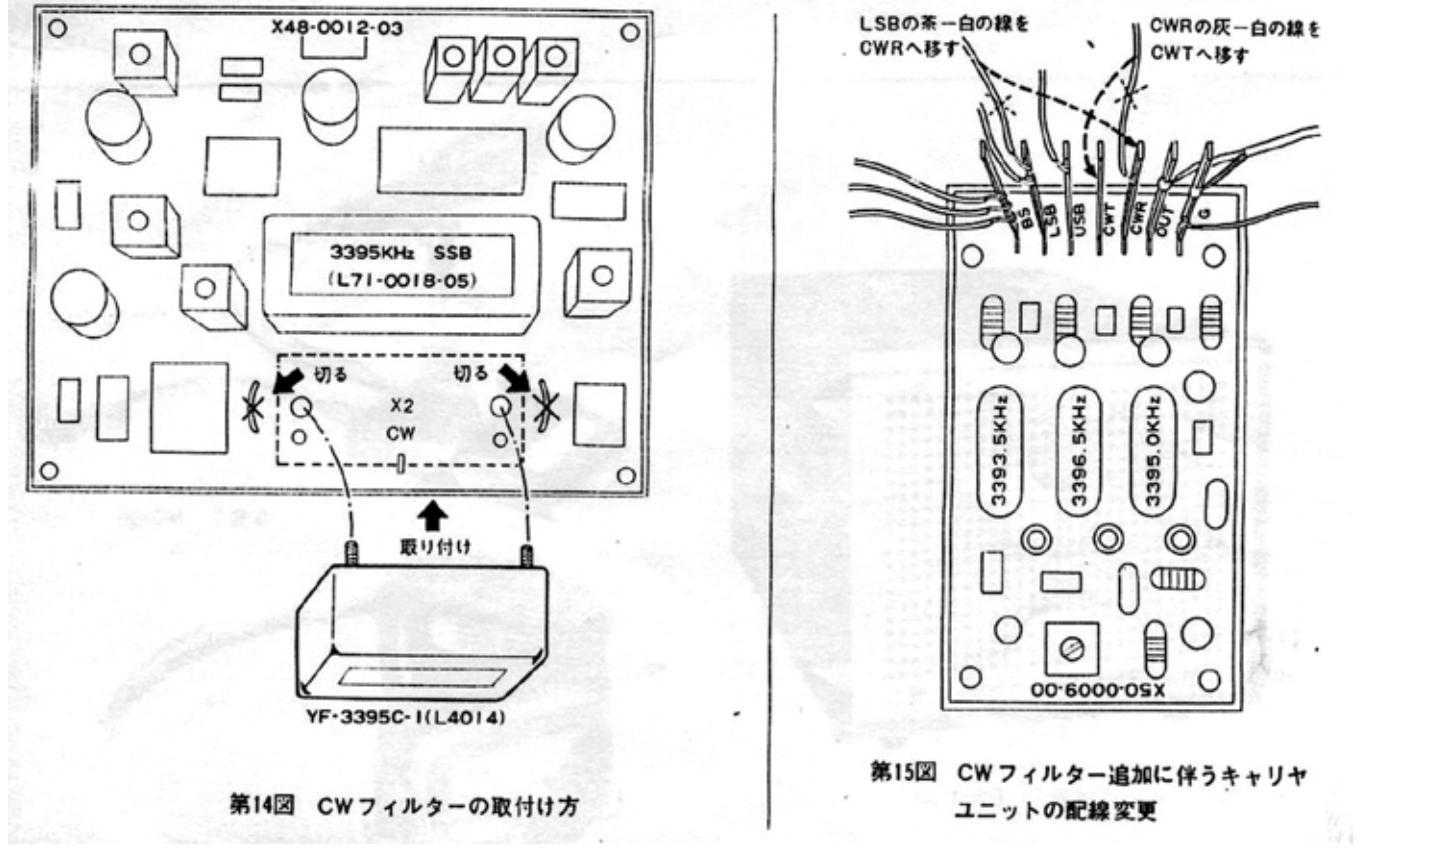
KENWOOD 511S Tips & Hints

CW filter installing – Masa Yamamoto AB9MQ provided this information that wasn't included in the owner's manual....(Also to review is Bill Shadid (W9MXQ) article that he wrote back in Feb. 2021...https://www.ozaukeeradioclub.org/index.php/newsletters)

The illustration shows some wiring changes to be made on the IF and Carrier boards for the CW to work properly.

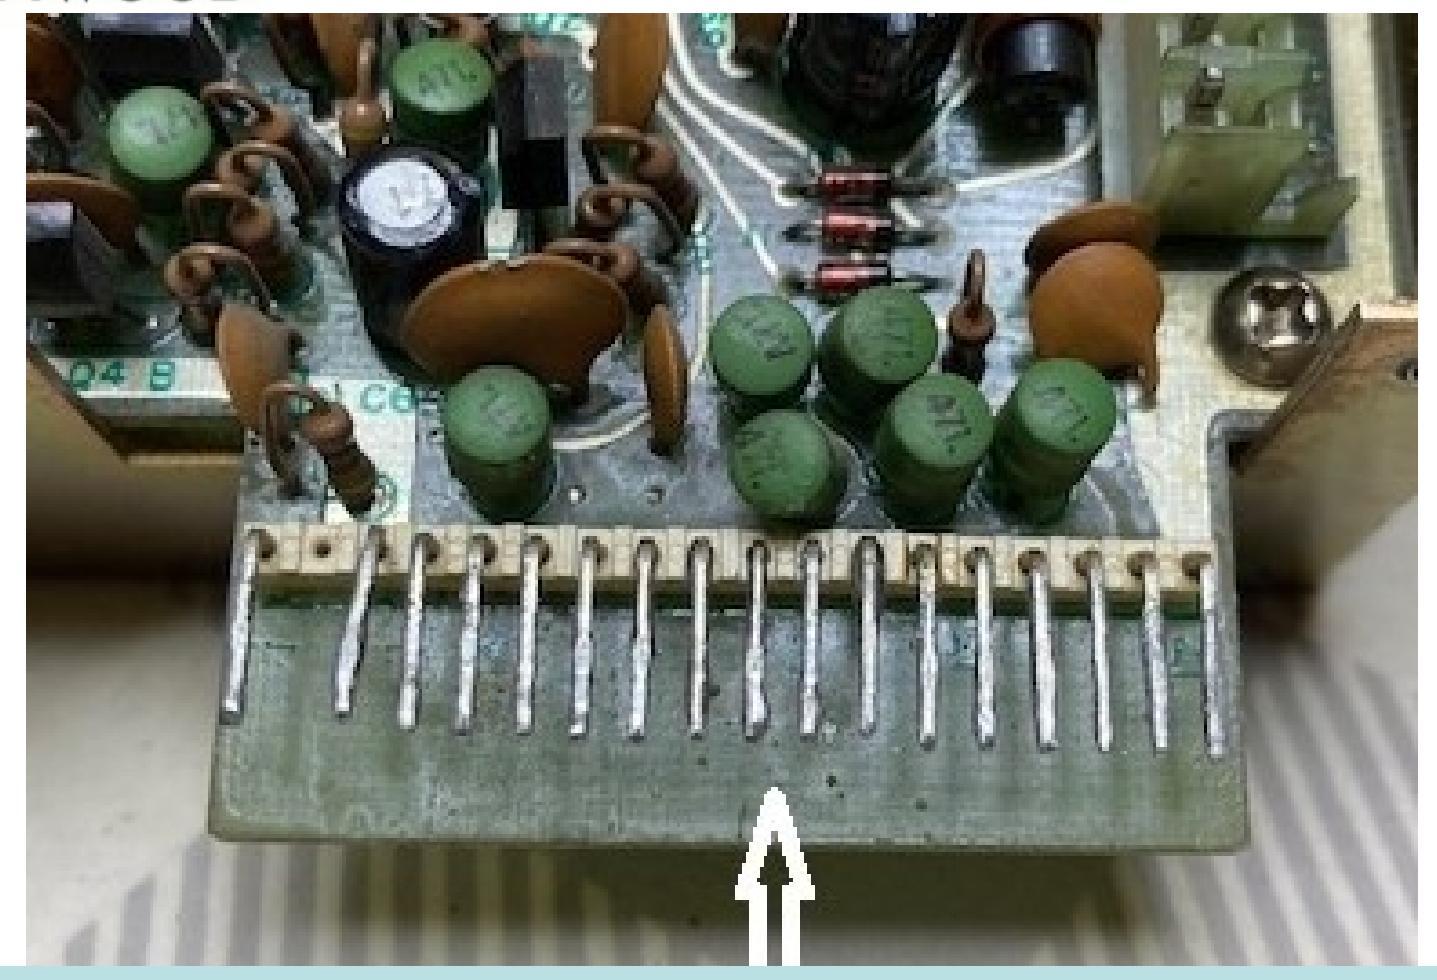
KENWOOD TS-820S DG-1 Molex Conn. Improper Repair Attempt

Solder Applied to Flat Male Stabs of DG-1 17 Pin Molex Connector on the DG-1 Unit

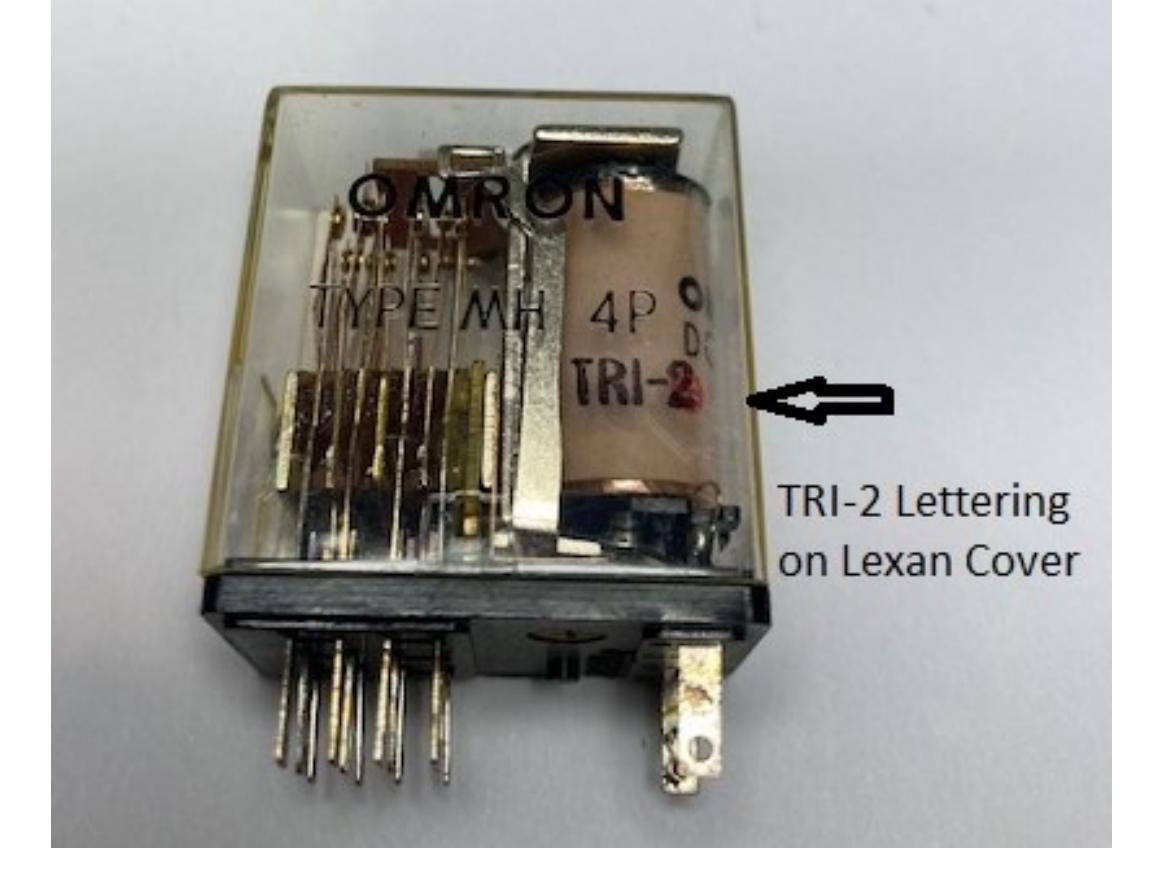
MH4P TRI-2 Antenna Relay

TS520/TS820 Omron MH4P Ant TR Relay Under Metal Shield Can. Actuating coil = 300 Ohms

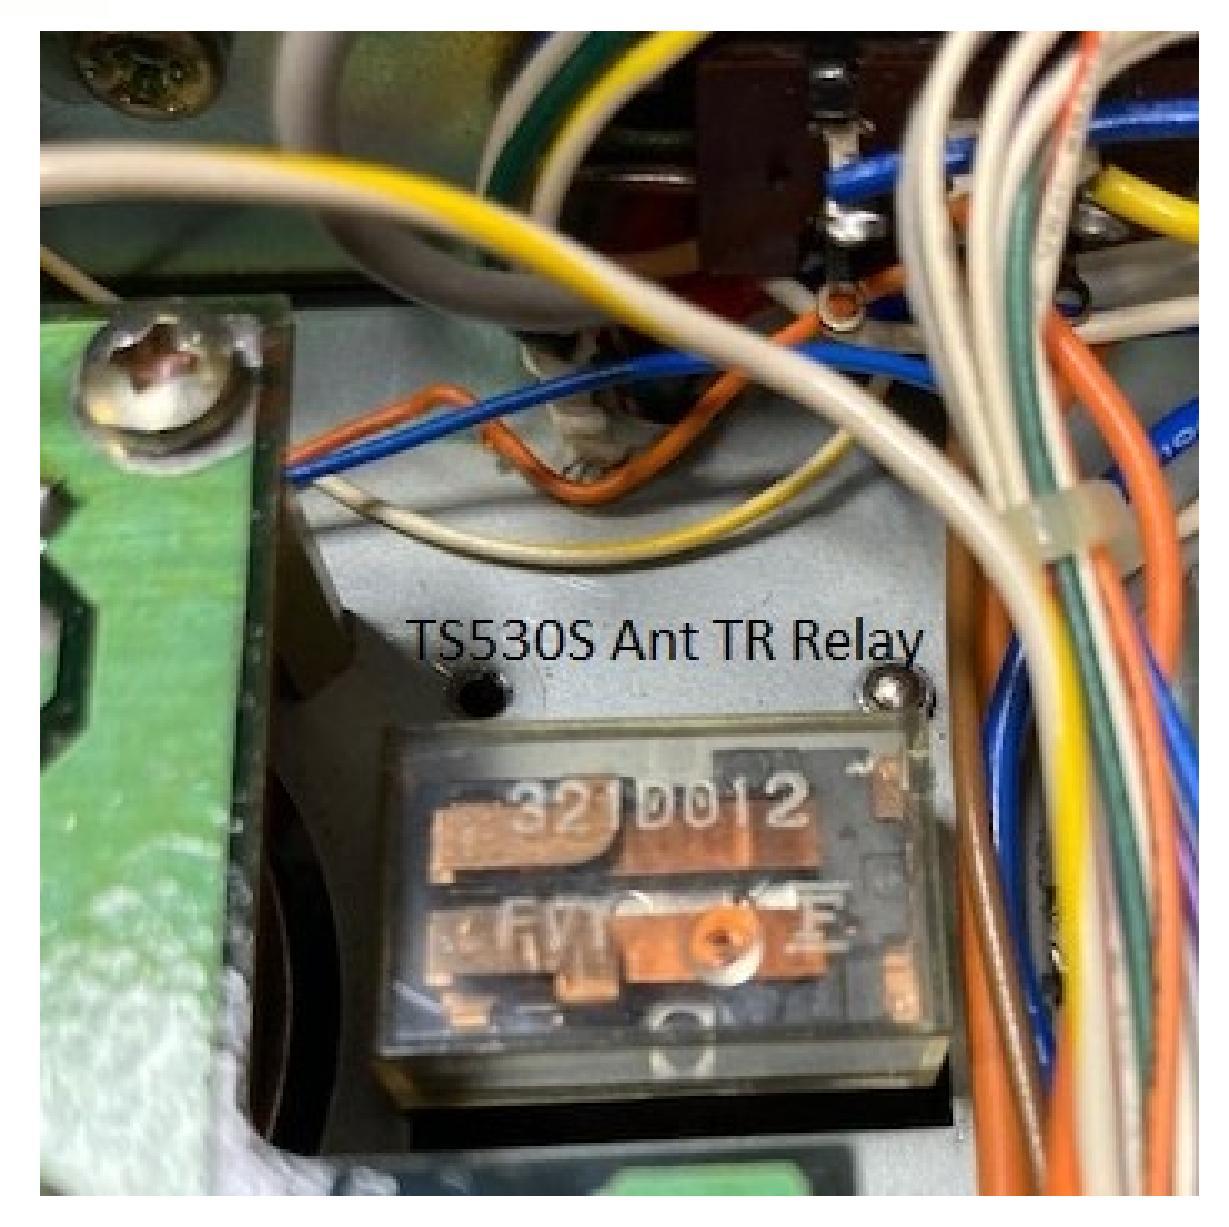
KENWOOD TS530S Clear Antenna TR Relay Fujitsu

TS530S Ant TR Relay. Two Types of Solder in Fujitsu Relays. One with clear Lexan Cover and one with Black Case

> TS5305 ANT TR FUJITSU FOR 321D012 BLACK LASE HERMETIC

SEALED COVER

COIL Res à 230 OHMS

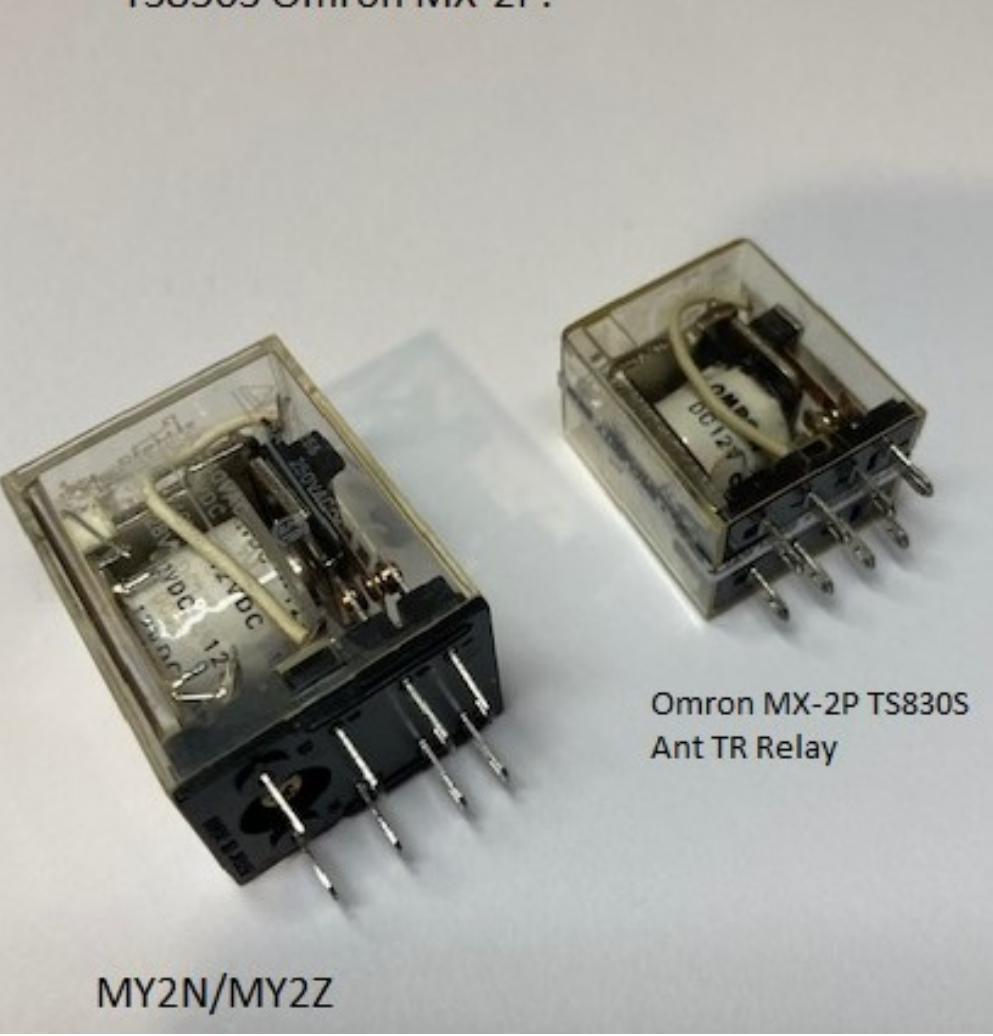
Omron MY2N vs. MX-2P

Omron MY2N and MY2Z are not subs for TS830S Omron MX-2P.

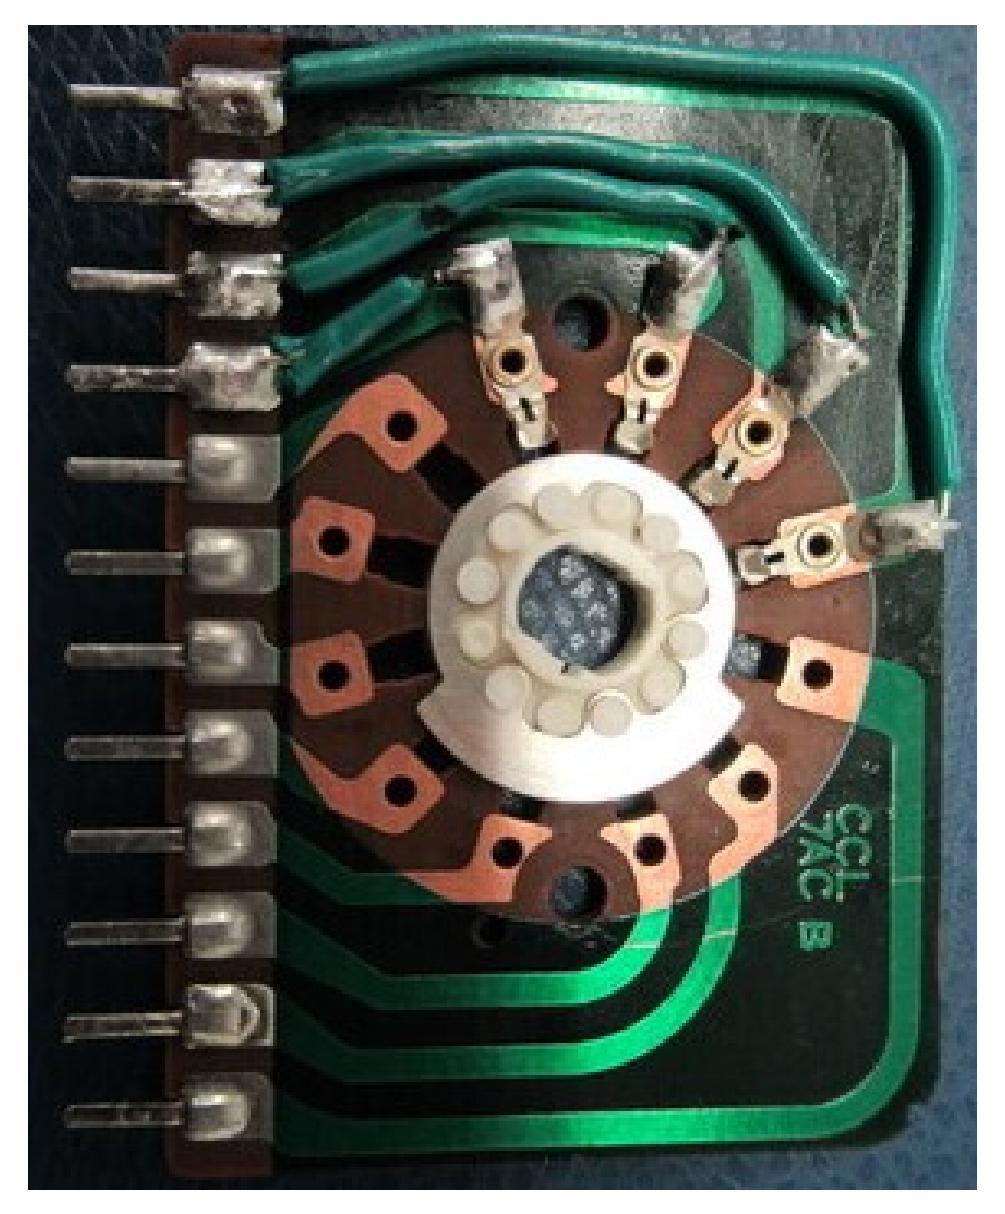
KENWOOD TS830S BS Contact Jumper Wire Repair

- Three ways to correct loose rivets condition. 1. Clean contacts and rotors and apply silver conductive ink as shown on K4EAA website 2. Clean contacts and solder hair pin contact to rivet head and foil trace. 3. Clean contacts and apply jumper wires from the solder lug of the hair pin contacts to the mating PC board male stabs. With all three methods must measure contact resistance to ensure problem has been corrected.

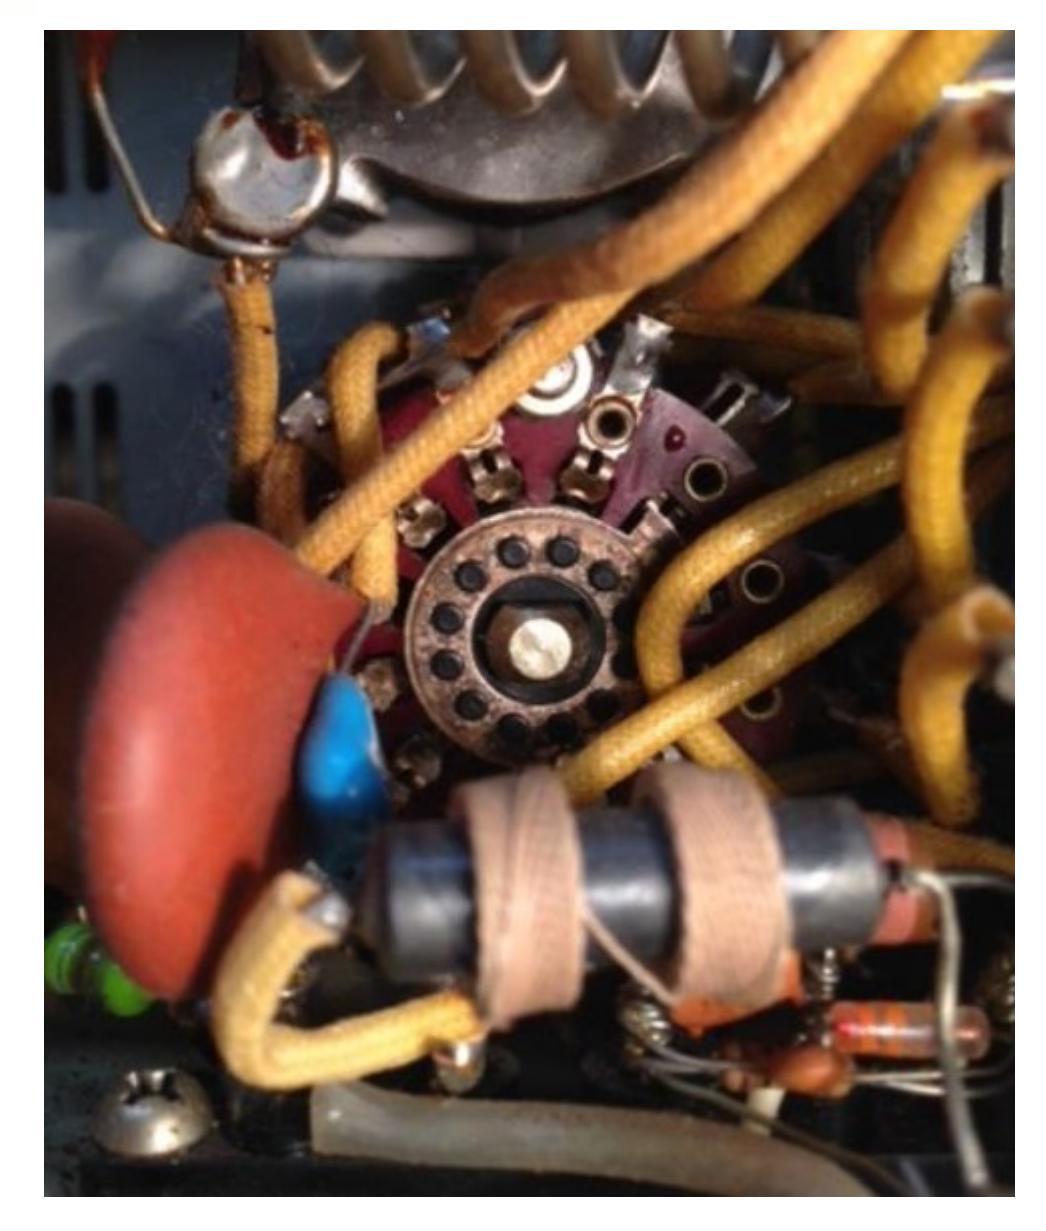
TS830S S22 Wiper

- See the detailed cleaning and repair procedure on Dick Housden's W0NTA website.
- The S22 switch contacts that switch in fixed Padder caps and select band specific Tank Coil taps are rarely bad. Often very dirty. Can be cleaned in place. Must remember to apply grease to the detents. Super Lube Silicone PTFE based is good choice. Apply to the accessible detent valleys with blade of small flat blade screw driver and to both ball bearings and distribute to all valleys with the two ball bearings.

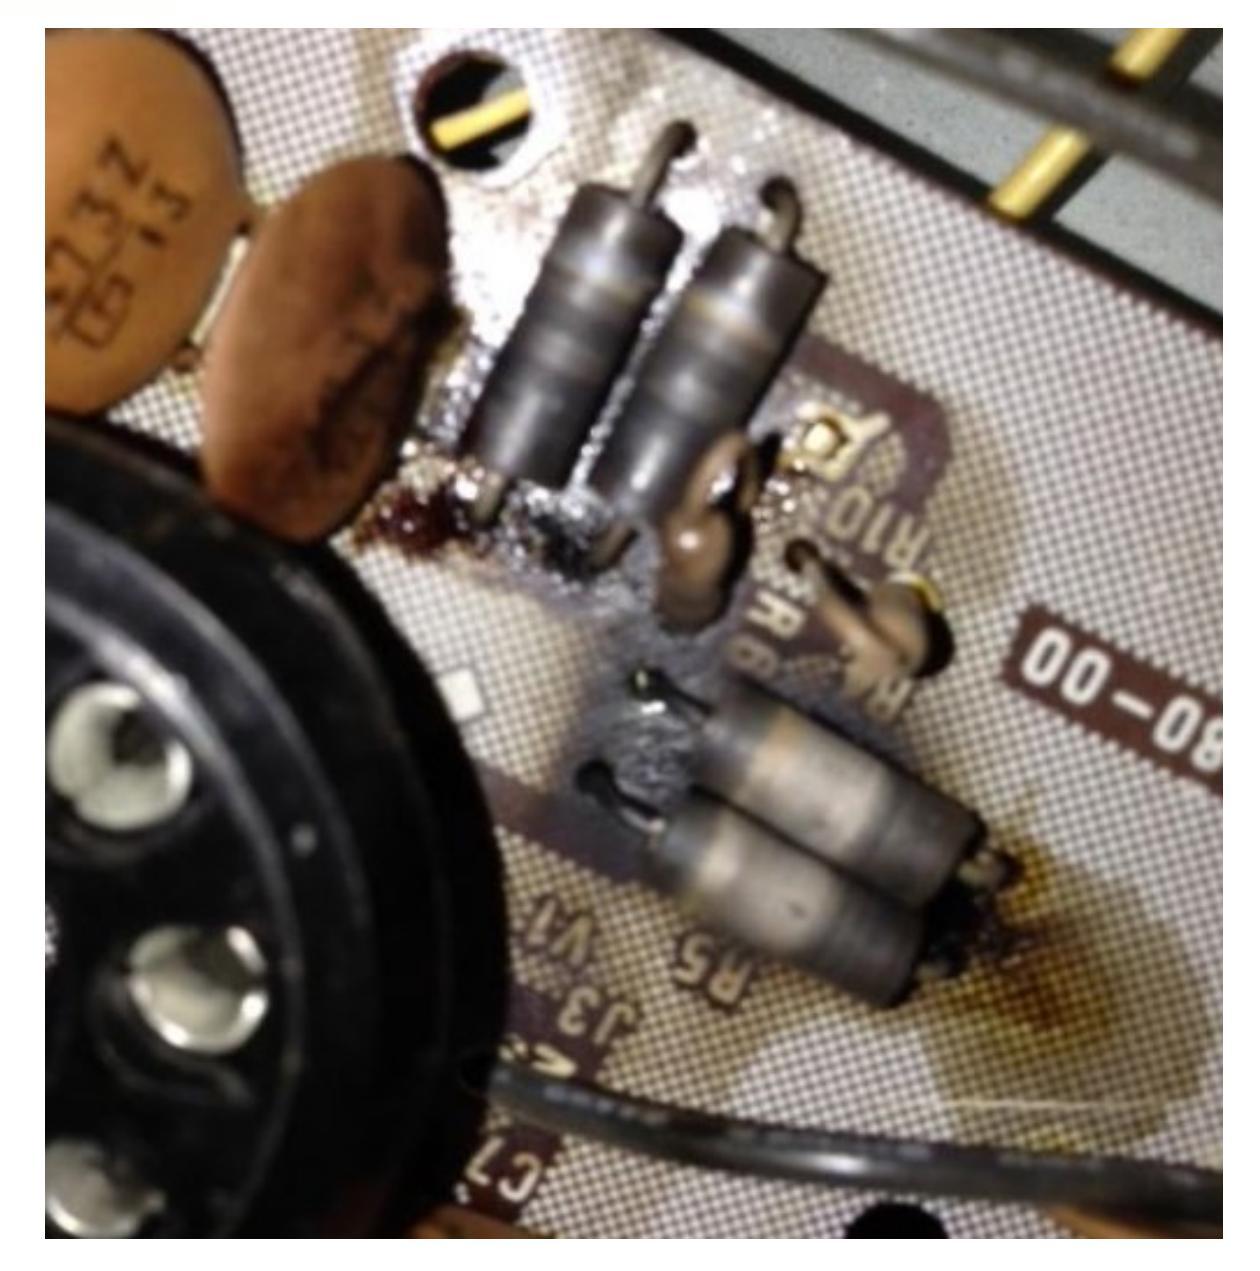
Cathode Resistor Damage

- Factory resistors are carbon composition and are hygroscopic. They draw moisture. Moisture at the area where the carbon is pressed around the lead wires causes corrosion and high resistance. Very common for the resistor value to drift high with age up to and including going open.

- There are two operational conditions that can damage and/or destroy the cathode metering resistors.
 - 1. Final tube arc over from the Anode to the Beam forming plates.
 - 2. Thermal runaway
- Strongly recommend installation of diode mod to protect the Panel Meter. Clamps the 900vdc across the resistors to approximately 2vdc.
- I use FR-257-B 1000PIV 2.5A Fast Recovery diodes, but common 1000 PIV 1A silicon rectifier diodes will work.
- Make sure there is a 6A fast blow fuse in the Holder. No MTH/MTL time lag/delay fuses and no high amperage automotive fuses (15 to 20 Amp 32 vdc).
