KENWOOD 2022 Dayton Hamvention Kenwood Forum

- Agenda:
 - Introduction Mark Gilger (WB0IQK)
 - Updating & repairing Hybrid- Jan Servaites (N8CBX)
 - Common Equipment Problems Terry Wagoner (K9TW)
 - Kenwood Legacy Equipment Resources Mark Gilger (WB0IQK)
 - Questions and Answer Session-
 - Jan Servaites (N8CBX),
 - Terry Wagoner (K8TW),
 - Mark Gilger (WB0IQK)

Hybrid Transceivers Common & Model Specific Problems

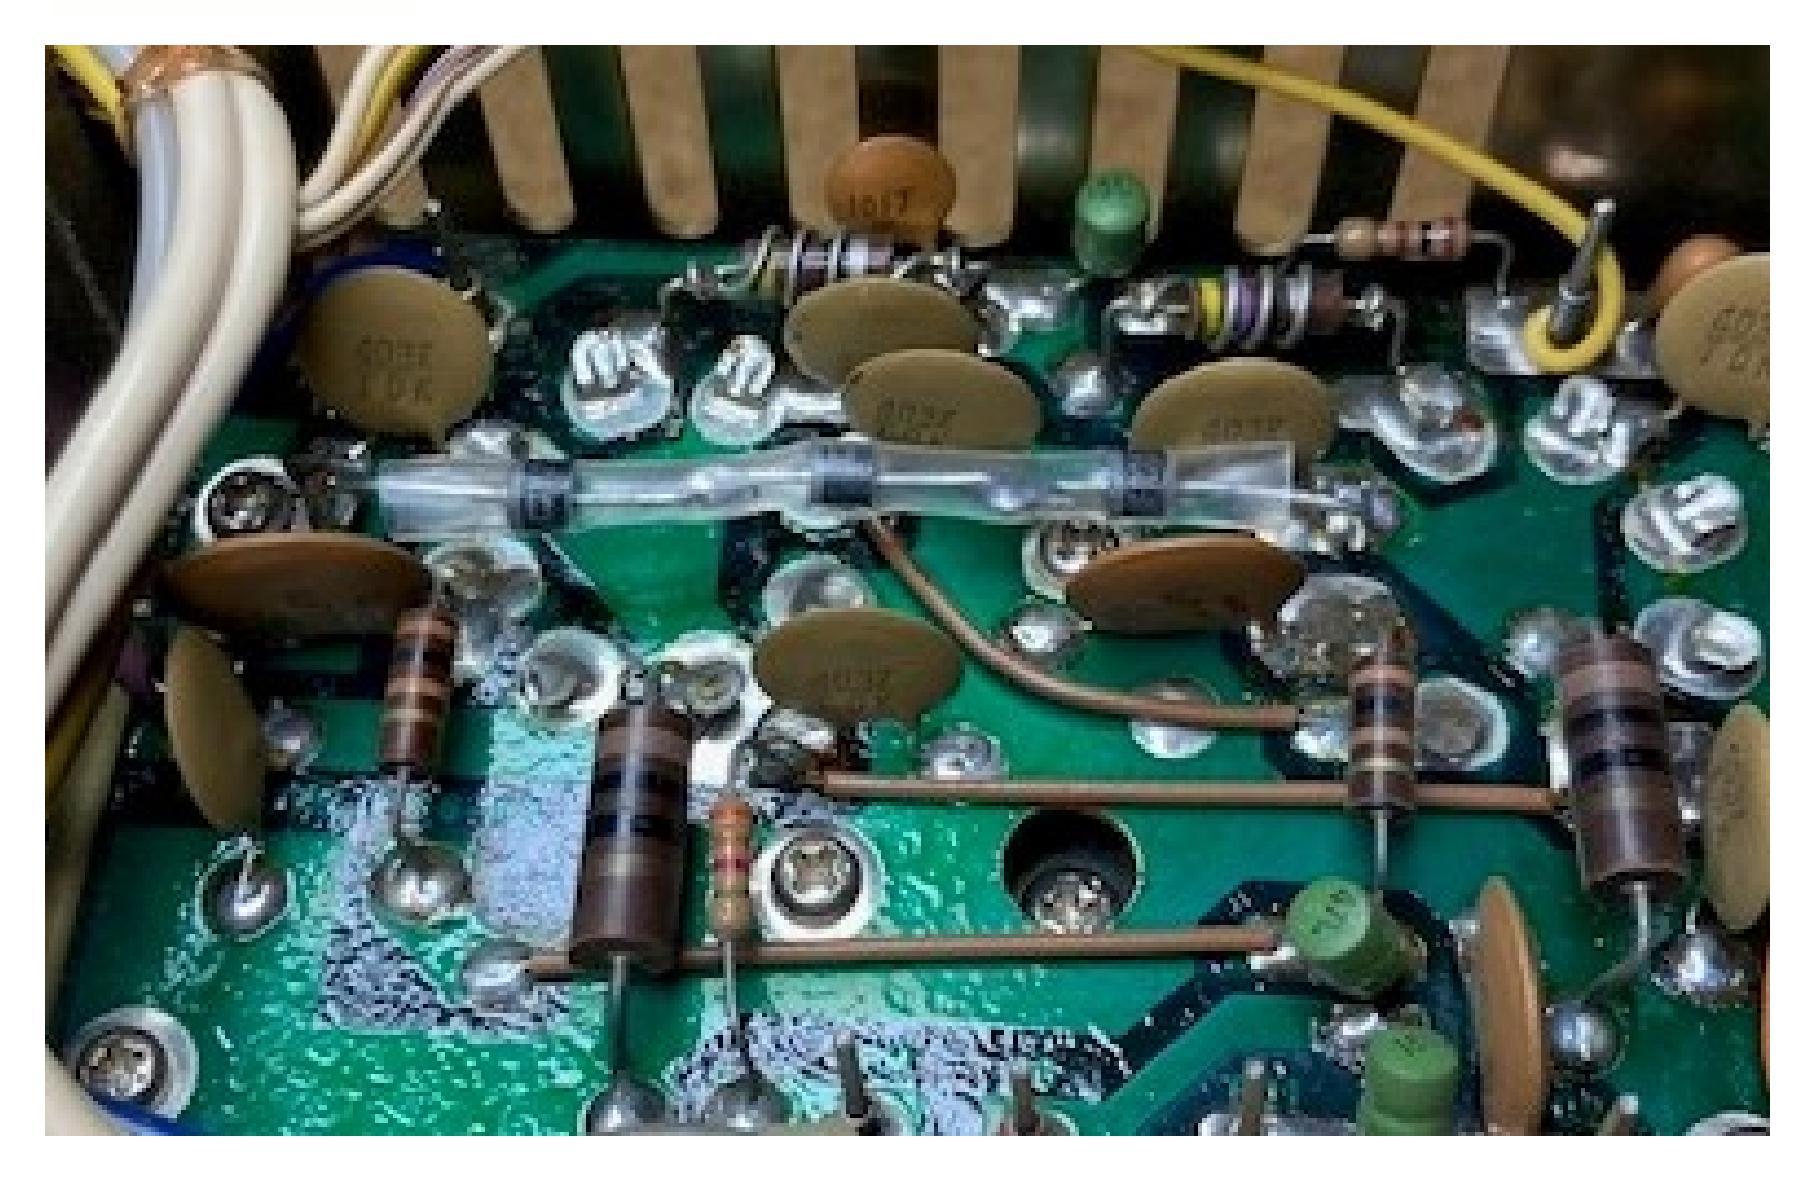
KENWOOD TS820S Final Tube Arc Over Protection Diodes

- Don't replace multiple parallel cathode metering resistors with a single resistor.
- The cathode metering resistors are not fuses. Do not increase wattage ratings. Install a 3 silicon rectifier diode string across the resistors to prevent Panel meter damage. See Kenwood pages on WB4HFN website.

- There are two operational conditions that can damage and/or destroy the cathode metering resistors.
 - 1. Final tube arc over from the Anode to the Beam forming plates.
 - 2. Thermal runaway
- Strongly recommend installation of diode mod to protect the Panel Meter. Clamps the 900vdc across the resistors to approximately 2vdc.
- I use FR-257-B 1000PIV 2.5A Fast Recovery diodes, but common 1000 PIV 1A silicon rectifier diodes will work.
- Make sure there is a 6A fast blow fuse in the Holder. No MTH/MTL time lag/delay fuses and no high amperage automotive fuses (15 to 20 Amp 32 vdc).
